Service Bulletin

Subject: Rear Body Fuse Block Loose Fuse Connection

Models: 2015-2017 Cadillac Escalade Models
2015-2017 Chevrolet Suburban, Tahoe
2015-2017 GMC Yukon Models

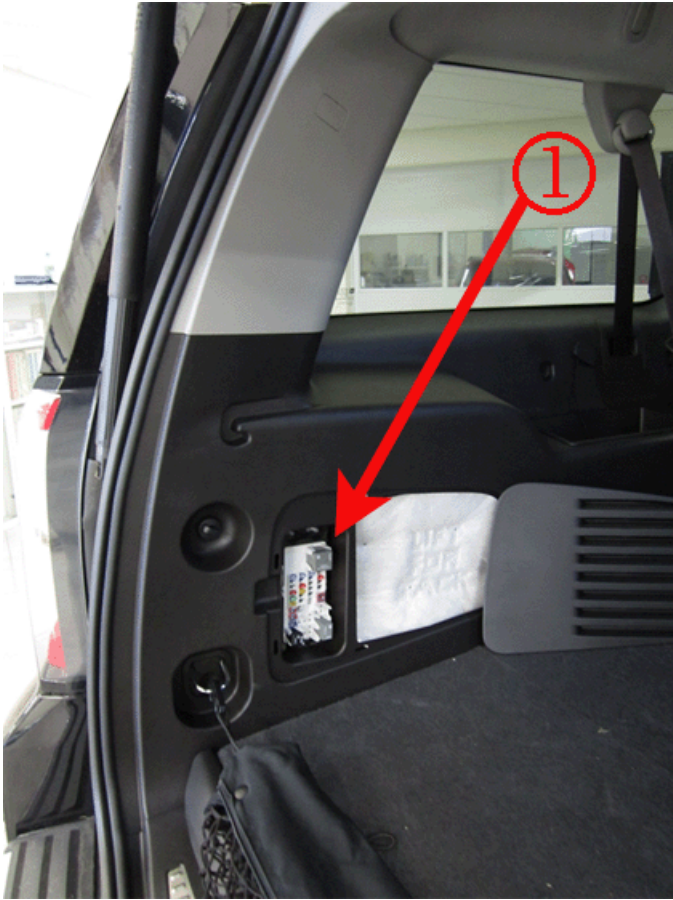
When working on any of the systems listed below that receive power from the rear body fuse block (1), inspect for loose fuse connections inside the fuse block itself. In some cases, the fuse has poor terminal tension and may cause intermittent or completely inoperative conditions for these systems:

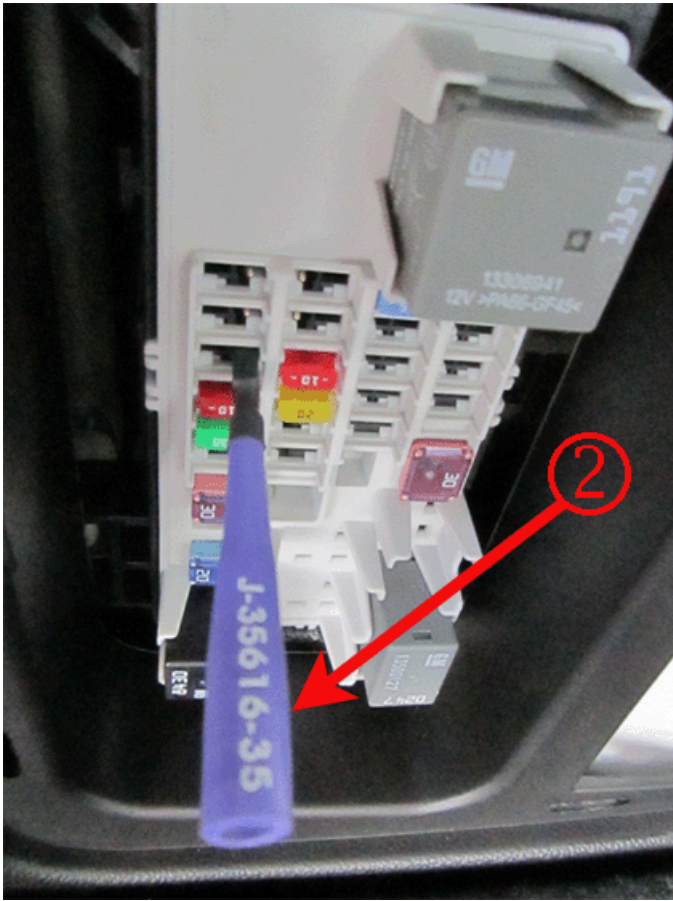
Using the "purple" J-35616-35 test probe, check for proper terminal tension at the suspect fuse (2).

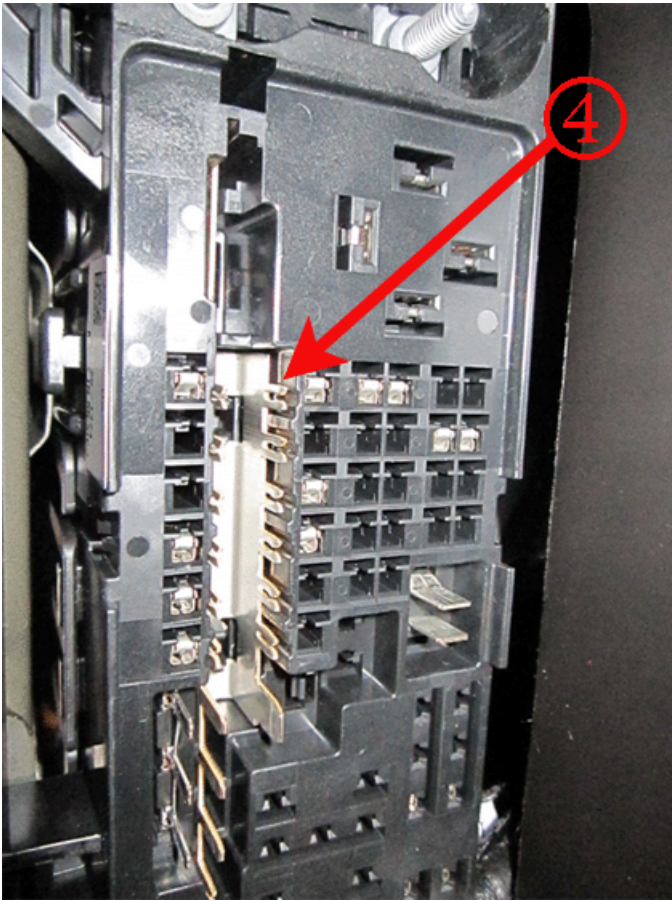
In many cases, the loose connection is on the main power buss bar (4), inside the rear body fuse block.
