Document ID: IK0900115

Title: Fan Shaft Failure Diagnostics

Applies To: 11/13L ProStar, PayStar, and TransStar with feature code 12THX (Viscous Fan Drive)

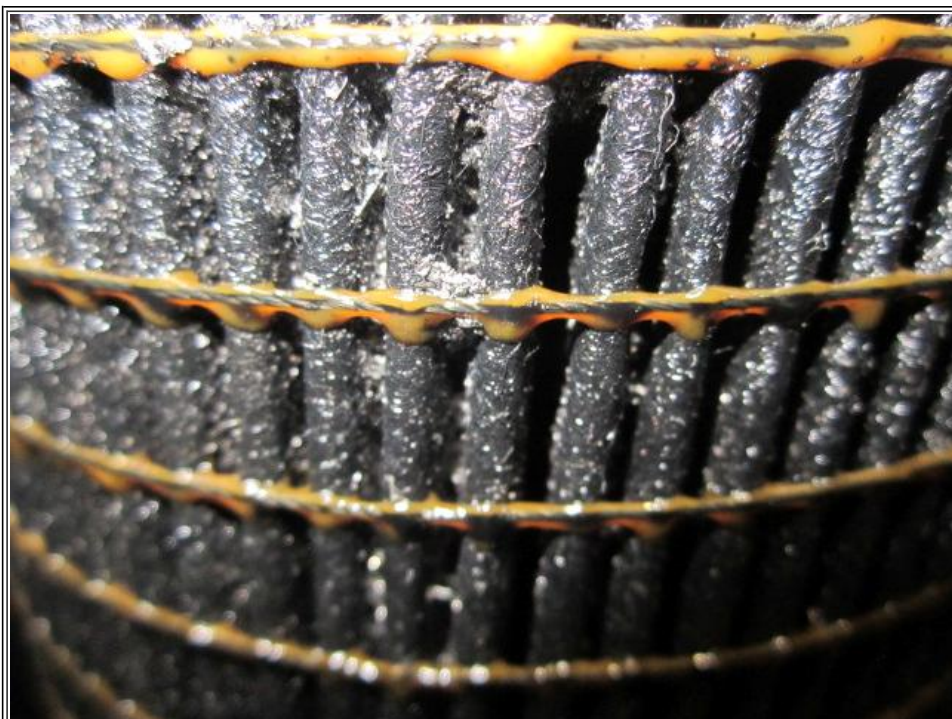
Figure 1: Oil filter with metal shavings present

Step	Action	Decision
1	INITIAL CHECKS: Have any of the following occurred? 1. Metal shavings in the oil. Both the oil and oil filter should be checked for this. See Figure 1 for an example. 2. Complete loss of oil. 3. Multiple fan shaft failures (i.e. this is not the first occurrence of the fan shaft failing on this vehicle.)	Yes: Proceed to Step 2.
		No: ProStar/PayStar models: proceed to Step 8. TranStar models: replace the fan drive.

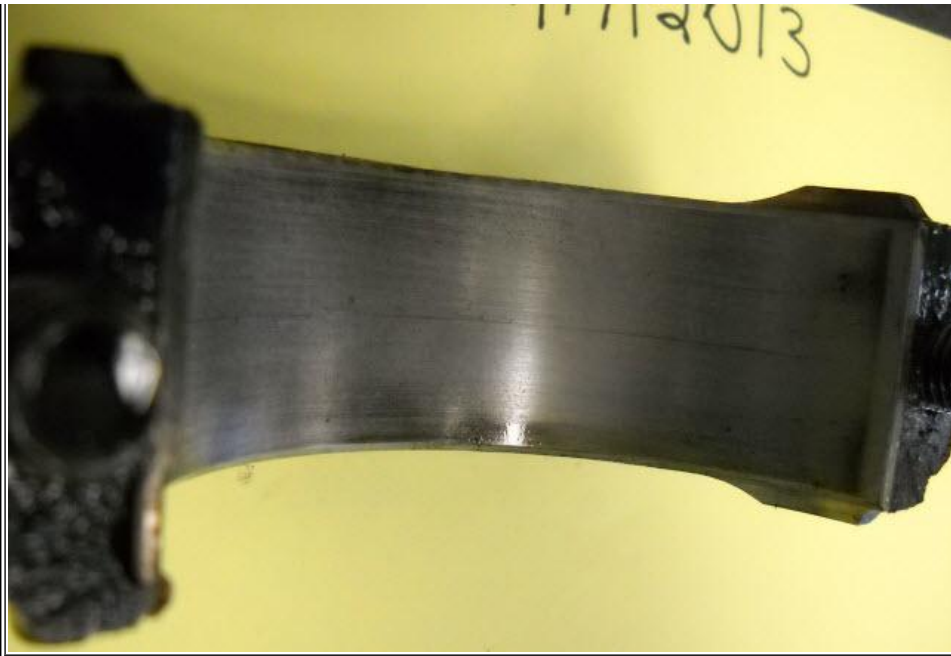
Figure 2: Good bearing - reusable

Step	Action	Decision
2	MAIN AND ROD BEARING INSPECTION: Drop oil pan and inspect each main and rod bearing and journal, one by one. A. Do all bearings meet reuse guideline? B. Are journals free from defects? See Figures 2 and 3 for examples.	A. Yes B. Yes Reinstall bearings and install new main and rod cap bolts, then proceed to Step 3.
		A. No B. Yes Replace damaged bearings and install new main and rod cap bolts, then proceed to Step 3.
		A. Either Yes or No B. No Create iApproval form for an engine replacement, continue to step 6.

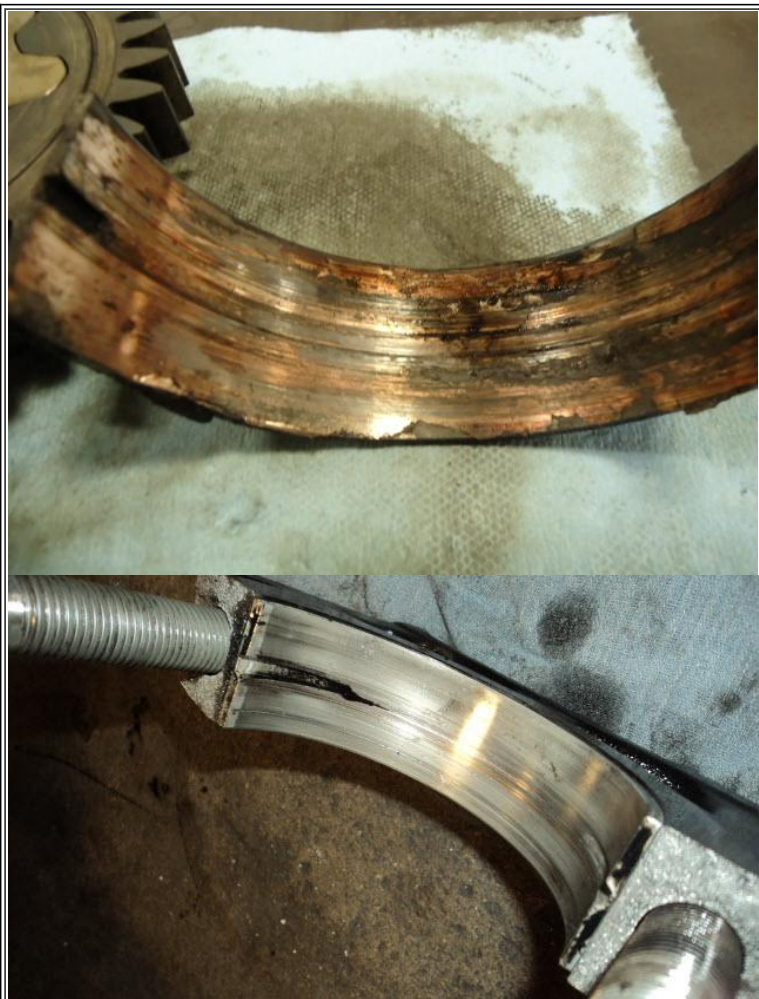
Figure 3: Unusable Bearings

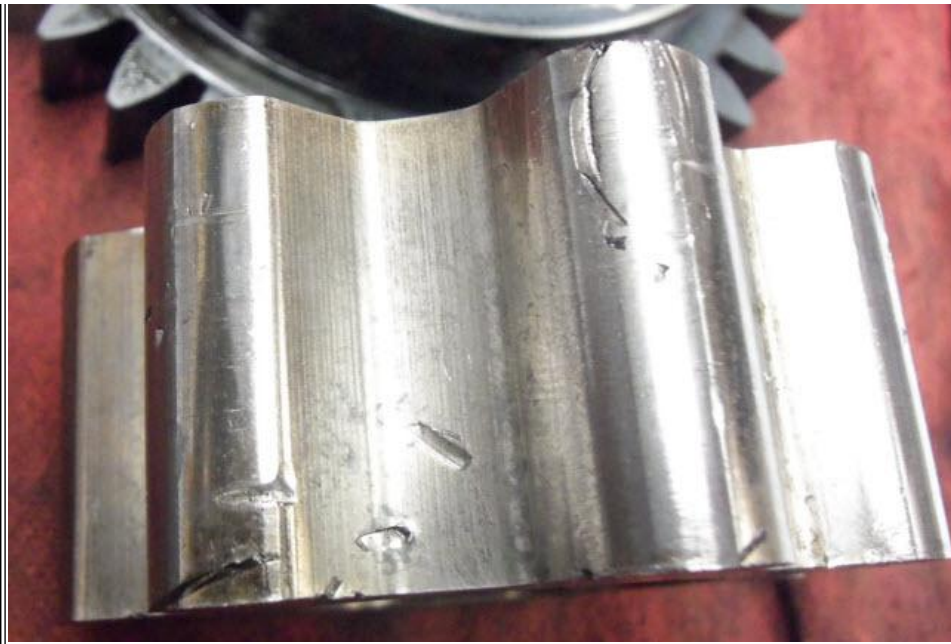
Figure 4: Damaged oil pump/gerotor

Action	Decision
<p>OIL PUMP GEROTOR AND OIL COOLER REUSE OR REPLACE DETERMINATION:</p> <p>Inspect oil pump gerotor. See Figures 4 and 5 for examples of damage.</p> <p>NOTE: there may be some light scoring on the block behind the oil pump as pictured in Figure 6. This amount is acceptable and will not lead to loss of oil pressure or engine performance/longevity as long as gear end play is in spec.</p> <p>However, this scoring does indicate that the oil cooler must be replaced.</p> <p>End play between the oil pump cover and oil pump gears must be measured while inspecting the oil pump. This procedure is outlined in the Engine Service Manual found on the Master Service Information Site. If end play exceeds specification, replace oil pump cover, pinion (gear) for oil pump, and ring gear as a set.</p> <p>Is the gerotor damaged?</p>	<p>Yes. Replace gerotor and oil cooler.</p> <hr/> <p>No. Complete all other repairs as needed.</p>

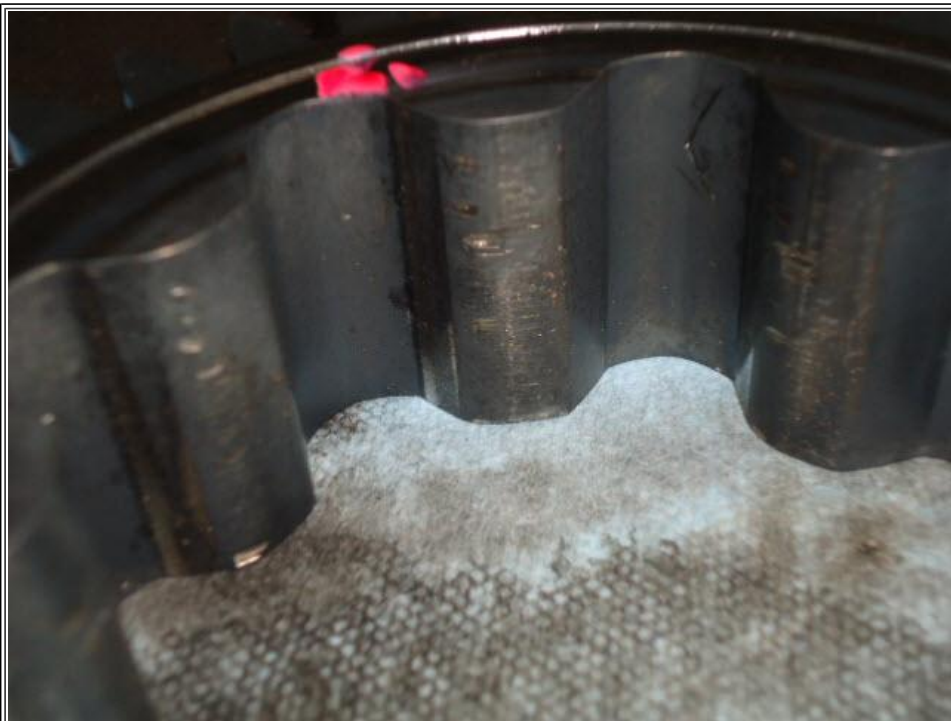
Figure 5: Damaged oil pump/gerotor

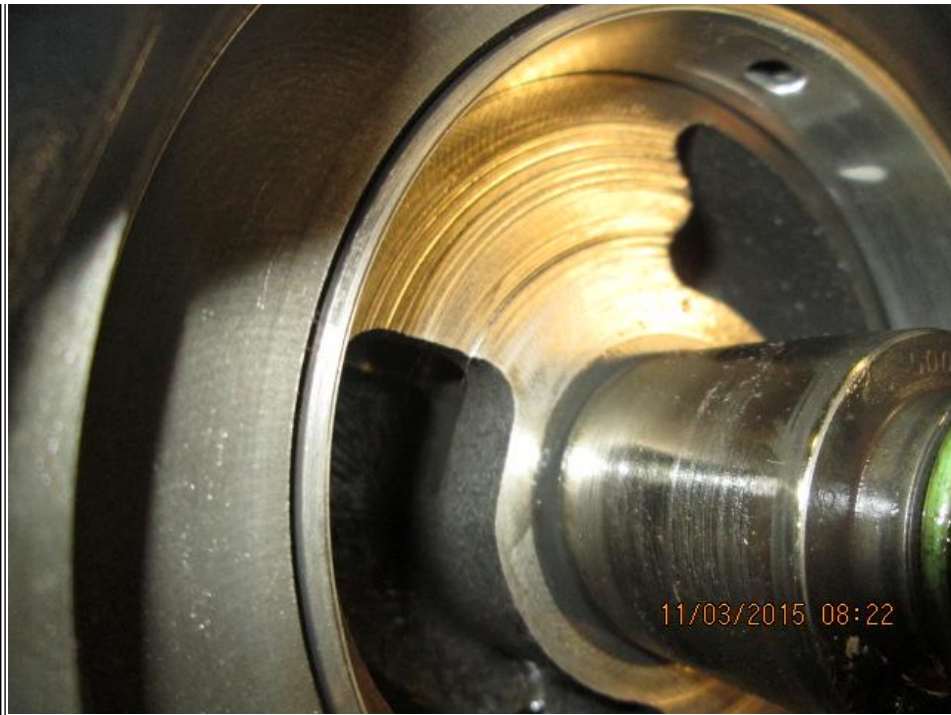
Figure 6: Acceptable engine block wear behind oil pump

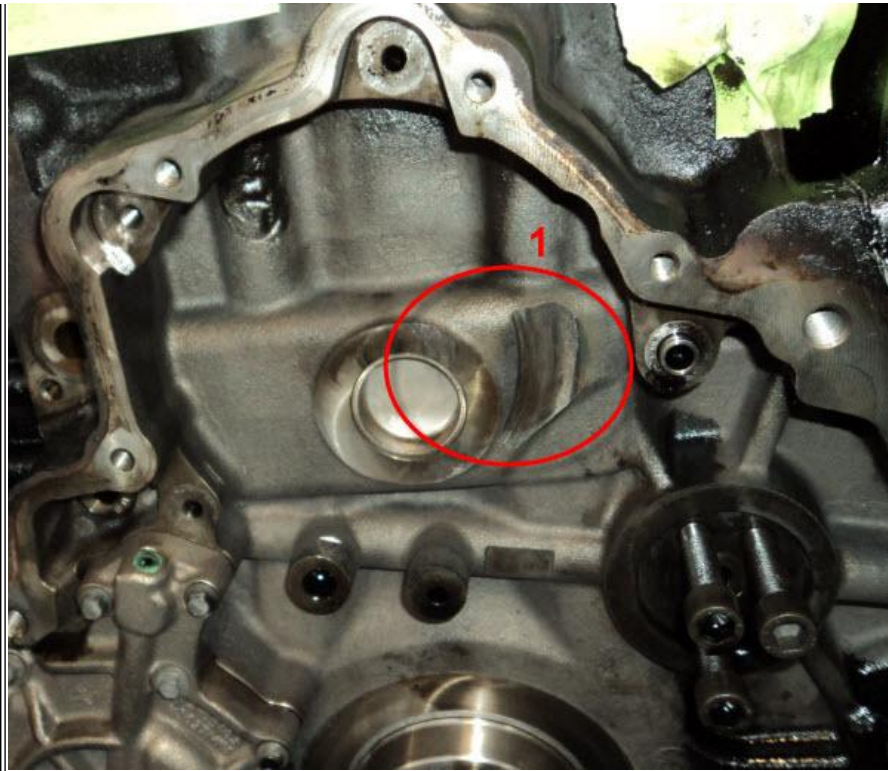
Figure 7: Acceptable engine block wear

Item 1: Gear contact to the engine block

Action	Decision
<p>FRONT GEAR TRAIN INSPECTION AND OIL COOLER REUSE OR REPLACE DETERMINATION:</p> <p>While the front cover is off, inspect remaining gears for damage.</p> <p>NOTE: It is possible that gear contact to the engine block has occurred. These engine blocks should be reused, and will not lose performance/longevity. See Figures 7 and 8 for examples.</p> <p>If gear contact to the engine has occurred, the oil cooler must be replaced.</p> <p>Are there any other gears damaged?</p>	<p>Yes. Replace damaged gears and oil cooler.</p> <hr/> <p>No. Complete all other repairs as needed.</p>

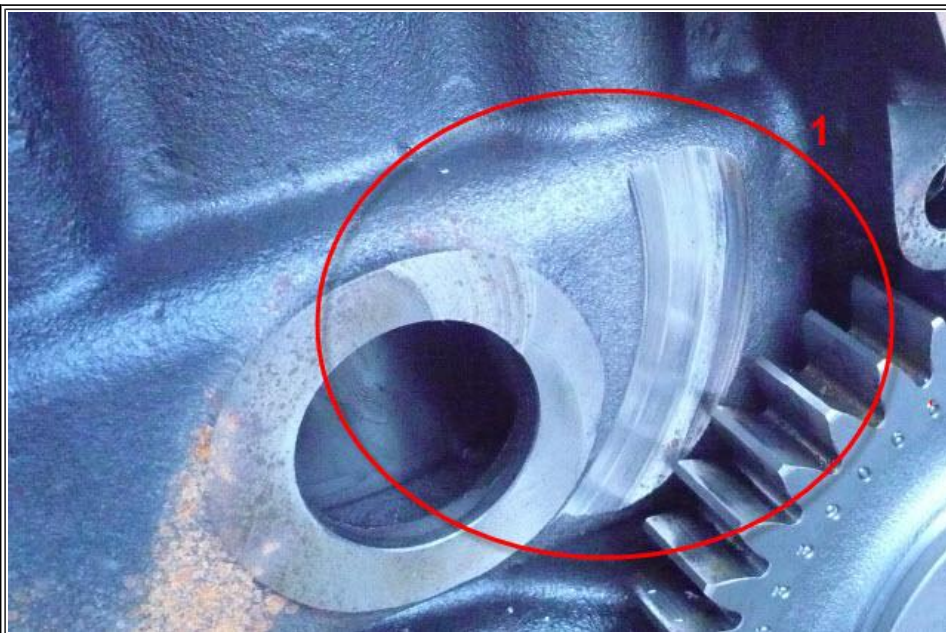
Figure 8: Acceptable engine block wear

Item 1: Gear contact to the engine block
