Title: SPN132(x) - FMI 31 Misfire Diagnostics IBB

Applies To: EPA 2010, 2013 and 2015 11L & 13L Engines

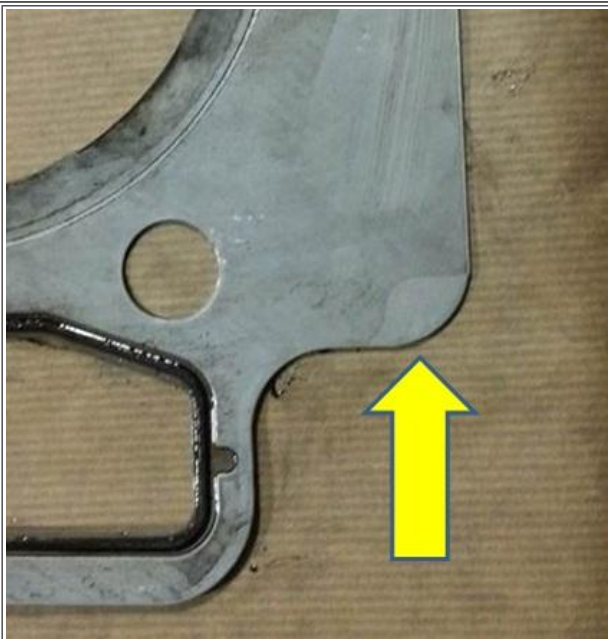
Figure 2: 11L Head Gasket

1: No Notch

1. Transfer 6 injector hold down spacer pucks beneath the injector hold downs over to the new head (Figure 1)
2. Compare the new and old Cylinder Head Gaskets. If an 11L Cylinder Head Gasket is installed on a 13L engine it will prevent the pistons from reaching top dead center once the head is torqued down. since the bore size is smaller than a 13L Piston.
  - A. 11L Gasket does NOT have a notch at the RR corner of the cylinder head gasket (Figure 2)
  - B. 13L Gasket does have a notch at the RR corner of the cylinder head gasket (Figure 3)
3. Be sure to properly time the cam gear per the service manual.
4. Reuse the Cam Bearings unless they are damaged

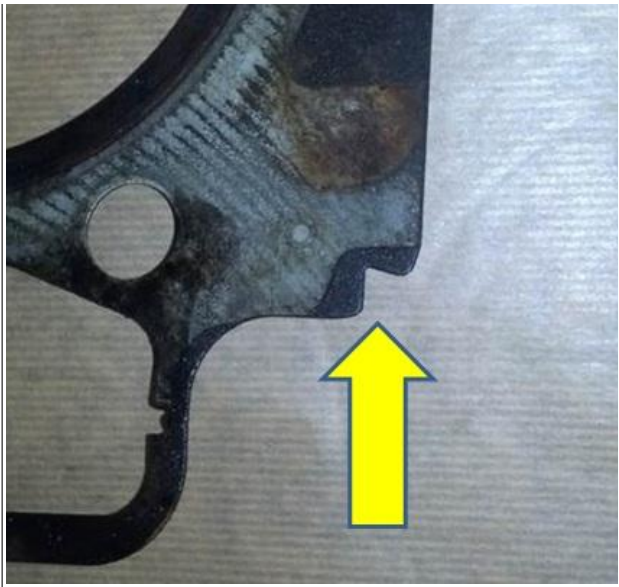
**Figure 3: 13L Head Gasket**

1: Notch out for Cylinder Head

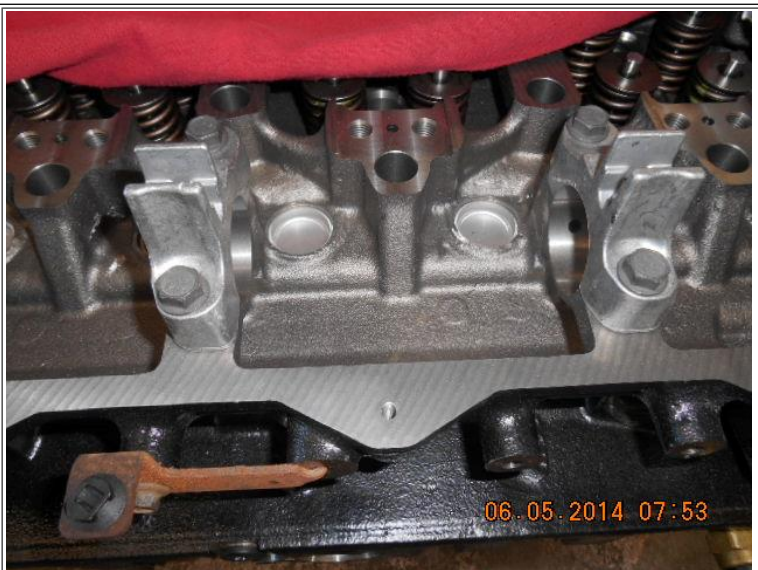
**Figure 4: Cylinder Head Camshaft Bearing Caps**

Some 2010 EPA heads have older style cam caps--they are okay to use and should be torqued to the 2010 service manual specs (18 lb-ft).
