Title: Pressure Transducer (PT) Switch Install

Applies To: ProStar / LoneStar 2012 -Current

This document will guide the user through the necessary steps to install the Pressure Transducer (PT) Switch Conversion Kit onto model year 2012 thru 2016 ProStar[®] and LoneStar[®]. This conversion is required to be performed during a A/C system failure in which the refrigerant system is opened.

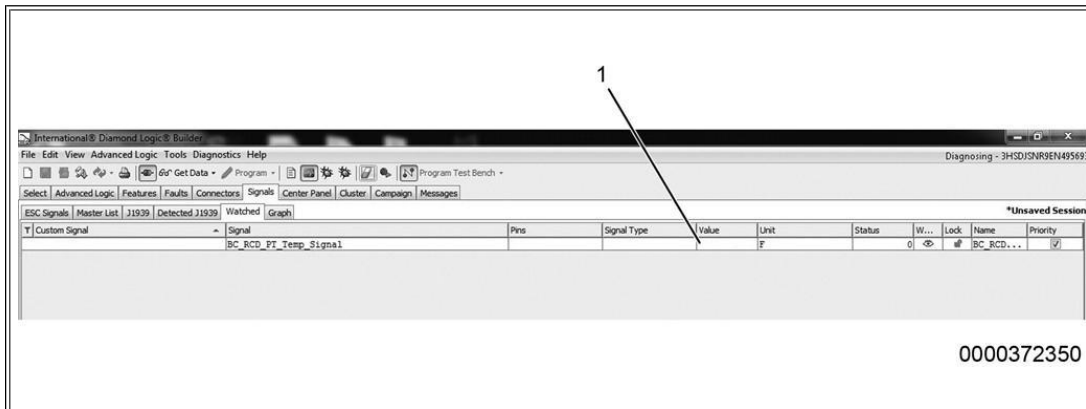
Figure 16: Incorrect Software Programming.

Item 1: Blank value

- If temperature signal is blank (Figure 16, Item 1), reprogram BCM.
- If temperature signal shows a value (Figure 17, Item 1), BCM programming is successful.

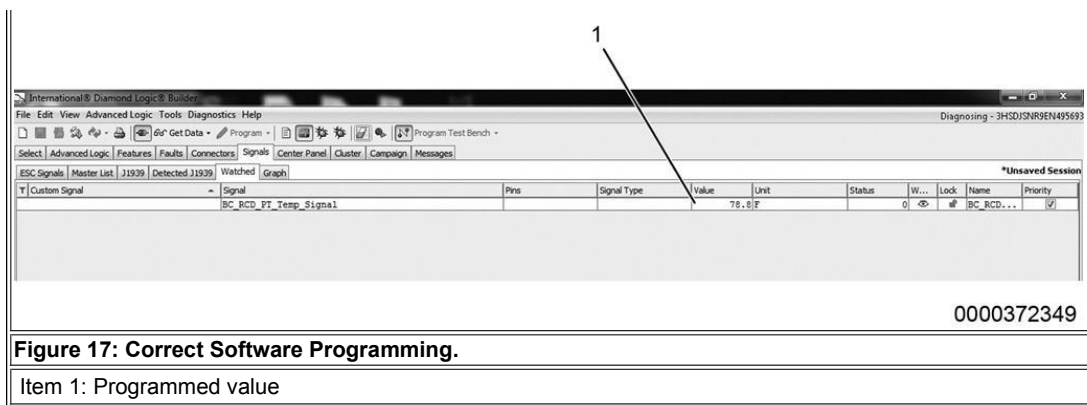
Figure 17: Correct Software Programming.

Item 1: Programmed value
