Product Upgrade Bulletin 161109REV

YEAR(S) AFFECTED:
2017

PRODUCT(S) AFFECTED:
Fleetwood Storm;
Holiday Rambler
Vacationer XE

SUBJECT:
Installing a
Compressor Delay
Timer Relay

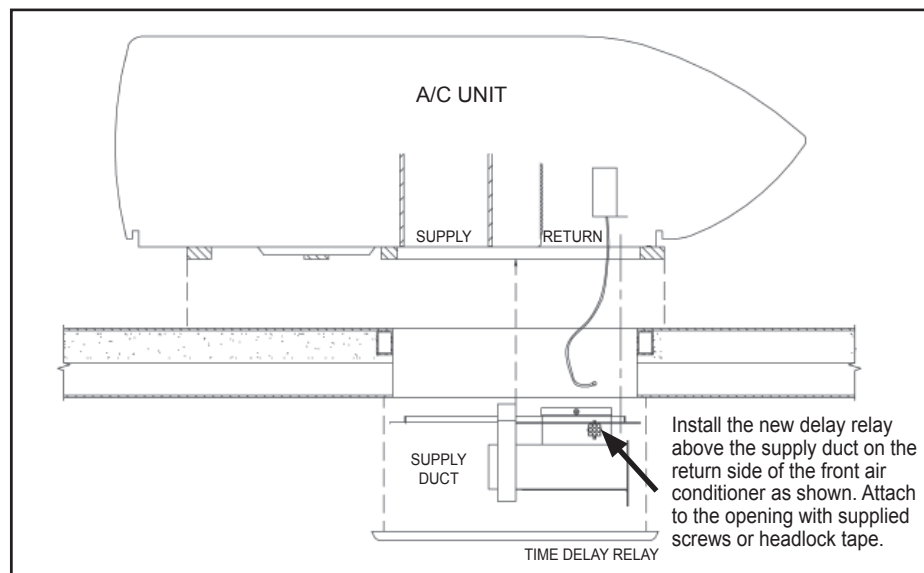
Figure 1

Due to over-sensitivity of the transfer switch, Auto Generator Start will not operate when the air conditioners are set to cool because the transfer switch will not allow the power from the generator through to the motor home.

1. Park the motor home on dry, level pavement. Turn off the ignition and remove the key. Place the transmission in PARK and set the parking brake. Turn off the ignition and remove the ignition key. Maintain control of keys while work is performed.
2. Remove the chill grille from the ceiling at the front air conditioner to expose the duct work.
3. Install the new delay relay (part # 10078336) in the opening for the front roof air conditioner, above the supply duct. Fasten using the screws that come with the kit or by using headlock tape. See Figure 1.
