HFL Microphone Concern? *Don't* Replace the Front Individual Map Light Assembly

AFFECTED VEHICLES

2015-16 CR-V (EX and above)

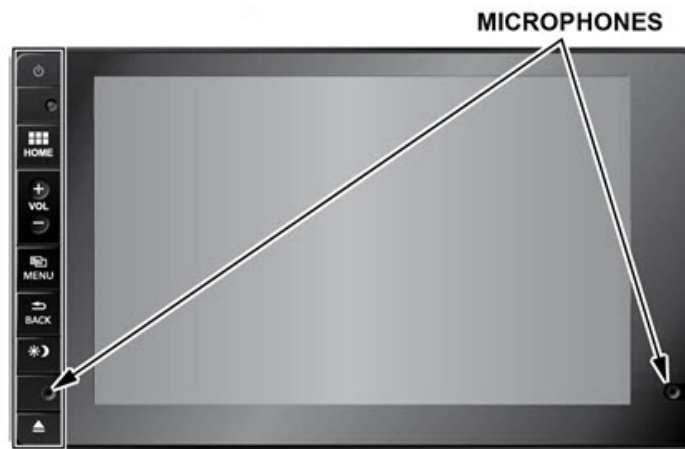
On 2015-16 CR-Vs (EX and above), the *Bluetooth*® HandsFreeLink® (HFL) and HFL microphone are built into the audio unit/audio-navigation unit. There's no longer a separate HFL control unit in the shift lever panel or HFL microphone in the front individual map light assembly.

Keep this in mind if you're troubleshooting HFL for a microphone concern. Replacing the front individual map light assembly **won't** fix anything since there's no microphone in this part!
