GROUP <b>BOD</b>	MODEL <b>2015-2017MY Sedona (YP)</b>
	NUMBER <b>158</b>	DATE <b>December 2016</b>
<b>TECHNICAL SERVICE BULLETIN</b>		
<b>SUBJECT:</b>	<b>2<sup>ND</sup> ROW STAND-UP SEAT LEVER MOUNTING BOLT REPLACEMENT (SA258)</b>

**SUBJECT: 2<sup>ND</sup> ROW STAND-UP SEAT LEVER MOUNTING BOLT REPLACEMENT**

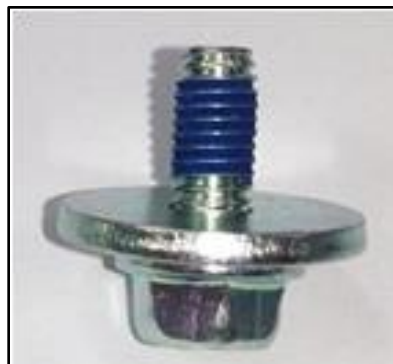
Seal Lock Adhesive Added

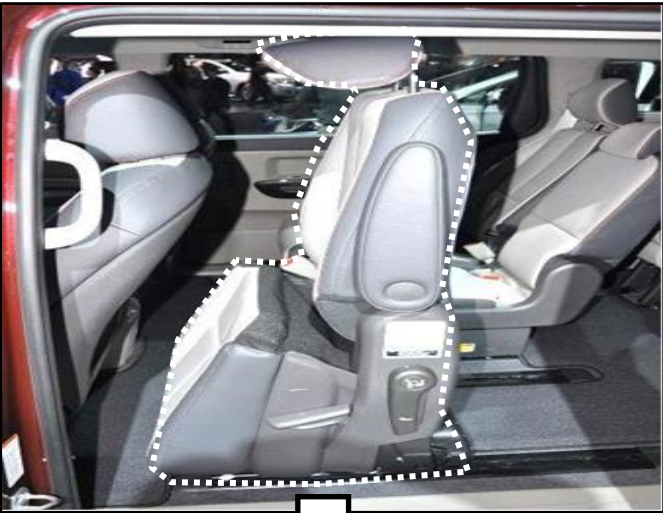
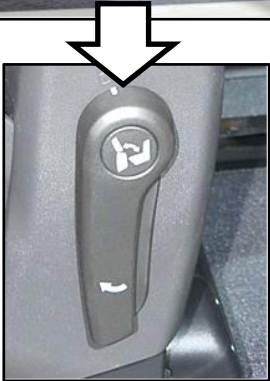
1. Inspect and validate that the 2<sup>nd</sup> row seats are equipped with manual type stand-up seats as shown in the illustration on the right.

Apply the same service procedure for both LH and RH seats.

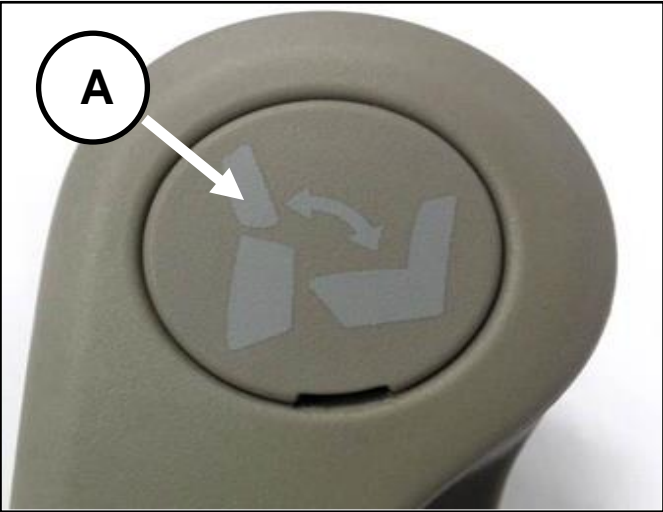
2. After confirmation, follow the service procedure below to replace the mounting bolt for the seat lever with an improved one.
3. Remove the seat lever cover (A) with an appropriate plastic trim removal tool.

Use a non-marring trim removal tool (such as Snap-on<sup>®</sup> Part Number PBN5 or equivalent).

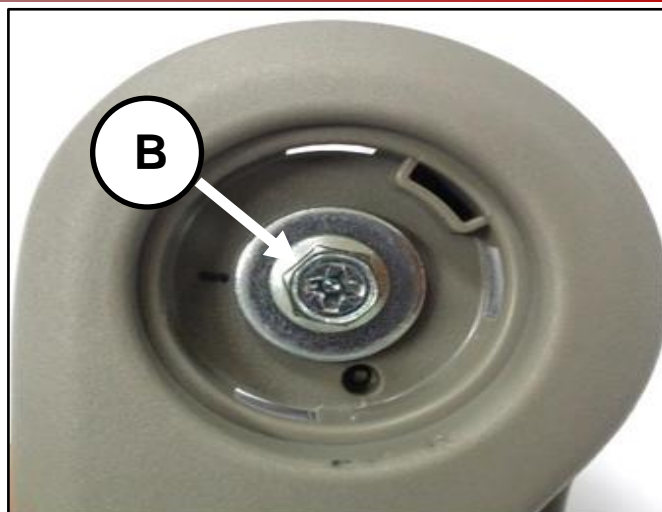
4. Remove the seat lever mounting bolt (B) and discard.

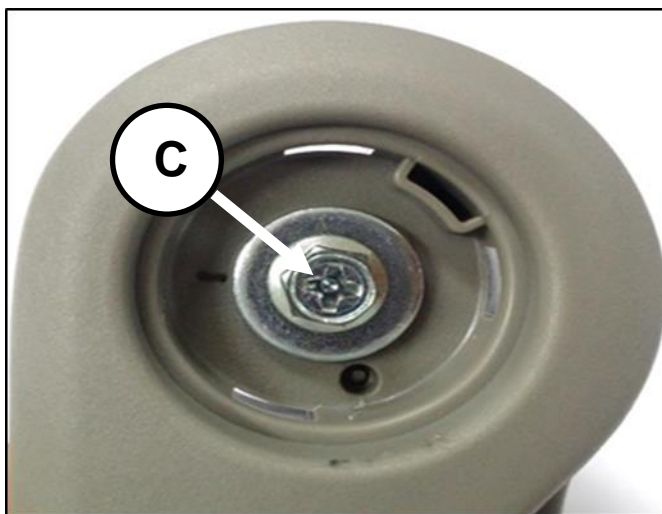
5. Install the new improved seat lever mounting bolt (C).

**Tightening Torque:**

3.6 ~ 4.3 lb-ft

(4.9 ~ 5.9 N.m 0.5 ~ 0.6 kgf.m,)

To ensure proper tightening, be sure to use a socket wrench when applying torque to the mounting bolt. **DO NOT** use a screwdriver.
