INFORMATION

Subject: Hem Flange Rust Repair

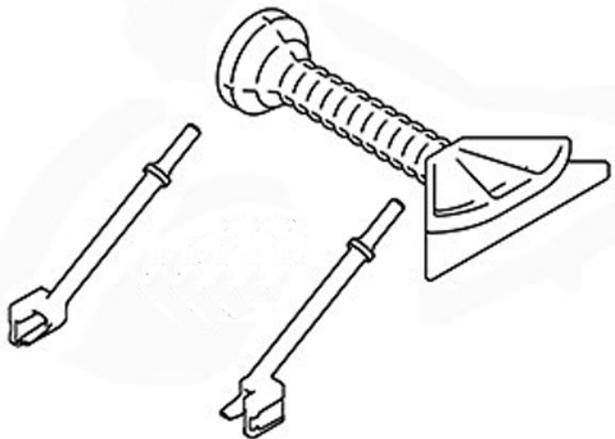
In the event that hem flange corrosion becomes a concern on lower door panels, a new tool has been released by Kent Moore, J-46162-A, which allows for easier opening and closing of the hem flange. This kit includes a left and right hand flange opening tool that is used with an air hammer, and a hem flange closing tool. Using these tools the lower door hem flange can be opened, the rust treated and the hem flange closed without having to refinish the outer door area.

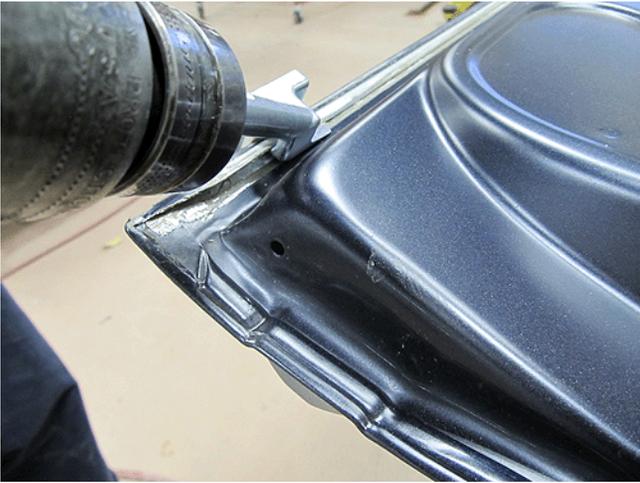
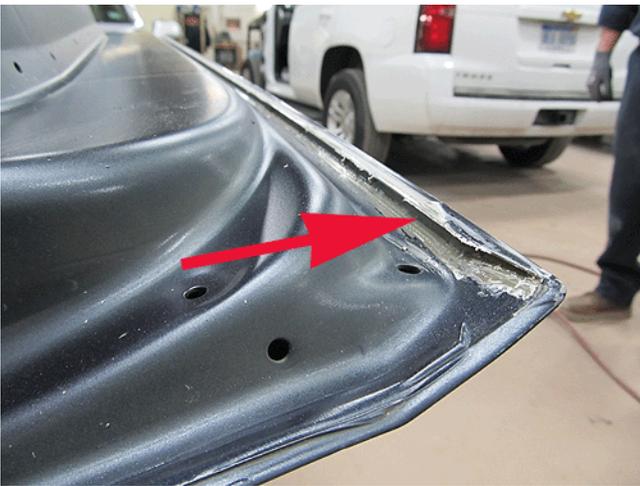
1. Remove the affected body panel from the vehicle and place on a clean non marring work surface.
2. Clean the hem flange area with wax and grease remover.
3. Inspect the area for rust perforation or "micro pin holes."

Important: If perforation is present, replace the affected panel.

4. Using the appropriate (left or right hand) flange opening tool, open the flange as shown.
