# Service Bulletin

**Subject:** Rear 60% Seatback Locked in Down Position When Folded, Will Not Return to Upright Position

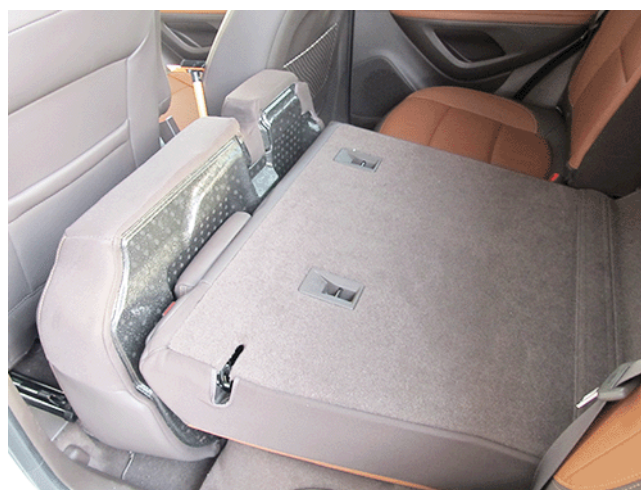
Some customers may comment that after folding the 60% seatback, it is locked in the down position and will not return to upright.
