Service Bulletin

INFORMATION

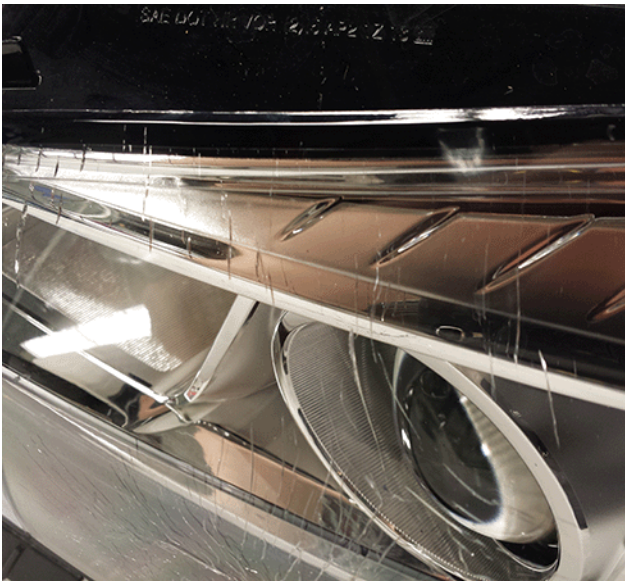
- The headlamps above show glazing caused by spray-on vehicle cleaner.

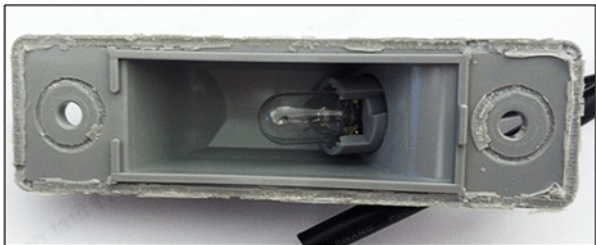
- The license lamp above exhibits a separation of the bond of the lens and housing, and a clouding of the polycarbonate lens. This condition was the result of applying chrome cleaner to the rear bumper and license lamp.

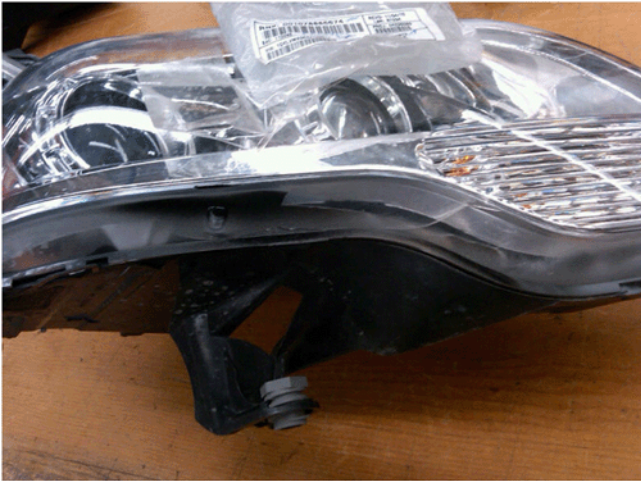
This lamp shows paint over spray along the lower edge where it would marry to the front fascia. The lower mounting tabs were also all fractured at the housing due to impact.

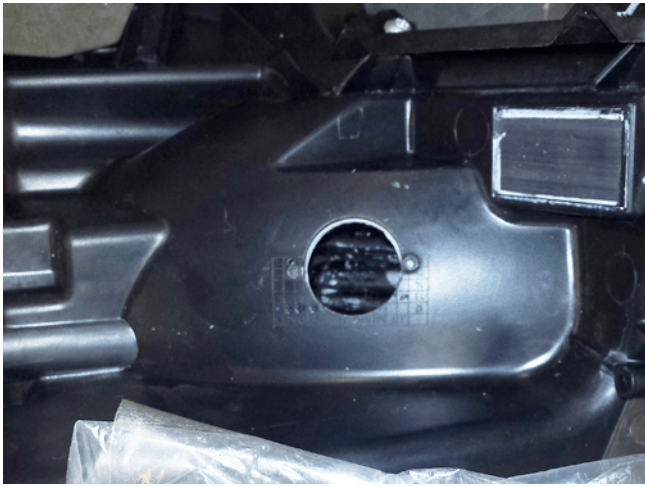
The above graphics show a hole which was drilled in the headlamp housing to accept an accessory modification and a LED insert for police applications. These parts are not covered by warranty.

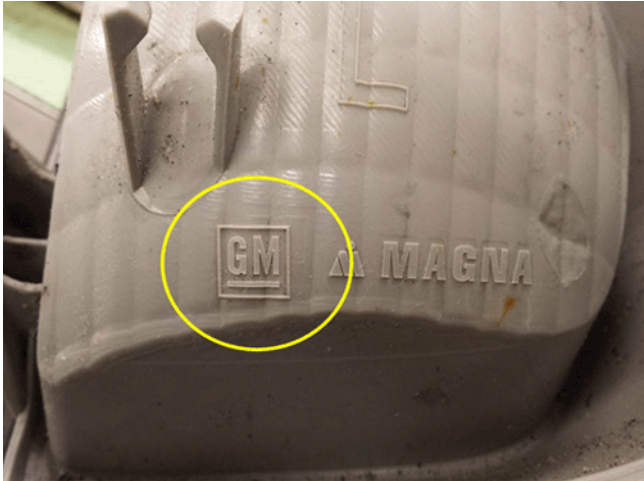
Heat Damaged Fog and Head Lamp Assemblies Caused By High Output Bulbs

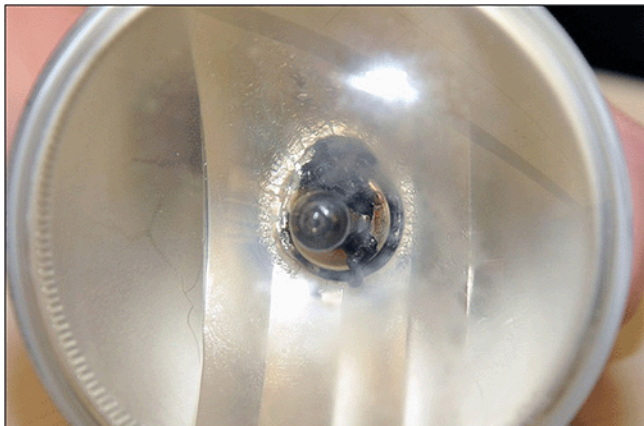
Notice: When servicing any exterior lighting assembly, be sure to transfer any electrical connection seals to the new part. They are often on the body side of the harness connection, but may have stayed on the part being replaced. If not transferred to the new part, the connection may corrode due to water entry.
