**Countries:** CANADA, UNITED STATES **Document ID:** IK0800521  
**Availability:** ISIS, Bus ISIS, FleetISIS, Body Builder **Revision:** 3  
**Major System:** ELECTRICAL SYSTEM **Created:** 11/12/2015  
**Current Language:** English **Last Modified:** 2/12/2016  
**Other Languages:** [Français](#) **Author:** Kevin Kochanek  
**Viewed:** 309

**Title:** Remote Power Module (RPM) Visual Inspection Guidelines

**Applies To:** WorkStar and DuraStar vehicles built before March 2009

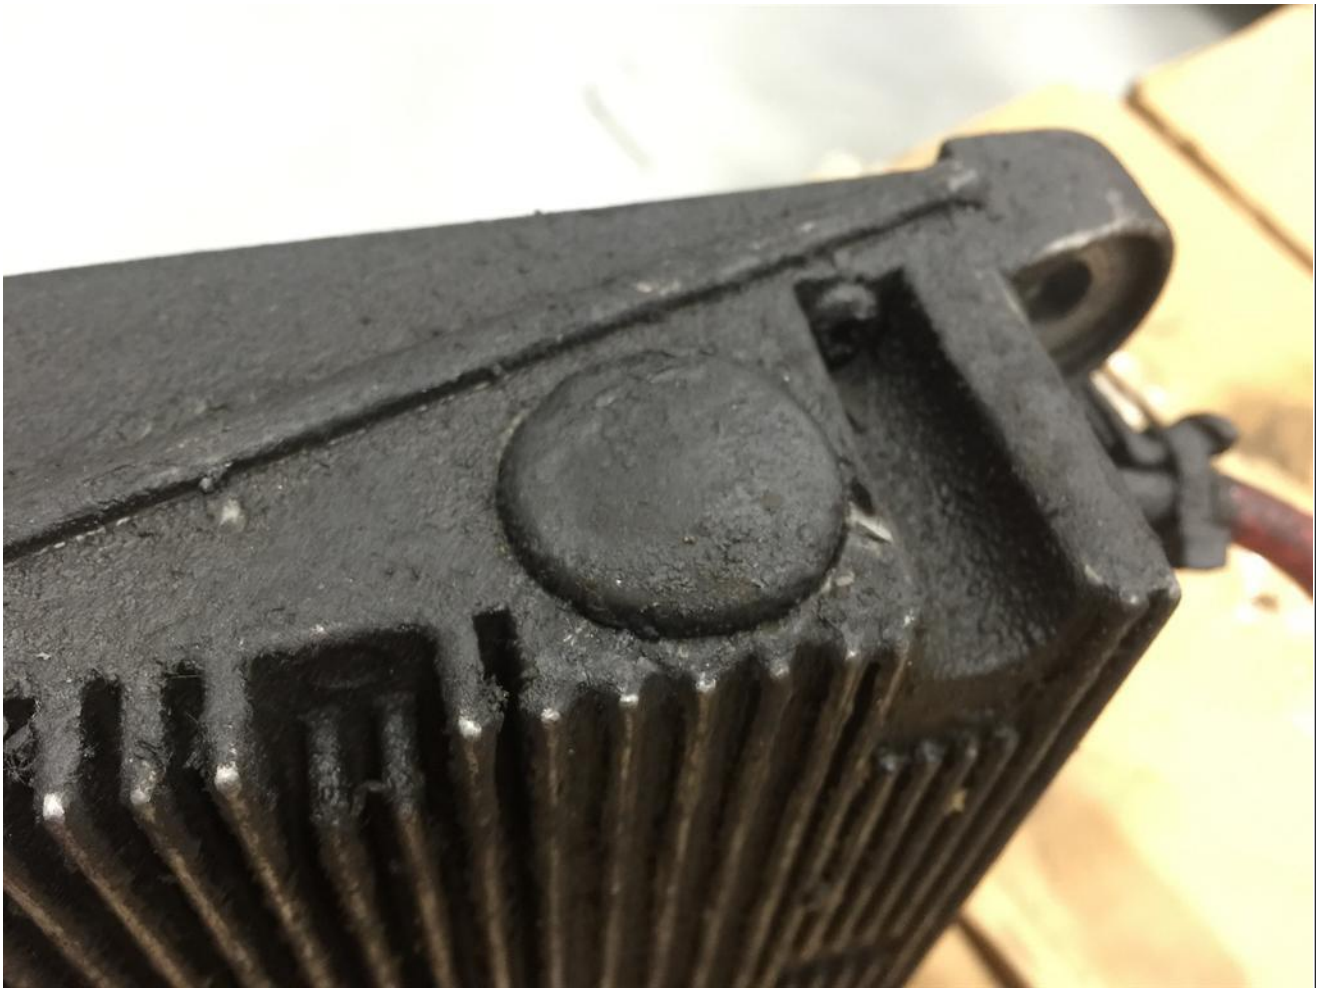
Figure 1: RPM is covered in debris, but there are no signs of infiltration under the rubber plug (plug is still seated on the housing, no signs of debris pushing the plug upwards). This RPM should not be replaced.

The rubber plug on the RPM should be checked periodically to ensure that it is not compromised. See figures below for examples of RPMs that should or should not be replaced.

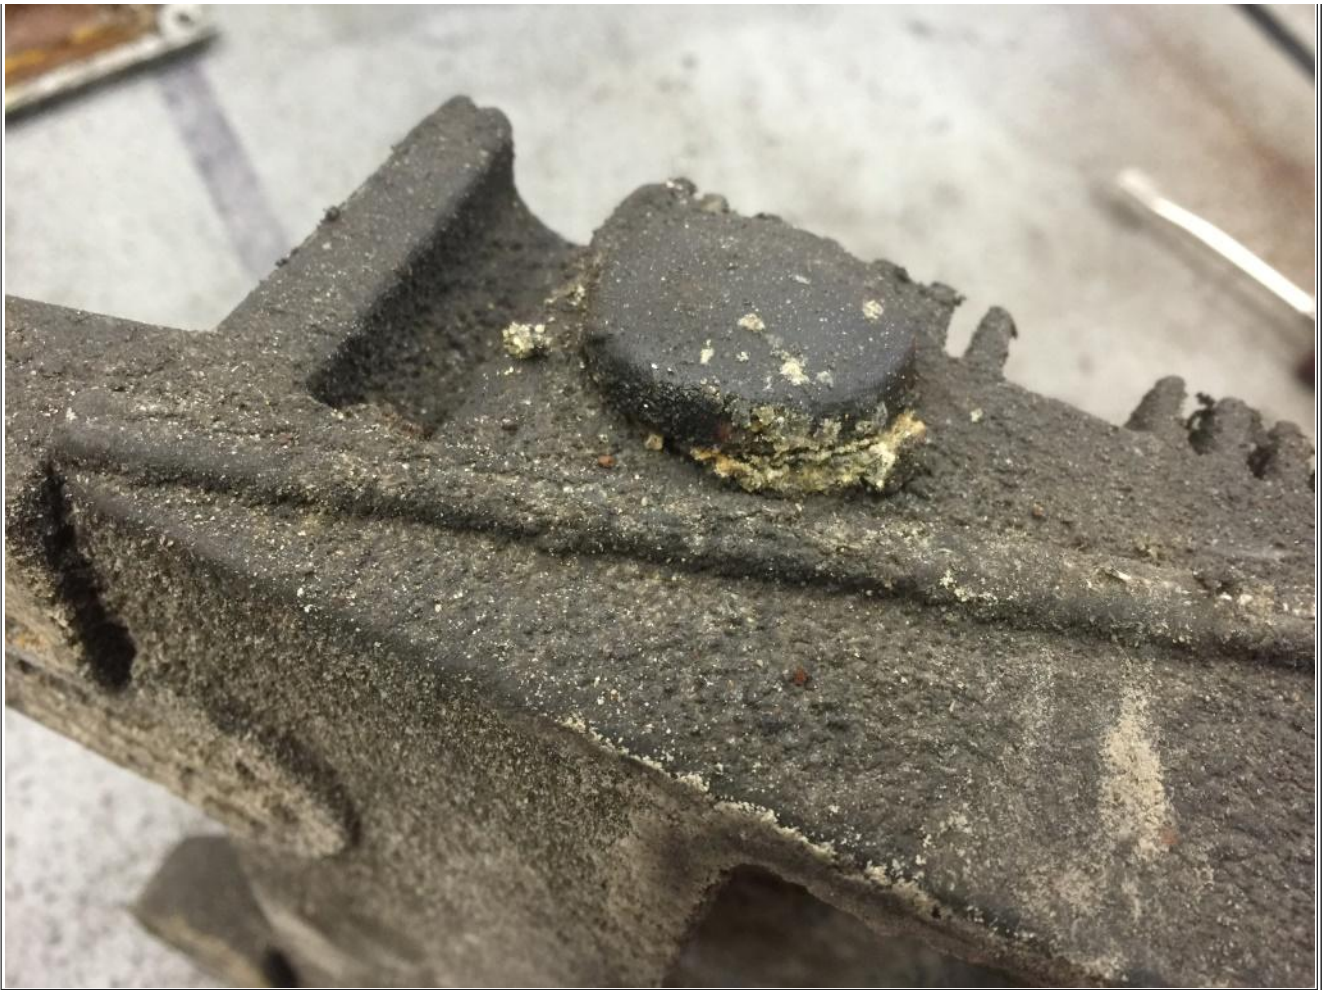
**Figure 2: The plug is being pushed upward by debris and it is clear that debris has begun to enter inside of the housing. This RPM should be replaced.**

Kit Description	Part Number
KIT, POWER MODULE REMOTE W/JUMPER	2588909C95

See service manual for removal and installation procedures.

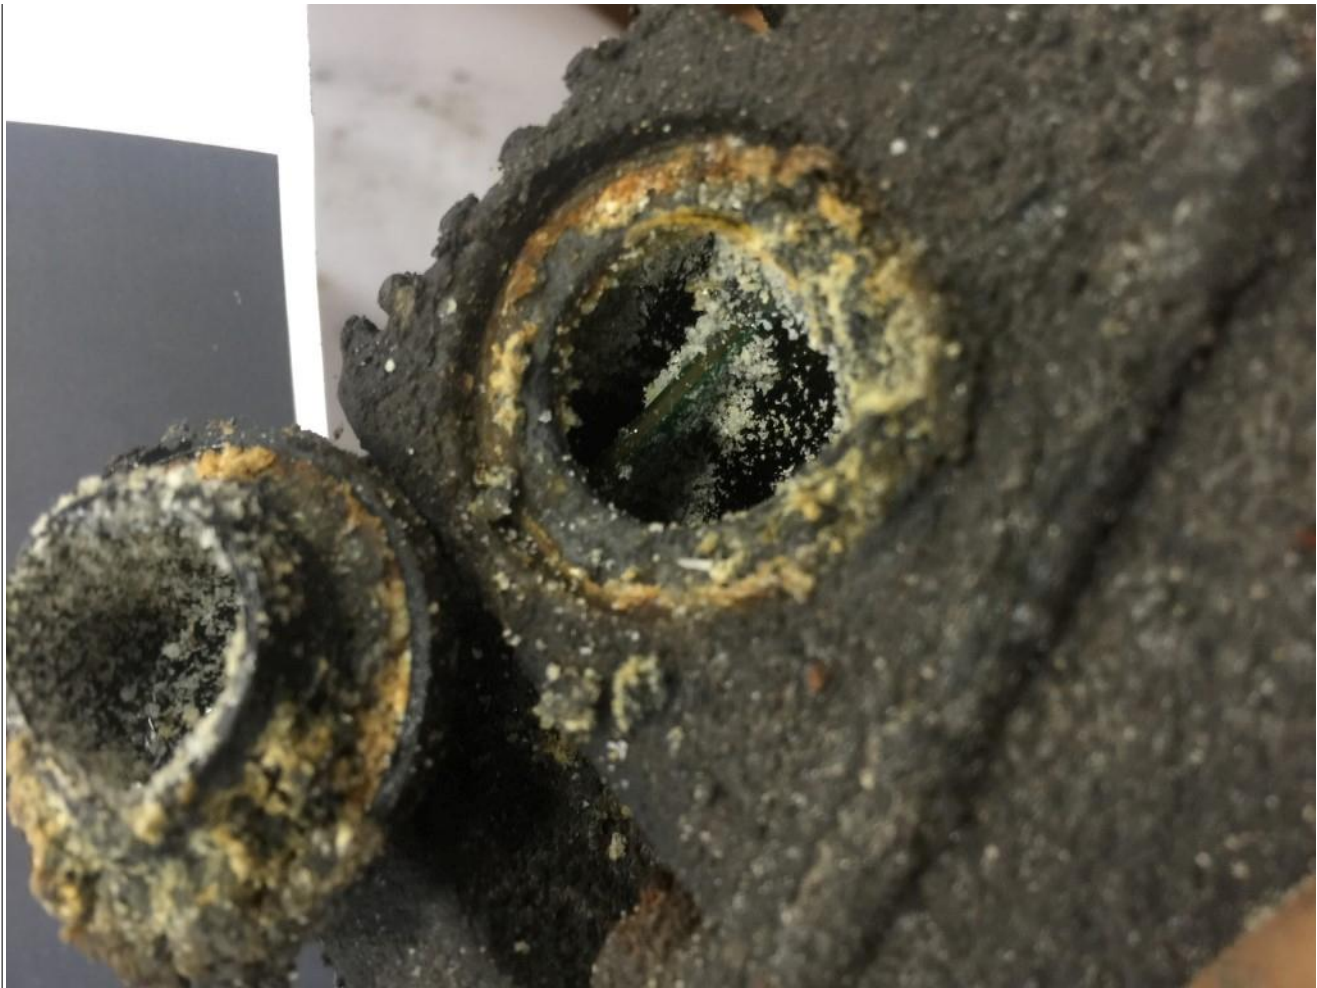
Figure 3: Same RPM as from Figure 2. The plug has been removed only for demonstrational purposes. Notice how debris has entered housing. This RPM should be replaced.
