**Title:** SPN132(x) - FMI 31 Misfire Diagnostics IBB

**Applies To:** EPA 2010, 2013 and 2015 11L & 13L Engines

This document provides diagnostics and repair procedures for SPN 132x FMI 31 Misfire Cylinder - (x) fault codes. Thoroughly review the document to ensure that the engine is repaired correctly and within warranty guidelines. Safeguards have been included in certain calibrations to prevent engine damage, and will not allow the engine to restart.

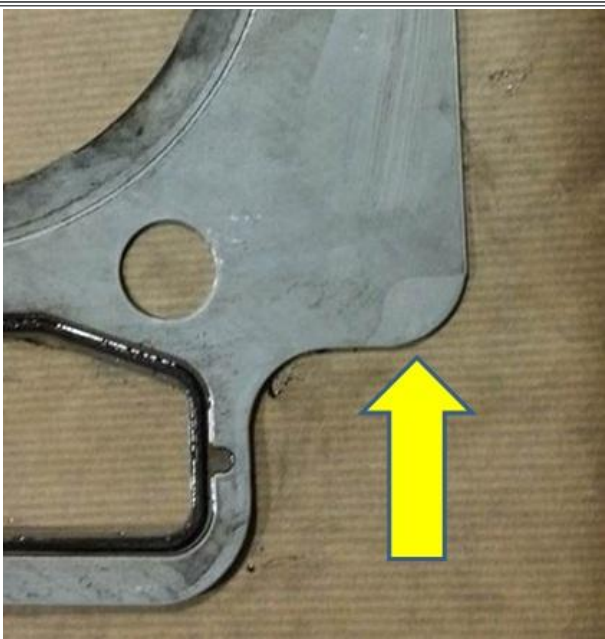
**Figure 2: 11L Head Gasket**

1. Transfer 6 injector hold down spacer pucks beneath the injector hold downs over to the new head (Figure 1)
2. Compare the new and old Cylinder Head Gaskets. If an 11L Cylinder Head Gasket is installed on a 13L engine it will prevent the pistons from reaching top dead center once the head is torqued down. since the bore size is smaller than a 13L Piston.
  - A. 11L Gasket does NOT have a notch at the RR corner of the cylinder head gasket (Figure 2)
  - B. 13L Gasket does have a notch at the RR corner of the cylinder head gasket (Figure 3)
3. Be sure to properly time the cam gear per the service manual.
4. Reuse the Cam Bearings unless they are damaged

1: No Notch

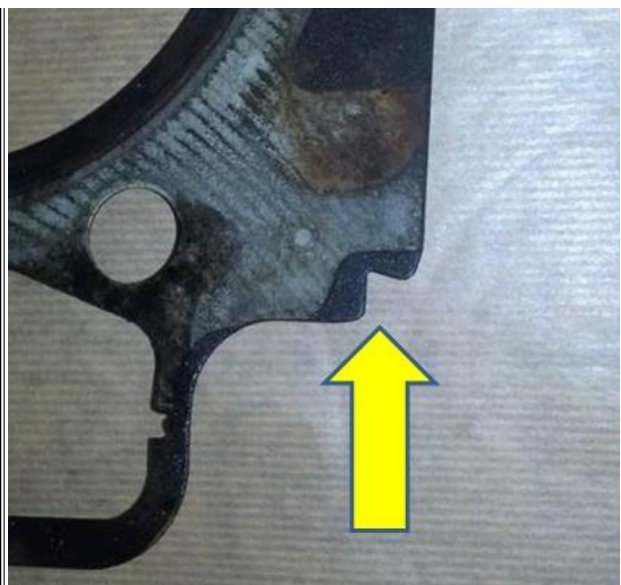
**Figure 3: 13L Head Gasket**

1: Notch out for Cylinder Head

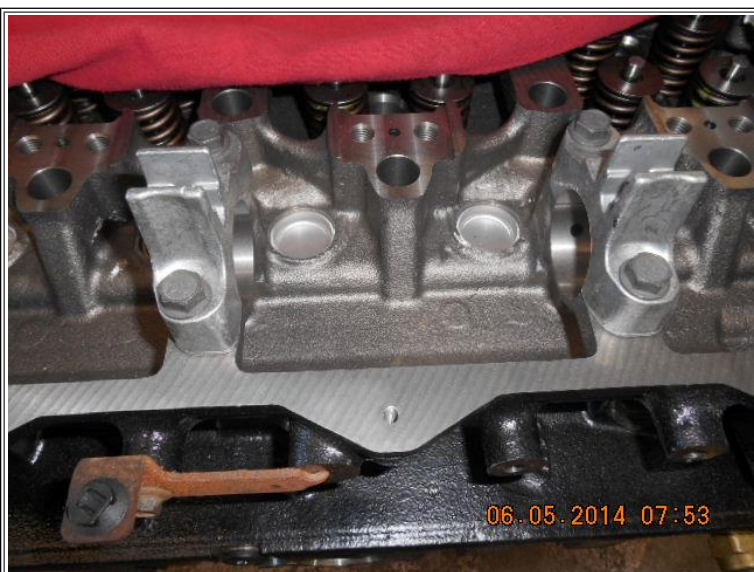
**Figure 4: Cylinder Head Camshaft Bearing Caps**

Some 2010 EPA heads have older style cam caps--they are okay to use and should be torqued to the 2010 service manual specs (18 lb-ft).
