**Title:** Maxxforce 11/13L, N13 and 2010+ Maxxforce 7 Cylinder Head Crack Inspection

**Applies To:** Maxxforce 11/13L, N13 and 2010+ Maxxforce 7 engines

**MF 11/13, N13 and MF7 Cylinder Head Crack Inspection Guide**

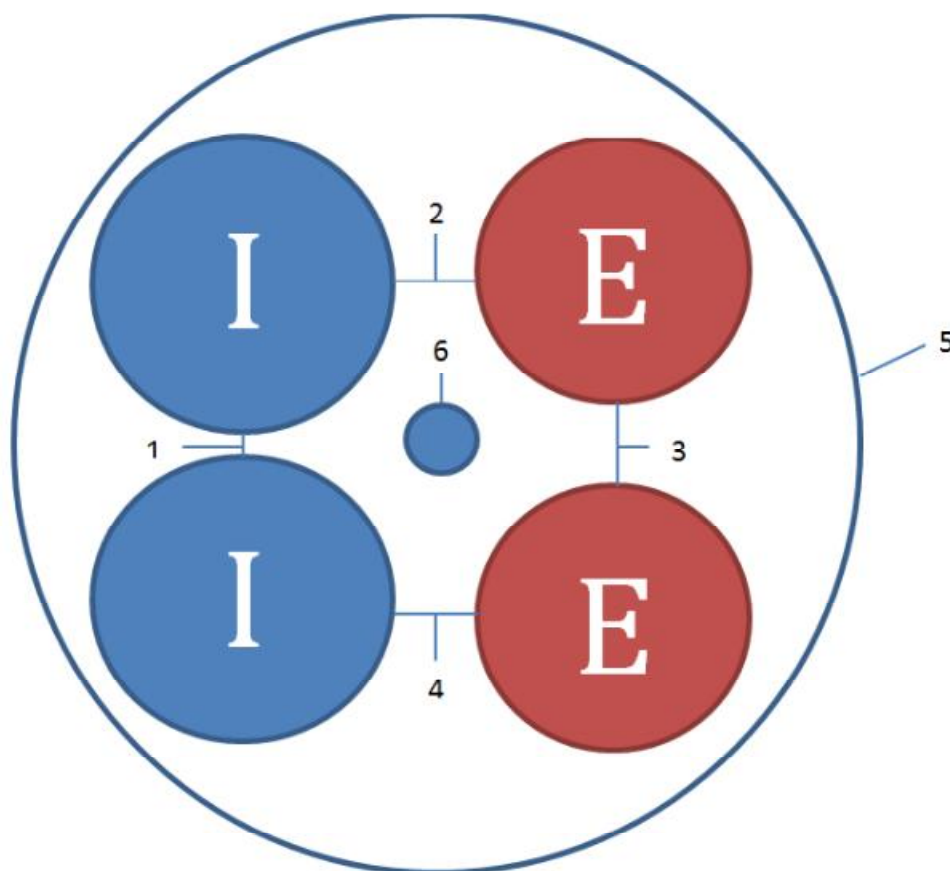
#### Acceptable Cracks

- Cracks of any length in location 1, between the intake ports, are acceptable
- Cracks of less than 3 mm length from location 6, Injector bore are acceptable
- Cracks between locations 2 & 4 are only acceptable if they are less than 3mm in length and do not contact the valve seat
- Cracks that appear on the surface of the fire deck and are less than 3mm in length; including cracks emanating from valve seats but not between valves

#### Unacceptable cracks

- Any cracks that run the entire length between the ports in locations 2, 3, & 4 are unacceptable and cylinder head replacement is needed
- Any cracks, regardless of length, that run along the combustion sealing surface, location 5, are unacceptable and cylinder head replacement is needed
- If there are multiple cracks propagating from a single valve seat, cylinder head replacement is needed
- If there are cracks in multiple locations 1-4, on any single cylinder, cylinder head replacement is needed
