SERVICE MANUAL INFORMATION

Group:	SERVICE MANUAL UPDATE
Bulletin No:	SB-16-010
Issue Date:	4-18-2015
Ref. No.	SB-A-11-078

Subject: CORRECTION OF WORKSHOP MANUAL FOR 2008MY-2017MY Correction of the Inspection of the DPR Filter

RELEVANT MODEL: 2008MY-2017MY Hino Trucks

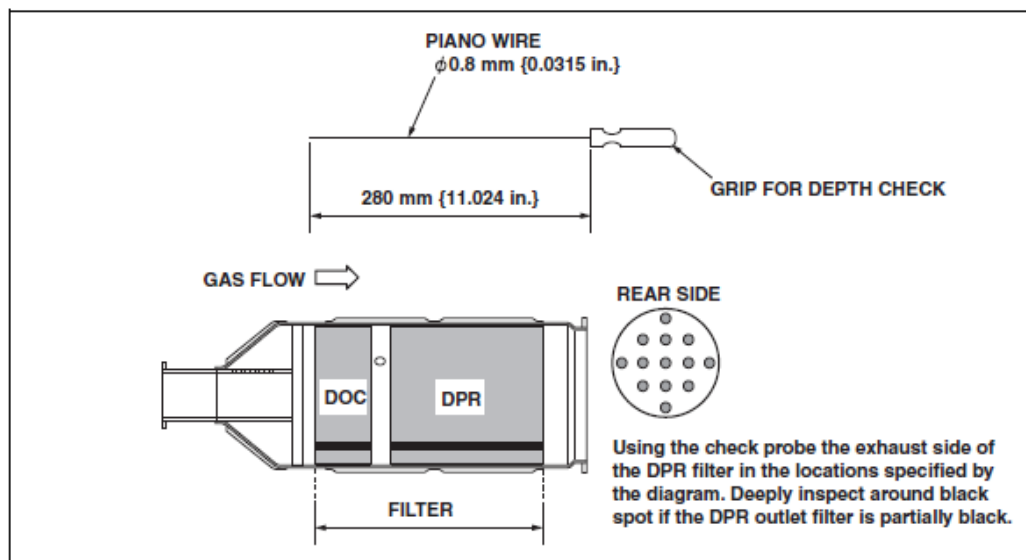
3 INSPECT THE DPR FILTER WITH THE DEDICATED CHECK PROBE.

1. Insert the check probe from the rear surface to inspect the inside.

SST: BOSCH part No. HDT650590
FILTER GAUGE ASSEMBLY

- DPR filter internal wall may be damaged if the check probe is significantly bent or skewed. Repair or replace the check probe.
- Do not force the check probe into the DPR filter or push the check probe past the DPR filter length, otherwise DPR filter may be damaged.

2. Does the check probe reach the desired depth?

Relevant models	Standard value (Desired depth)
2008-2010MY (HINO 145, 165, 185, 238, 258, 268, 308, 338)	237.5-250.5 {9.351-9.862}
2008-2017MY (HINO 155, 195, 155h, 195h)	
2011-2017MY (HINO 238, 258, 268, 338, 358)	175.9-184.9 {6.926-7.279}

Replace with a new DPR filter and new ^{*}PM sensor, and install them on the vehicle.

DPR filter is normal, clean the tail pipe and then install it on the vehicle.
