TECHNICAL SERVICE BULLETIN

Group:	O-GENERAL
Bulletin No:	SB-16-022
Issue Date:	8-16-2016
Vendor Ref.:	HMM-160805-B1

BURNER ATOMIZER REPAIR PROCEDURE

SUBJECT VEHICLES: 11MY-14MY Conventional Trucks (238, 258, 268, or 338)

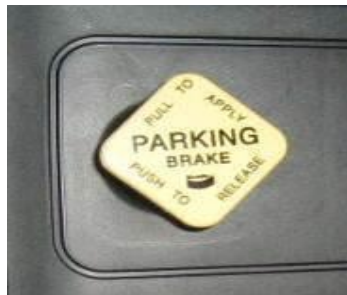
3. Apply the parking brake.

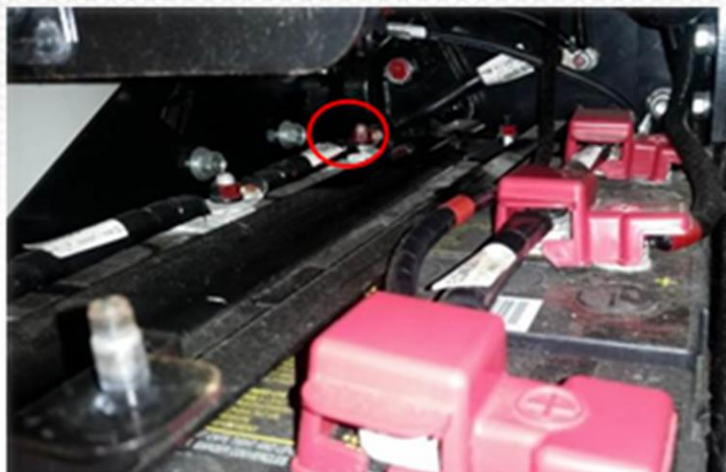
5. Disconnect the negative battery cable. Do not reconnect the negative battery cable until instructed to do so.

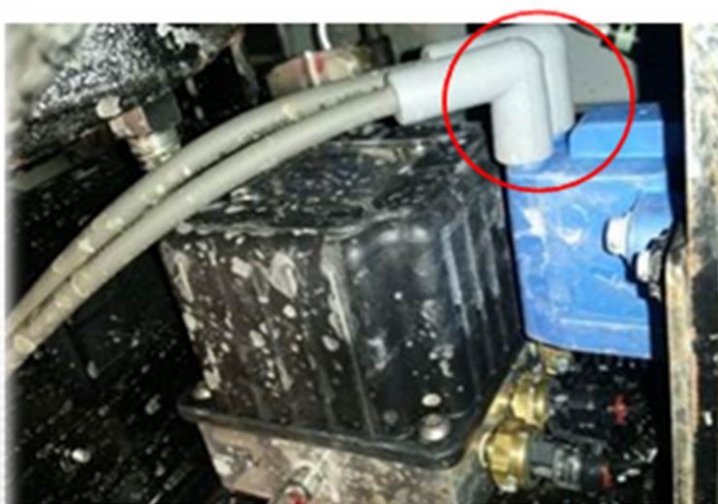
1. Working from underneath the passenger side of the vehicle, disconnect the ignition wires from the ignition coil and reposition them away from the ignition coil.

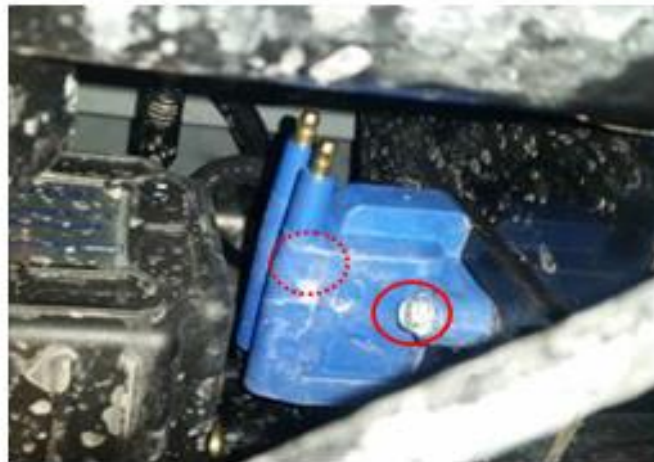
2. Remove the two mounting bolts securing the ignition coil. Once the coil is lowered slightly, the connector on the backside can be released and the coil removed from the vehicle. Retain the ignition coil and the two mounting bolts for reassembly.

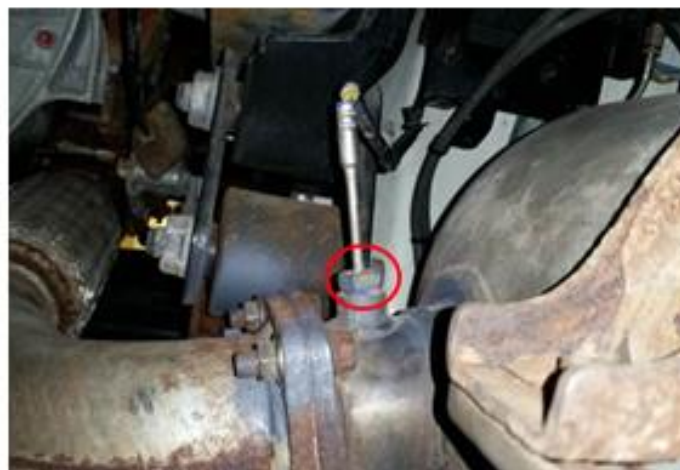
3. Remove the combustion chamber inlet temperature sensor and reposition it to allow for sufficient clearance to remove the atomizer cover. The harness can be left connected.

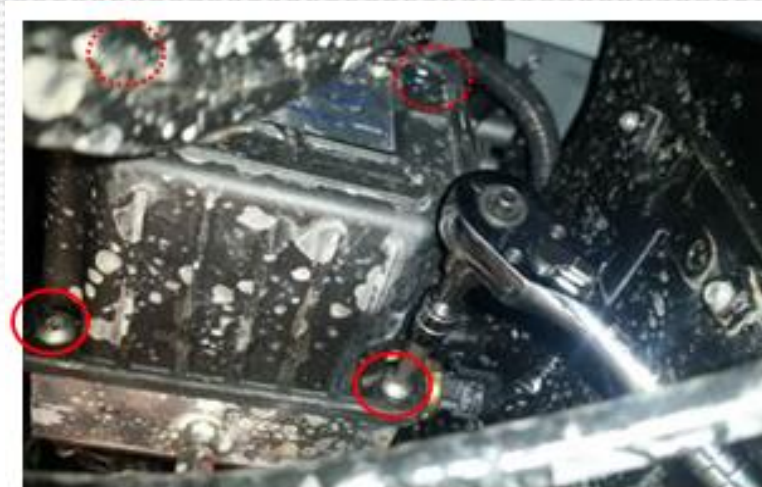
4. Using a T27 security Torx bit, remove the four screws retaining the atomizer cover. Retain the four screws for reassembly.

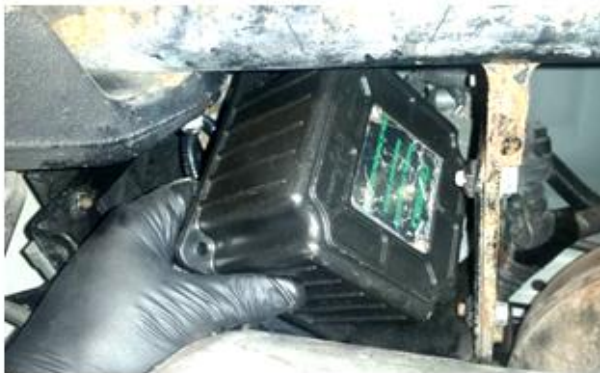
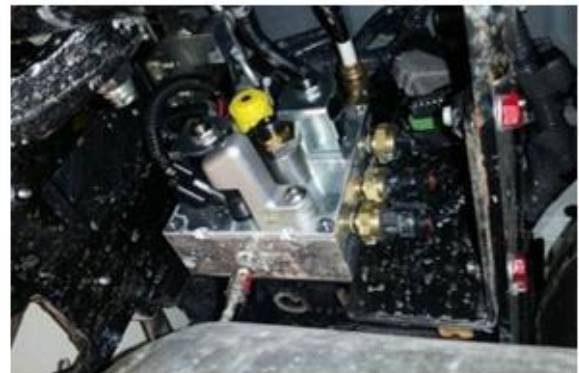
5. The atomizer cover can be removed by first rotating the cover over into the space previously occupied by the ignition coil. Make certain the wire harness grommet releases from the front side of the cover. The cover can then be moved downwards toward the combustion chamber and again rotated to remove. This is a very tight fit, but the cover can be removed without force once it is positioned correctly.

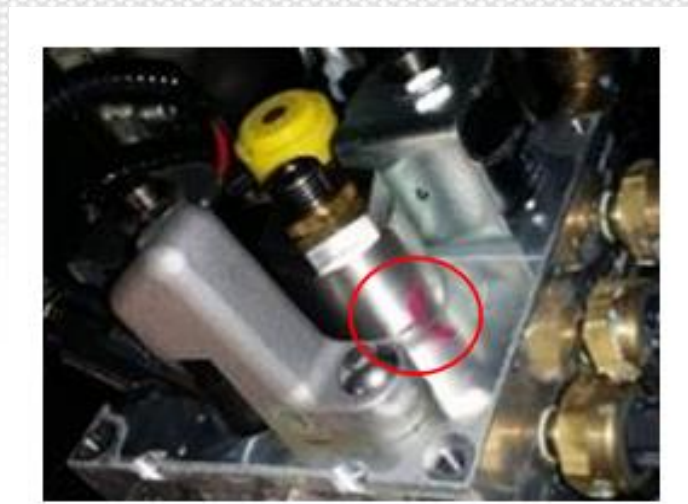
6. It will be necessary to mark the location of the fuel pressure regulator housing with a paint pen to ensure the regulator is returned to this position when reinstalled. Refer to the photograph below for reference.

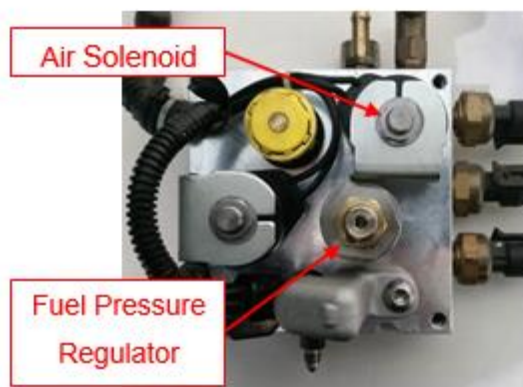
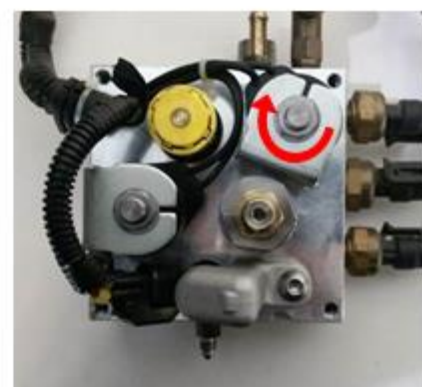
7. To allow a socket to be placed over the fuel pressure regulator housing for removal, it will be necessary to loosen the air solenoid retaining nut located above the fuel pressure regulator and rotate slightly. Refer to the photographs below, which show a view of the atomizer from above, for reference. The atomizer pictured has been removed from the vehicle for clarity.

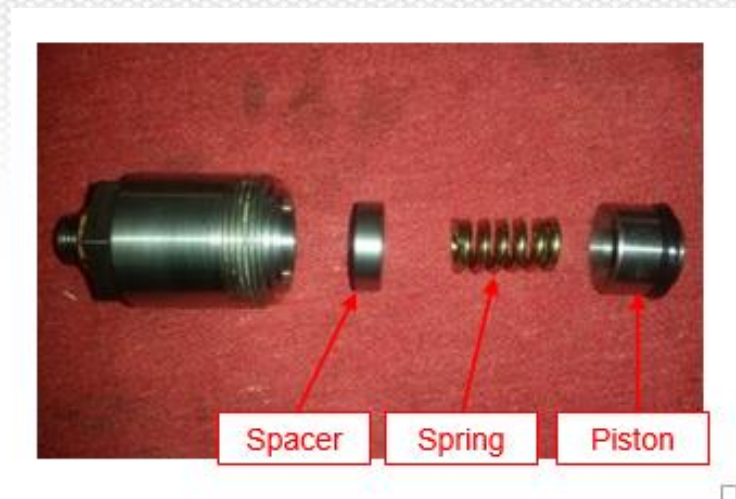
8. Remove the fuel pressure regulator. Set the regulator on a clean shop rag. The photograph below illustrates the fuel pressure regulator components.

NOTICE: Use caution to prevent the regulator piston from falling out of the pressure regulator housing during removal.

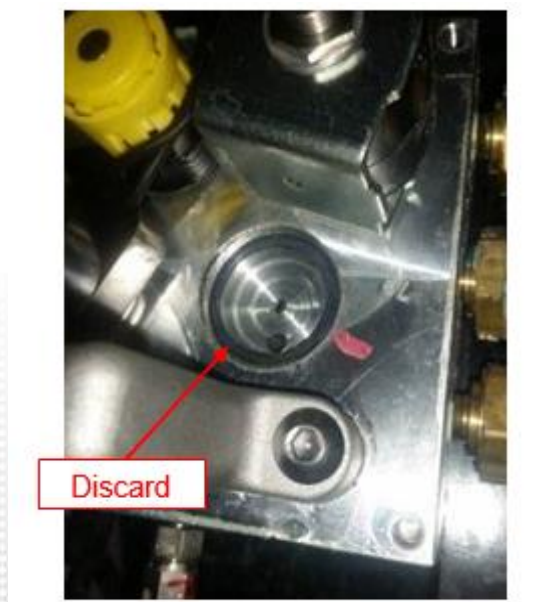
9. The fuel pressure regulator housing O-ring may remain in place in the atomizer. Remove and discard this O-ring.

NOTICE: Do not allow any debris to enter the fuel pressure regulator opening on the atomizer, as damage to the atomizer may result.

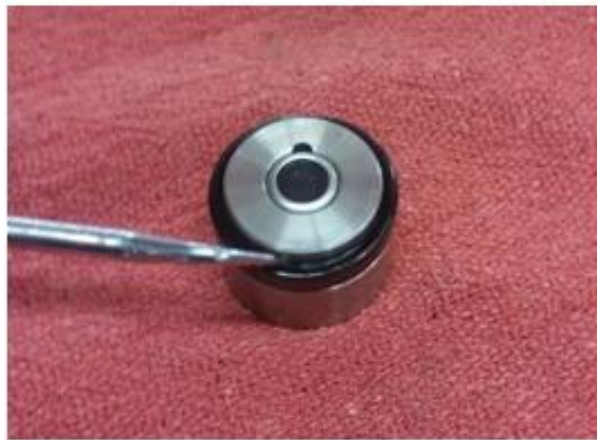
10. Using a pick, carefully remove the old U-cup seal from the fuel pressure regulator piston. Discard the old U-cup seal.

NOTICE: Use caution to avoid scratching or damaging the regulator piston. Scratching or damaging the regulator piston will cause sealing issues.

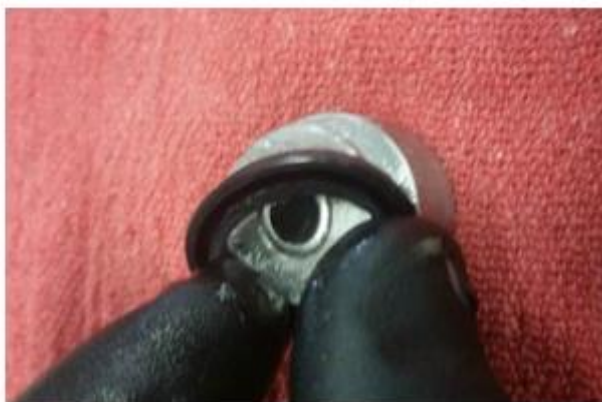
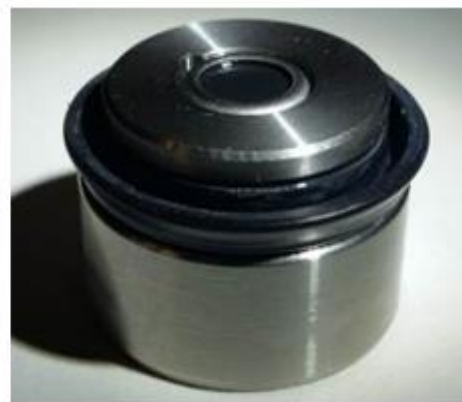
11. Lubricate the piston and the new U-cup seal lightly with silicone grease to ease installation. Slide the new U-cup seal over the piston, ensuring the cup faces away from the piston as shown.

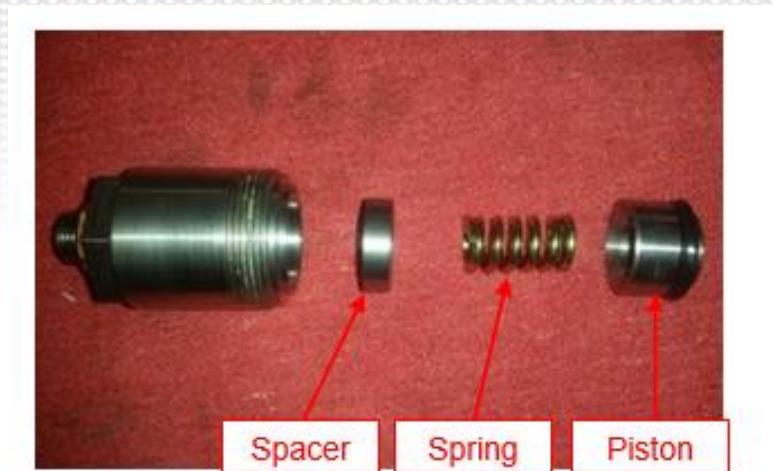
12. Clean any debris from inside the fuel pressure regulator housing. Lightly lubricate the outside diameter of the piston using silicone grease and insert into the fuel pressure regulator housing. Ensure all fuel pressure regulator components are in proper order. The photograph below shows the proper order of the regulator components.

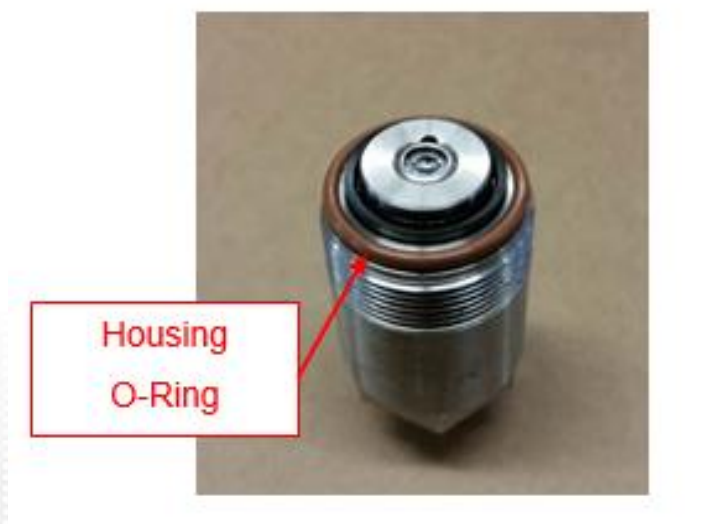
13. Place the new housing O-ring on the fuel pressure regulator housing. Rethread the fuel pressure regulator into the atomizer. Carefully tighten the fuel pressure regulator to the paint mark made in step 6. Be careful not to overtighten.

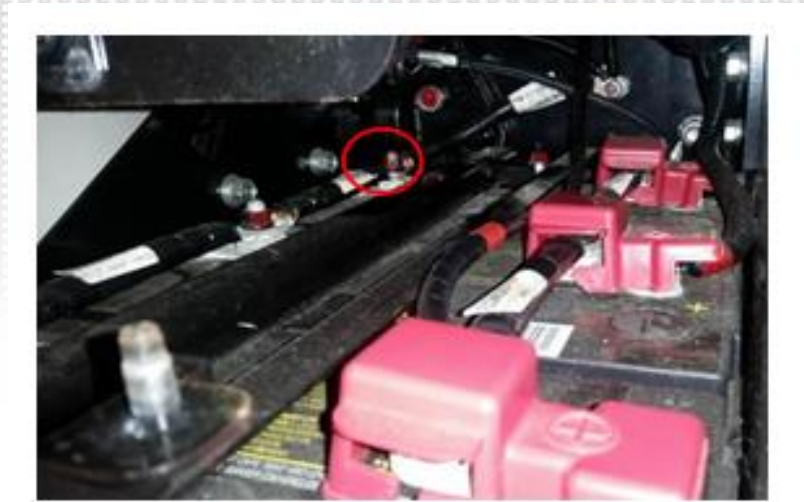
14. Reconnect the negative battery cable.

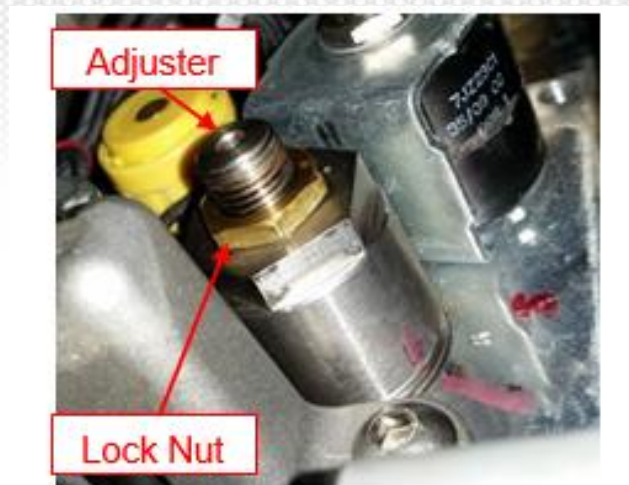
17. To adjust the fuel pressure, loosen the lock nut on the fuel pressure regulator. Rotate the adjuster clockwise to increase fuel pressure, and counterclockwise to decrease fuel pressure. Torque the locknut to the specified torque.

Specified Torque: 16 lb-ft (22Nm)

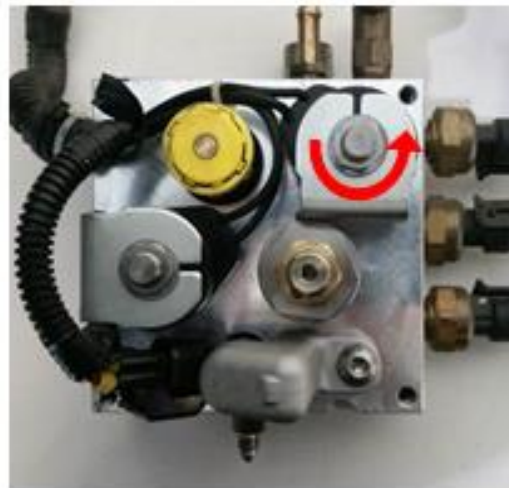
19. Rotate the air solenoid back to its original position and torque the retaining nut to the specified torque.

Specified Torque: 16 lb-ft (22Nm)

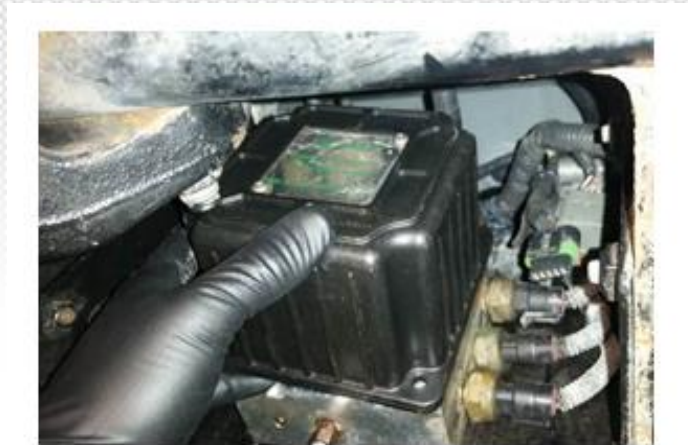
20. Replace the cover on the atomizer. Make certain that the wiring harness grommet on the forward side of the atomizer properly engages the groove on the atomizer cover.

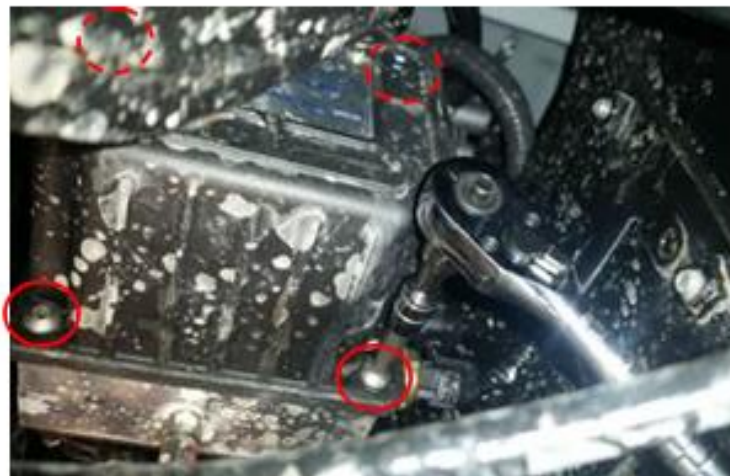
21. Replace the four screws retaining the atomizer cover and tighten to the specified torque.

Specified Torque: 3.3 lb-ft (4.5 Nm)

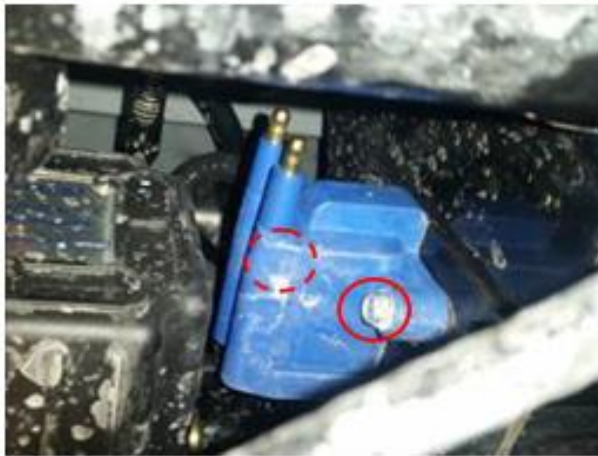
22. Reconnect the ignition coil electrical connector. Install the ignition coil and torque the two bolts to the specified torque.

Specified Torque: 6.6 lb-ft (9 Nm)

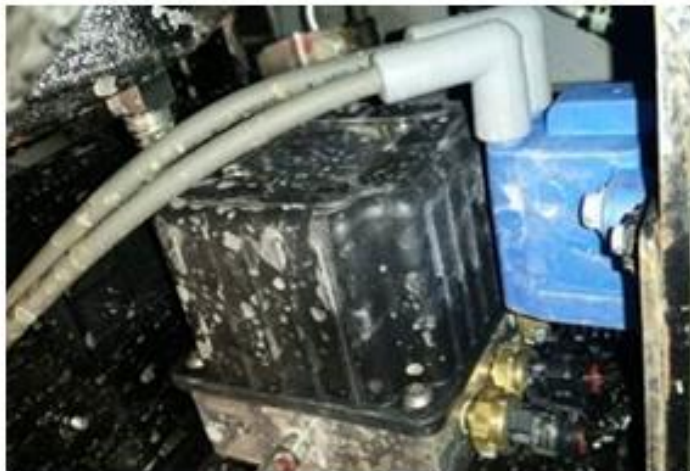
23. Reconnect the ignition wires to the ignition coil.

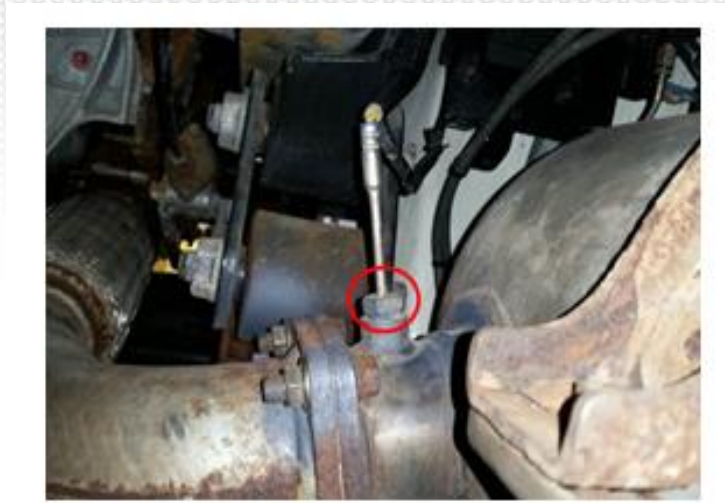
24. Reinstall the combustion chamber inlet temperature sensor and torque to the specified torque.

Specified Torque: 33.5 lb-ft (45 Nm)
