**SUBJECT:** 2014-2016 Mazda6 – Door Sash Molding Concern  
Special Service Program SSPA5

Mazda Motor Corporation has decided to conduct a Special Service Program (SSP) on certain 2014-2016 Mazda6 vehicles produced from October 25, 2012 through January 30, 2015.

On the subject vehicles, the metal part of the front and rear door sash molding(s) may be exposed and could harm vehicle occupants upon contact.

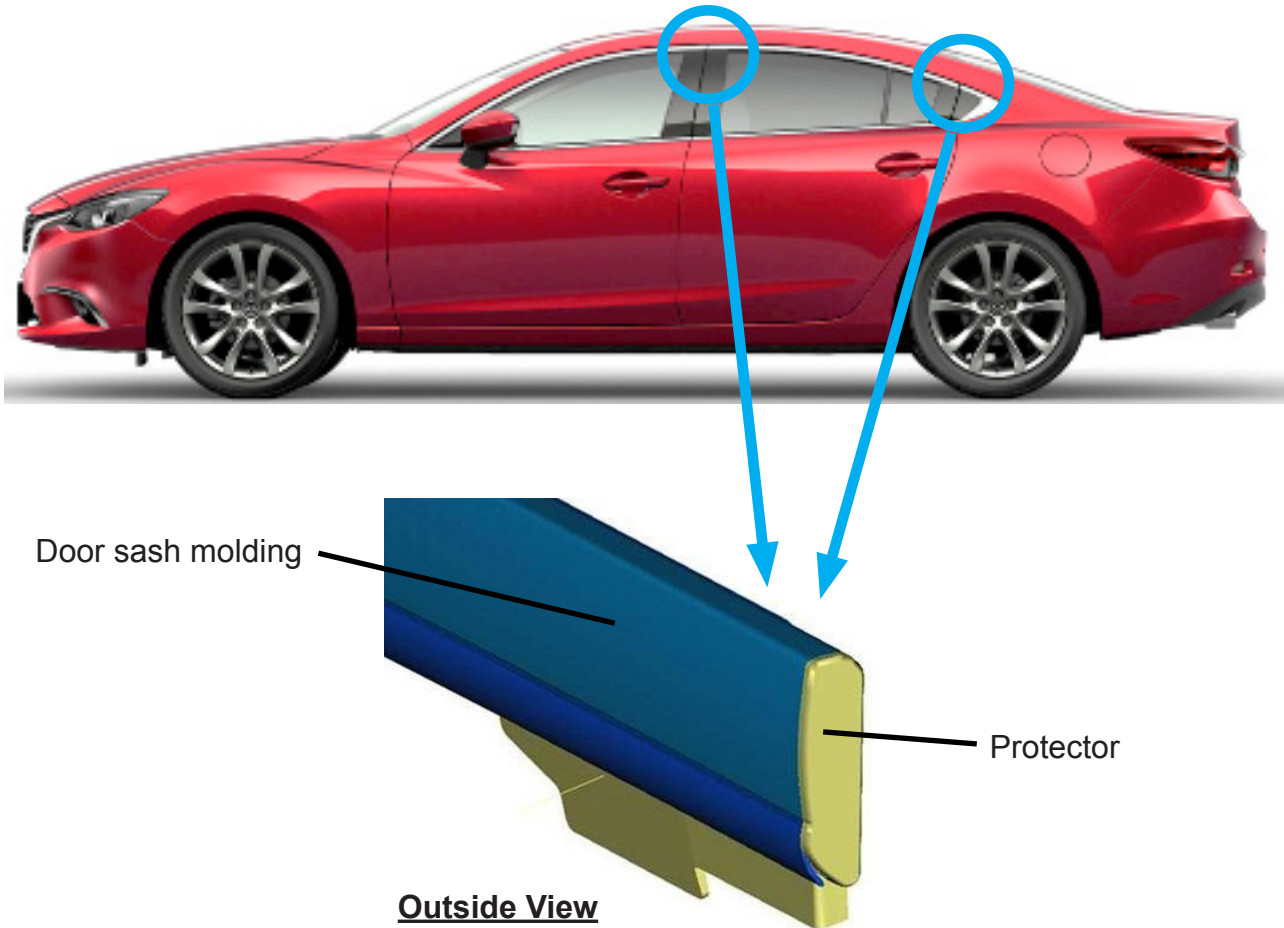
#### Door Sash Molding Repair

1. Inspect the protector(s) on all doors. If the protector(s) is(are) broken and/or separated, replace the door sash molding(s).

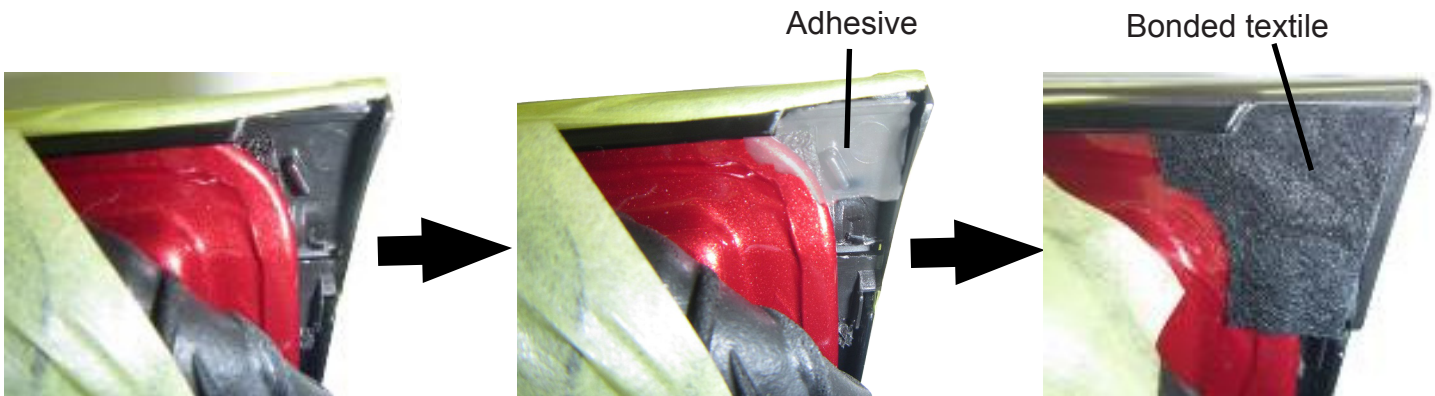
Inside view

2. If the protector(s) is (are) not broken or separated, repair the protector(s) and cover the edge of the door sash molding using adhesive. (For all doors)

Right front door is shown as an example

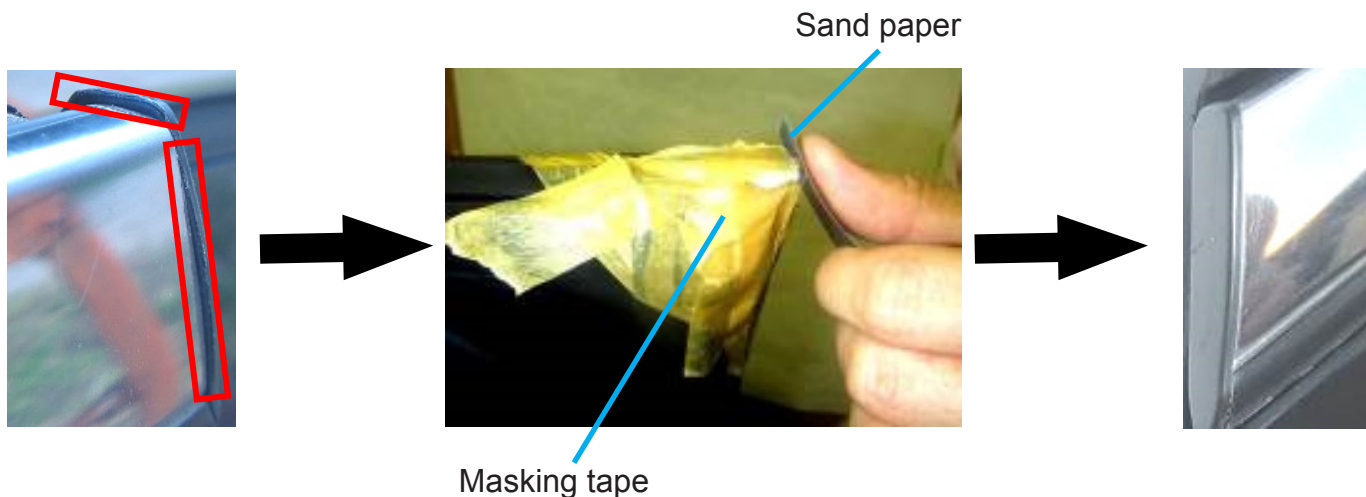
3. Inspect the protrusion (edge) of the protector. If the height is over 0.4 mm, file off the protrusion using sand paper. (For all doors)

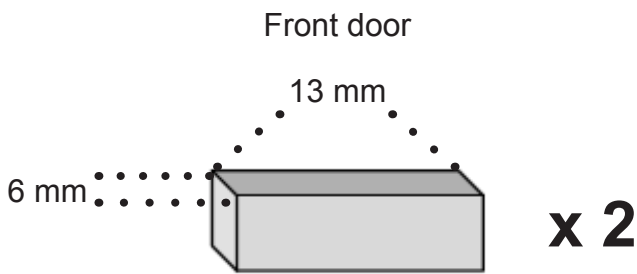
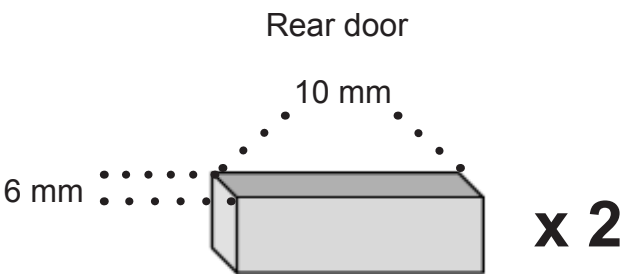
2. Cut the sponge rubber (Thickness 3.0 mm) to the following shape: (Used to prevent adhesive sagging)

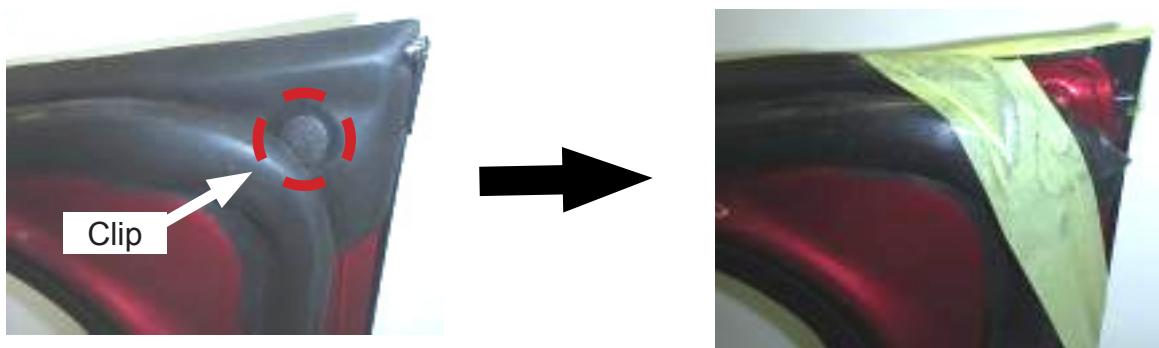
3. Open the door and flip the weather strip as shown below: Then fold it down and use masking tape to hold it.

**NOTE:** Do not remove the weather strip clip.

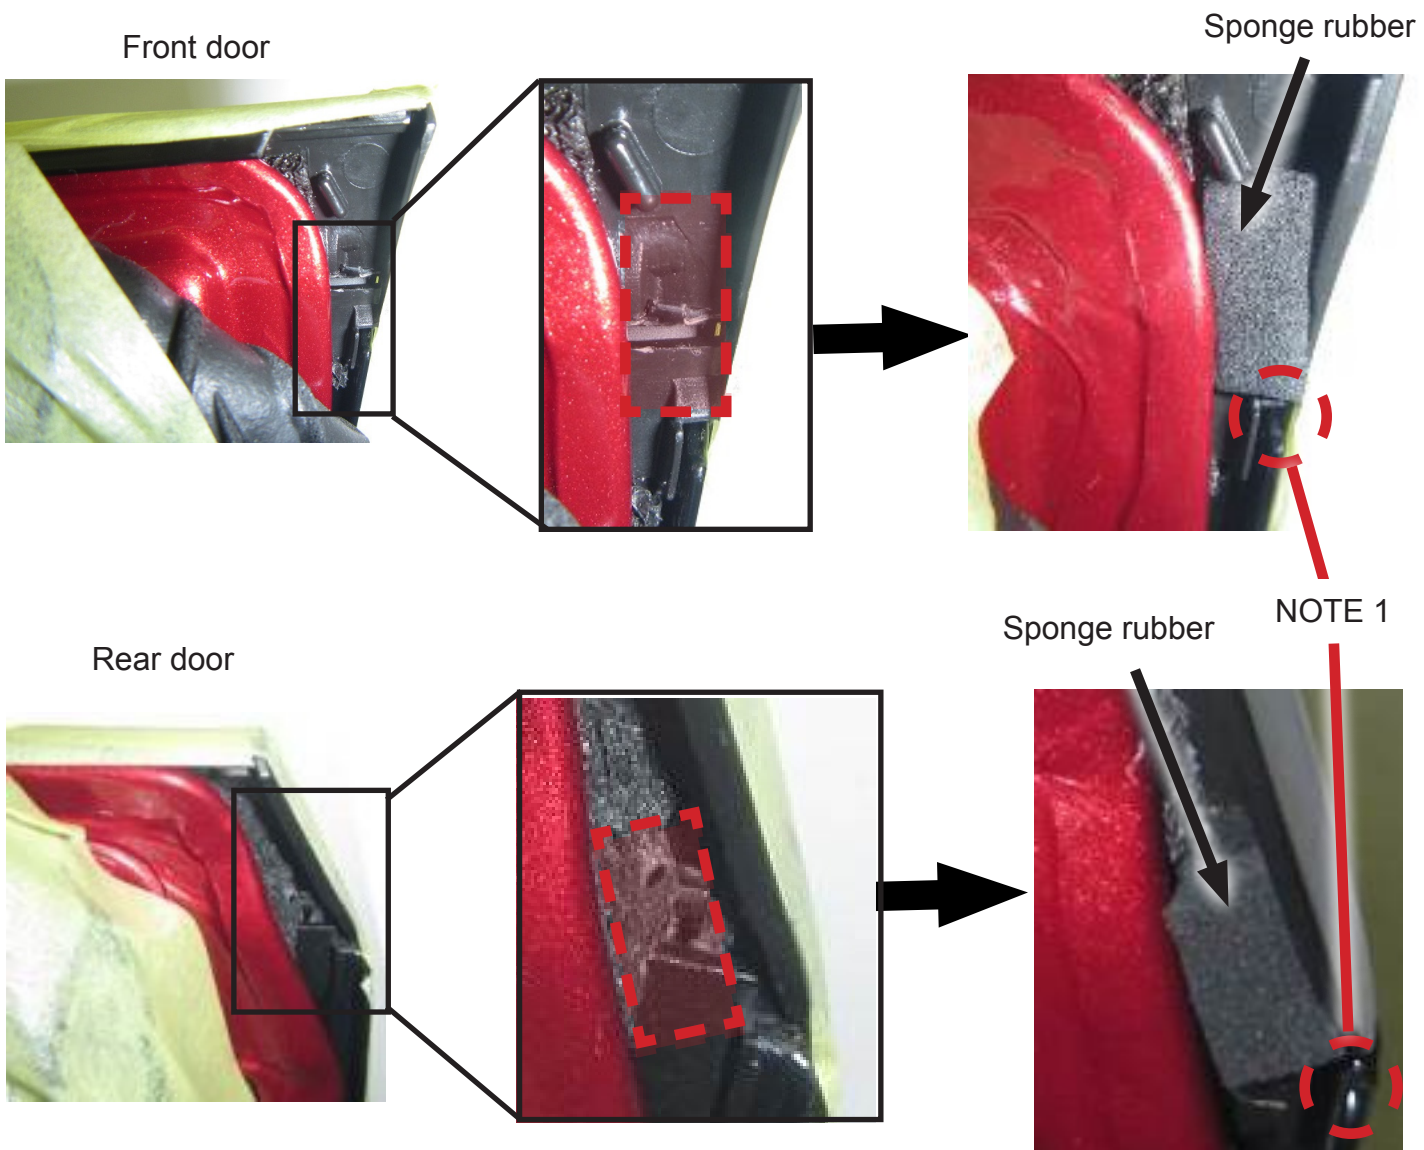
4. Apply the sponge rubber to the door sash molding as shown:

**NOTE 1:** Prevent the protrusion of sponge rubber between the protector and the door garnish.

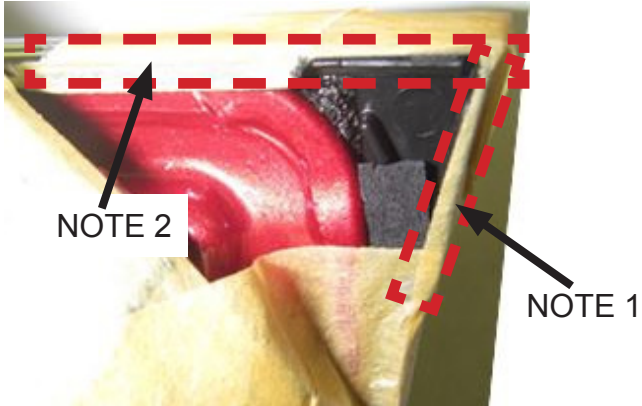
Front door

5. Apply the masking tape on the door sash molding, protector, door panel and weather strip as shown in the figure below.

**NOTE 1:** Apply the masking tape at the inside edge of the protector.

**NOTE 2:** Apply the masking tape at the end of door sash molding.

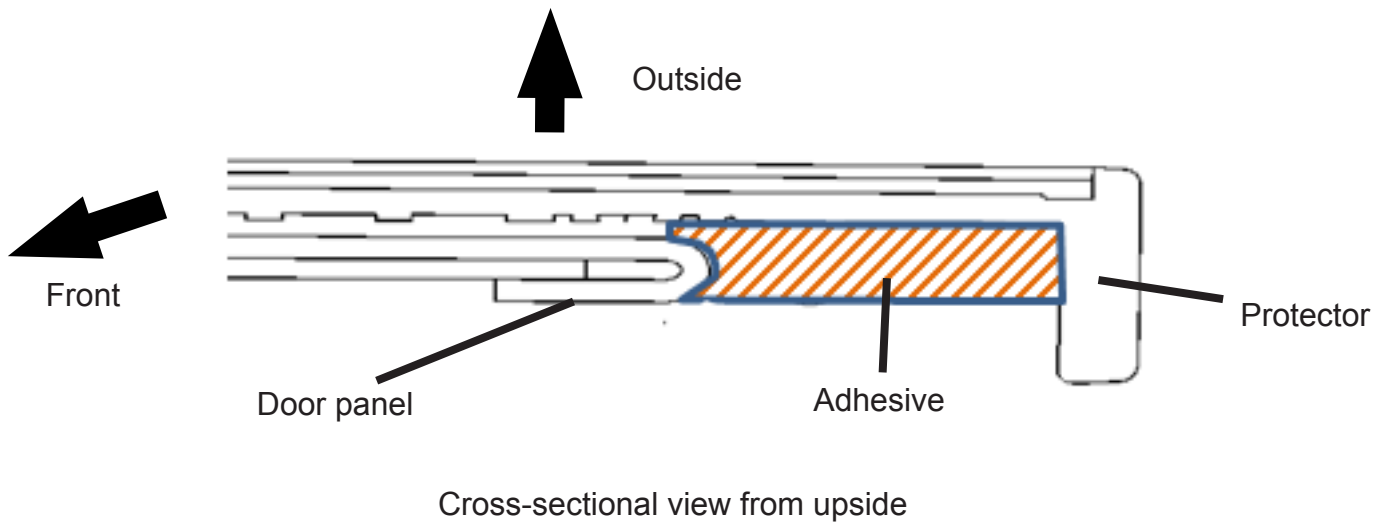
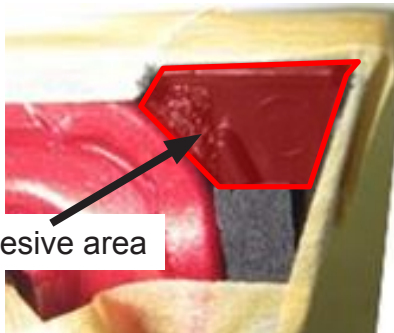
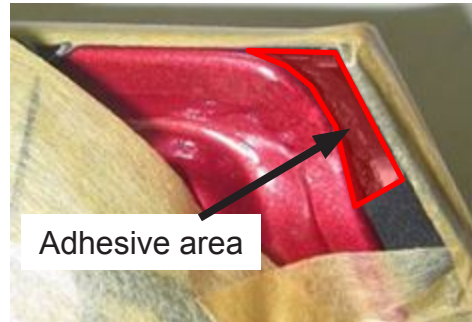
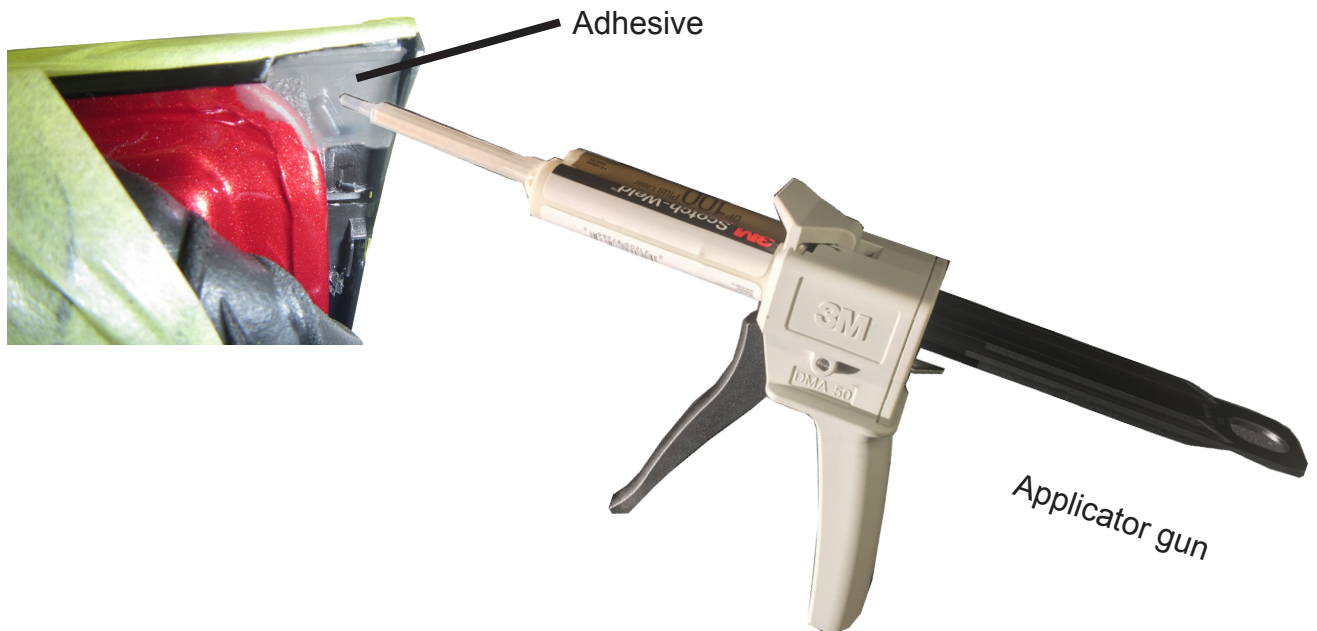
8. Apply the adhesive on the bonding area of the front and rear door as shown below.

- Recoat the adhesive to the same thickness as the door panel.
- The adhesive may run down when applied. Use a pallet on the adhesive until it cures enough to stop running down.

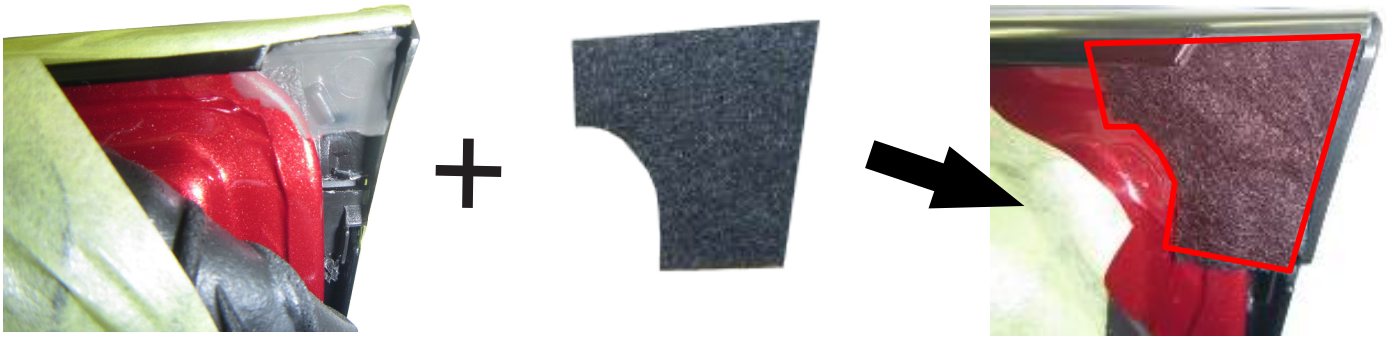
9. Approximately 10 minutes after applying the adhesive, apply the bonded textile on the adhesive.

**NOTE:** Before the adhesive is fully cured, apply the bonded textile.

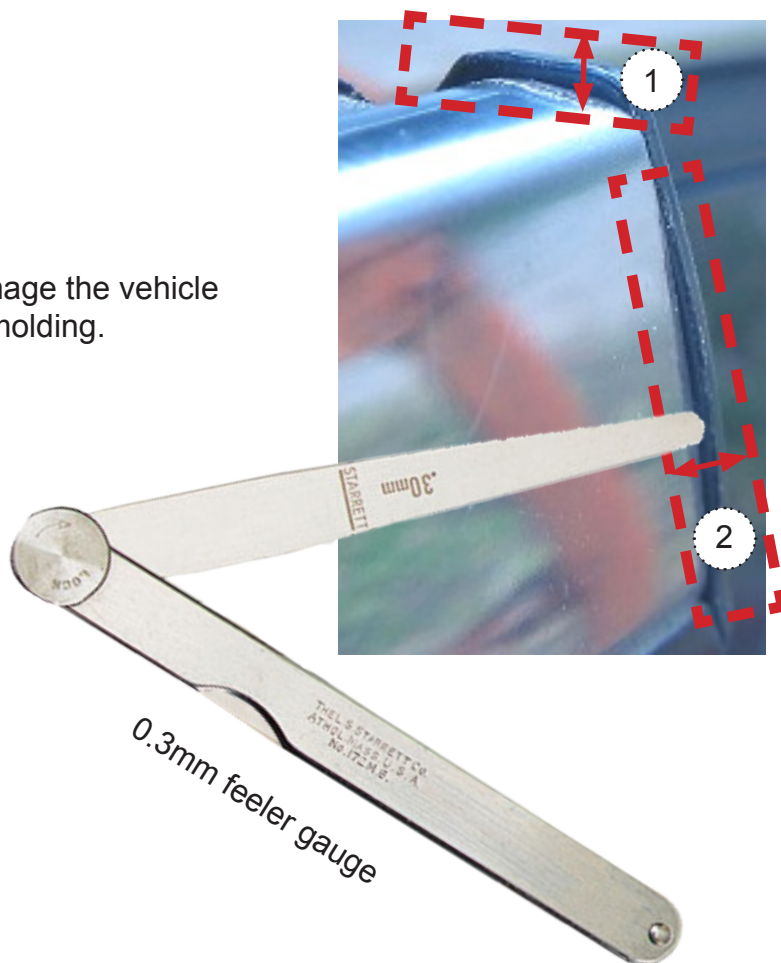
Vehicle front

1. Inspect the protector for excessive protrusion. Measure the protrusion height at (1) / (2) using a 0.3mm feeler gauge.

The height is equal or less 0.3 mm, filing is NOT required.

The height is over 0.4 mm, filing is required.

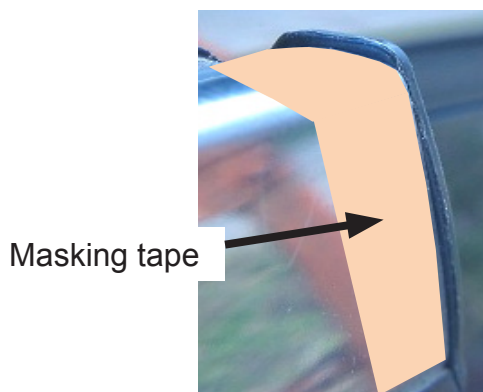
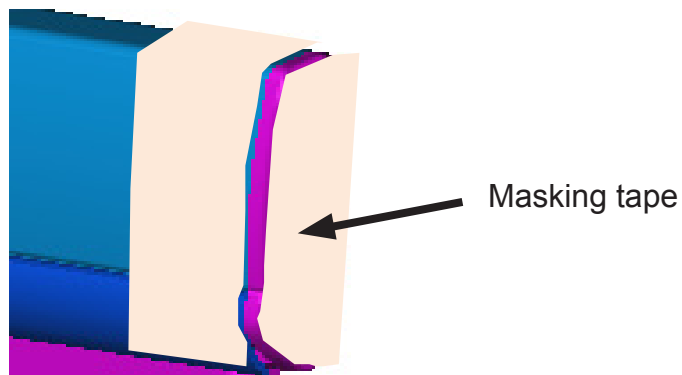
2. If filing is required, apply masking tape on the door sash molding as shown below.

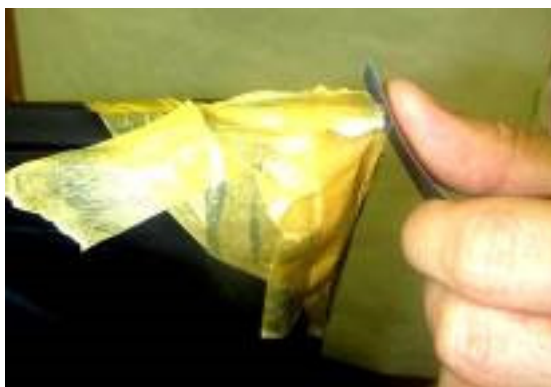
3. File the protector until the height of the protrusion is equal or less 0.3 mm using the sand paper. Then, remove the sharp edges of the protector using sand paper.

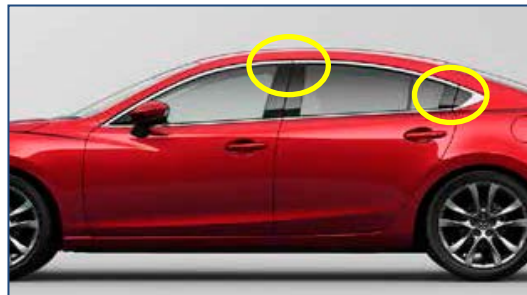
On certain subject Mazda6 vehicles, the front and rear doors may have a gap between the door sash molding and the resin protector. The protector may separate or break, causing the metal part of the door sash to be exposed. If the driver or passenger contacts this metal part when entering or exiting the vehicle, injury may occur.

Your Mazda dealer will reinforce all the door sash moldings to prevent this condition. Also, any protector separation or breakage will be repaired. The repairs will be performed free of charge, and will take approximately ½ day to complete; however, it may take less time depending on the repair required and/or service workload at your Mazda dealership.
