# SERVICE BULLETIN

SB1261A

| <b>SUBJECT</b> | : Bevel gear of front axle steering system |

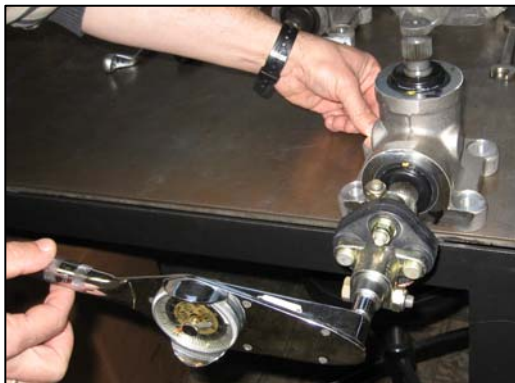
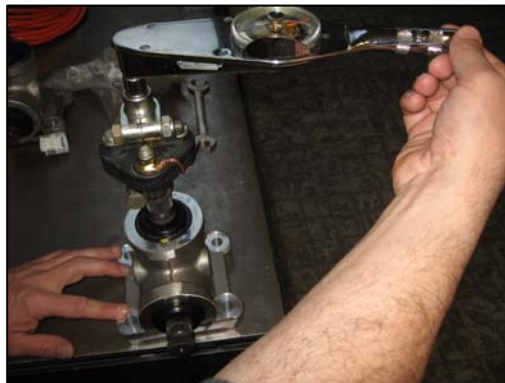
| Step | Action |
|---|---|
| 1 | Position the bevel gear on a work bench. |
| 2 | Position a torque tester suitable for measuring small torques at the input or output shaft of the bevel gear. Check the bevel gear rotating torque by progressively increasing the force on the arm of the tester. The bevel gear must be replaced when the reading on the torque meter exceeds 0,7 Nm (0.52 ft.lbf). |

Additionally it has been determined that in some cases water has penetrated the bevel gear via the sealing thereby contaminating the grease. The penetrating water will start corrosion of the bearings. This problem shows a gradual, but continual increase of the steering forces and will not disappear at higher ambient temperatures or when the bevel gear is in use. Checking the bevel gear rotation torque will help in determining if the bevel gear needs to be replaced.

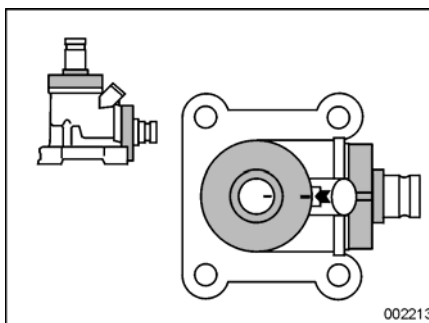
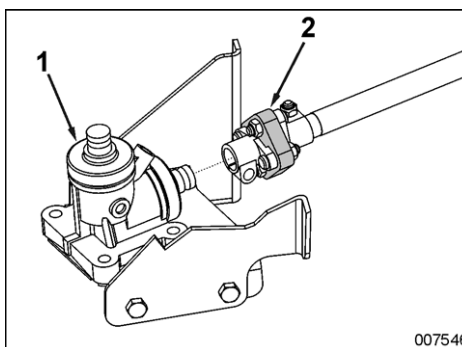
| Step | Action |
|---|---|
| 2 | Rotate the bevel gear input shaft to align the marks on the dust cap and on the input shaft itself with the ridge on the housing. This is the "zero backlash" position of the bevel gear. |
| 3 | Slide output shaft of bevel gear (1) into elastic coupling (2) of the intermediate shaft. Make sure that the bevel gear remains in the "zero backlash" position during this step (refer to step 2). |

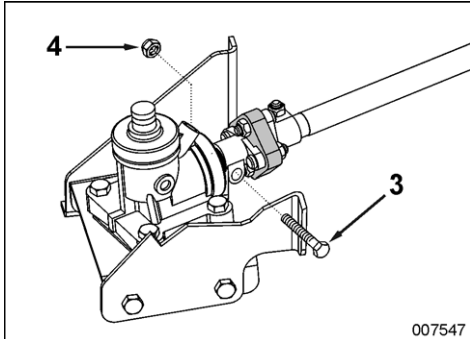
| 5 | <p>Install clamping bolt (3) with a new self-locking nut (4). If necessary, slacken the nut of the elastic coupling clamping bolt at the intermediate shaft side to ease installation of bolt (3).</p> |
| 6 | Tighten the clamping bolt(s) of the elastic coupling to a torque of $48 \pm 5$ Nm ( $35 \pm 3$ ft. lbf). |

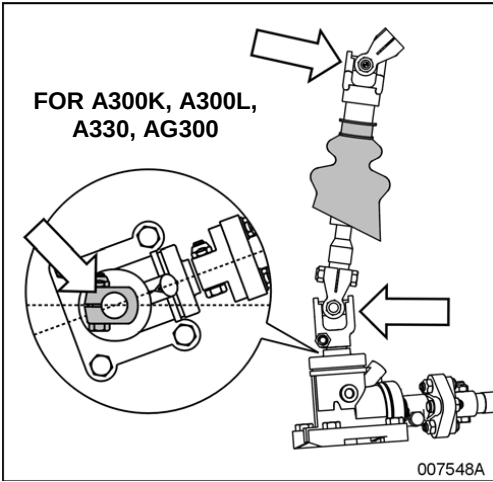
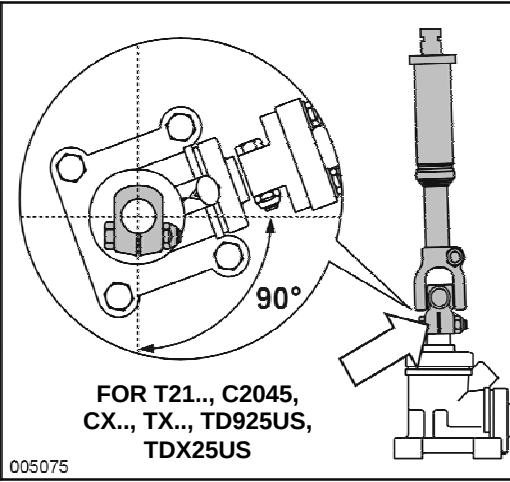
| 7 | <p>Secure the universal joint of the steering column to the bevel gear with a bolt provided with a new self-locking nut.</p> <ul style="list-style-type: none"> <li>• For busses: ensure that the clamping slot of the universal joint is parallel to the longitudinal vehicle axis (as shown in the left figure).</li> <li>• For coaches: ensure that the clamping slot of the universal joint is perpendicular to the longitudinal vehicle axis (as shown in the right figure).</li> </ul> <p>Tighten the clamping bolt nut of the universal joint to a torque of <math>48 \pm 5</math> Nm (<math>35 \pm 3</math> ft.lbf).</p> <div style="display: flex; justify-content: space-around;"> <div data-bbox="375 1106 869 1585"> <p>FOR A300K, A300L,<br/>A330, AG300</p> </div> <div data-bbox="901 1106 1412 1585"> <p>FOR T21..., C2045,<br/>CX..., TX..., TD925US,<br/>TDX25US</p> </div> </div> |
