# PREVOST

## WARRANTY BULLETIN

### WB15-19E

DATE :	OCTOBER 2015	SECTION :	22 - HVAC
EXPIRATION:	OCTOBER 2017		
SUBJECT :	<b>BITZER A/C COMPRESSOR VIBRATION – ADDITION OF A REINFORCEMENT BRACKET TO THE MOUNTING</b>

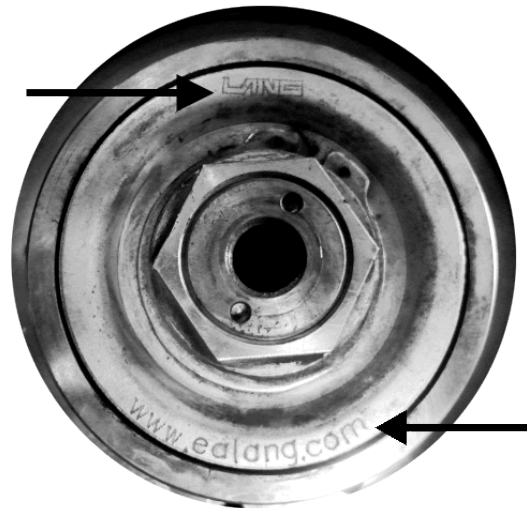
8. As an alternate way to confirm **LANG** Type clutch, locate "LANG" engraving on the hub center.

In addition to kit #457769, confirm you have two #5001616 socket head cap screws in your available material.

These additional screws will be used to install the reinforcement bracket on the compressor.

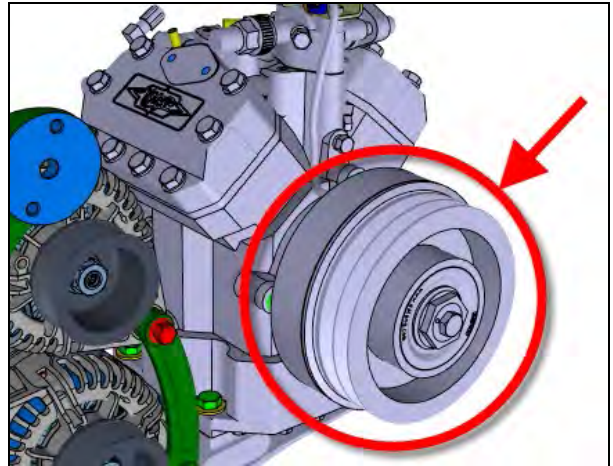
10. Remove the LANG electromagnetic clutch assembly.

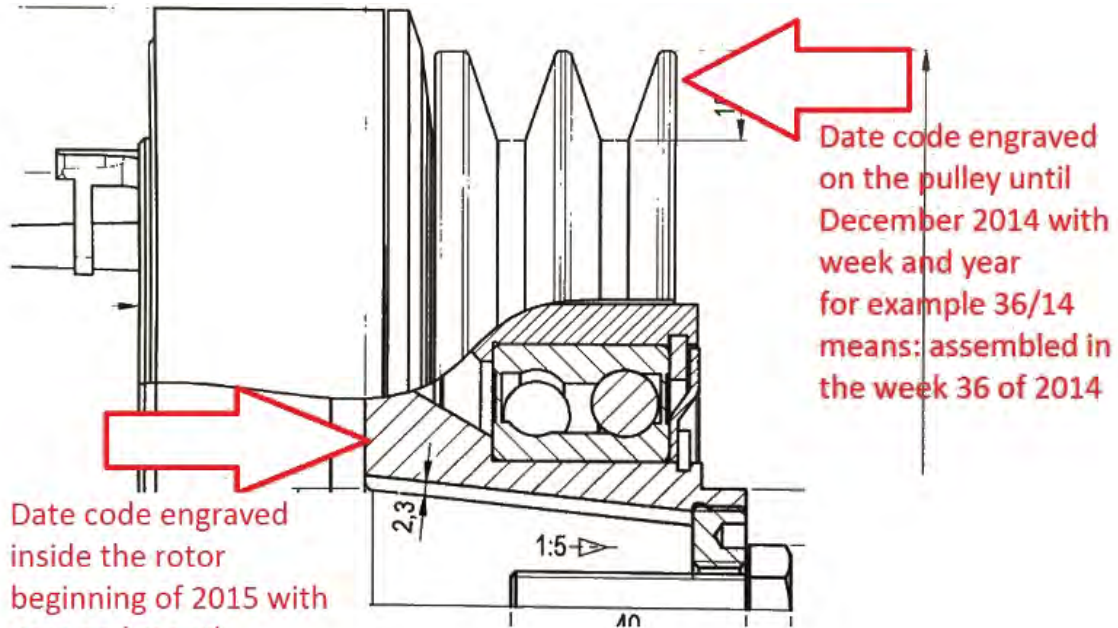
Date code engraving location has changed beginning of 2015 (image below).

10.6. IF CLUTCH DOES NOT HAVE A DATE CODE, OR CODE FORMAT IS DIFFERENT FROM BELOW, DO NOT REPLACE THE COIL

Date code engraved inside the rotor beginning of 2015 with year and month for example S02

S= 2015

02= February

10.5. Check the date code on the clutch pulley. If it is before S05 (May 2015), install a new coil #950533 in replacement of this one.

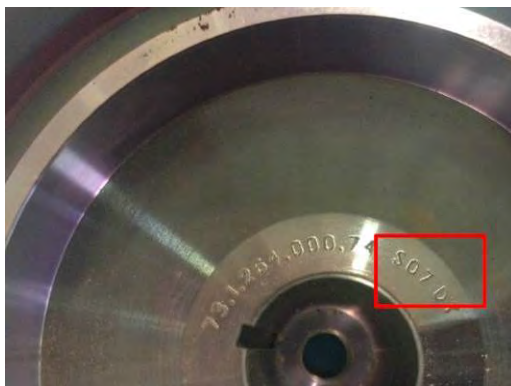
11. Remove the existing shaft seal drain tube and support.
12. Reinstall on the opposite side as seen on the image on the right.

*Note: Use existing hex socket head bolt and lock washer. Use blue Loctite 243 on threads.*

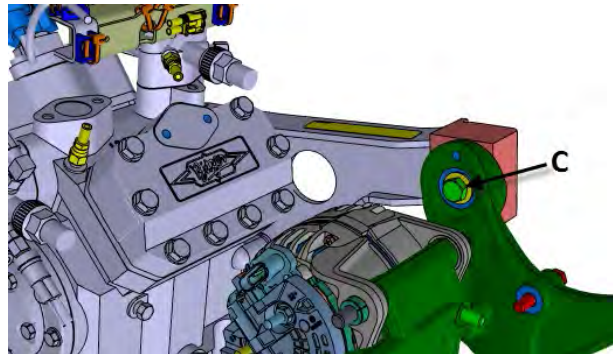
- 13.1. Carry on with the installation of new reinforcement bracket #457675 as shown. Use two "cylindrical head" socket cap screws #5001616 (E).

*Tighten to 40 lbf-ft (43 N-m)*

*Note: Use blue Loctite 243 on threads.*

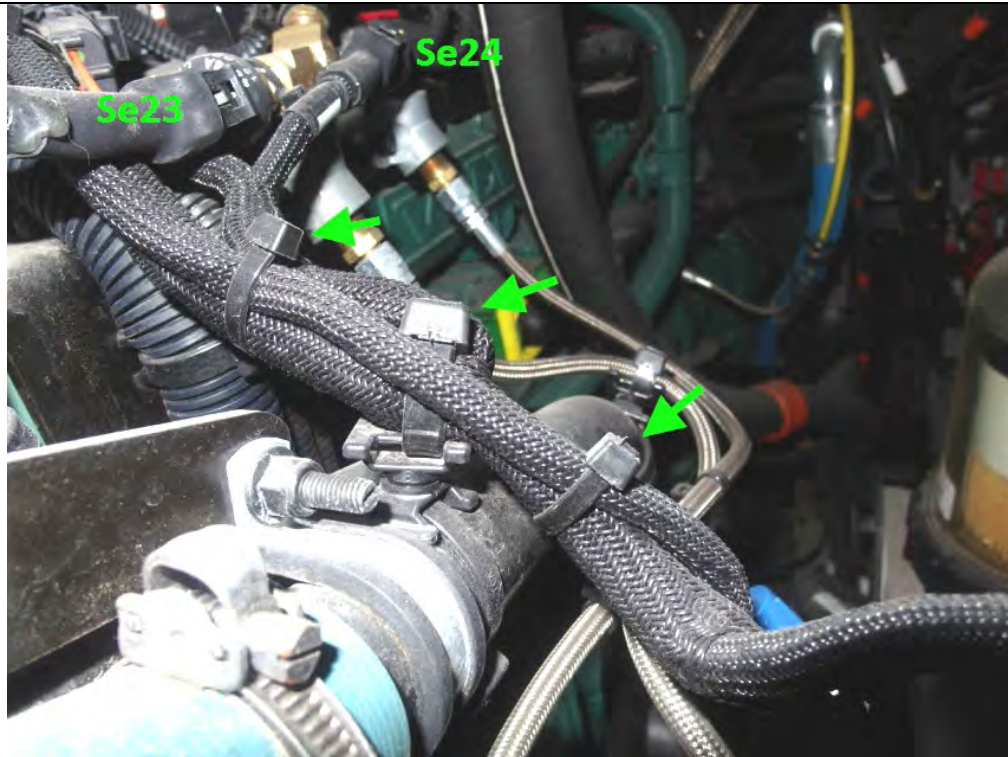
ATTACH THE EXCESS LENGTH OF CABLE ALONG MAIN STRAND OF HARNESS AS SHOWN- NYLON TIES LOCATION SHOWN BY ARROWS

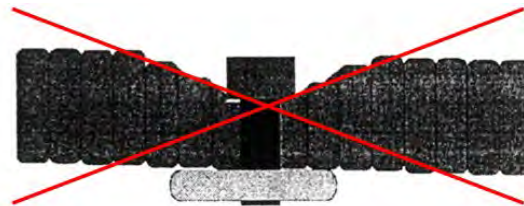
- No over-tightening of cable ties. (Must only prevent harness movement)
