Service Bulletin

Subject: Integrated Center Stack Display Delaminating Distorted Or Appears Bubbled Behind Lens

Models: 2013-2016 Cadillac ATS, SRX, XTS
2014-2016 Cadillac CTS VIN A, ELR, Escalade
Equipped with Cadillac CUE 8 Inch Touch Screen

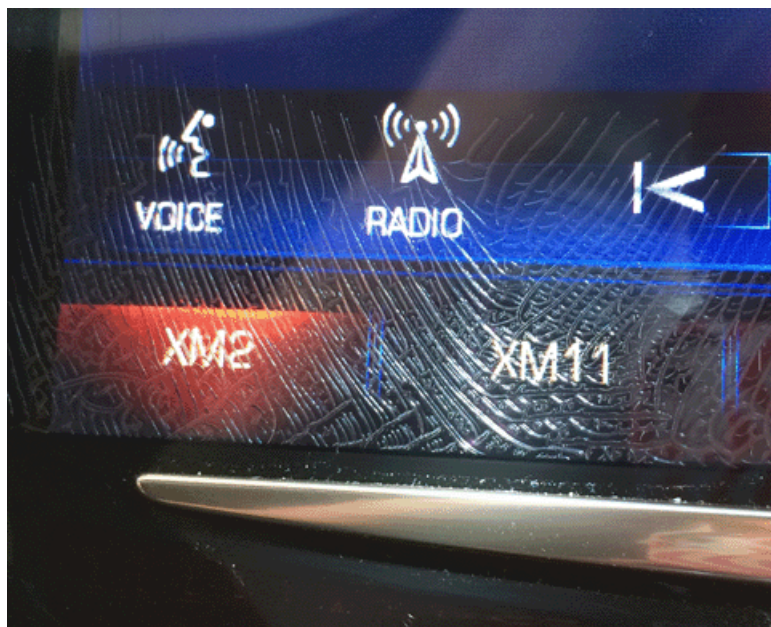
Customers may report their radio screen appears bubbled or is delaminating.

Note: THIS PI ONLY APPLIES TO THE TOUCH SCREEN (see picture below). If the ICS was damaged by cleaning agents or excessive force do not refer to the information in this PI, please refer to the latest version of bulletin 08-08-44-015.

If this concern is encountered, replace the ICS (Integrated Center Stack) by following the SI replacement procedure.

2013-2015 model years, please contact your ESC and replace the ICS for this concern.

2016 model years, please contact GMTAC for authorization prior to contacting your ESC for an exchange ICS.
