HYUNDAI NEW THINKING. NEW POSSIBILITIES. Technical Service Bulletin	GROUP CAMPAIGN	NUMBER 16-01-048
	DATE November 2016	MODEL(S) Santa Fe Sport (ANa)
SUBJECT: SANTA FE SPORT (ANa) REAR SEAT RELEASE INSPECTION AND REPAIR (SERVICE CAMPAIGN TRR)

Description: On some Santa Fe Sport (ANa) vehicles, the Rear Seat Release Handle may be inoperative. When the seat release handle is pulled in affected vehicles, the rear seatback will not fold down. This bulletin describes the procedure to inspect and if necessary, reconnect the rear seat release cable.

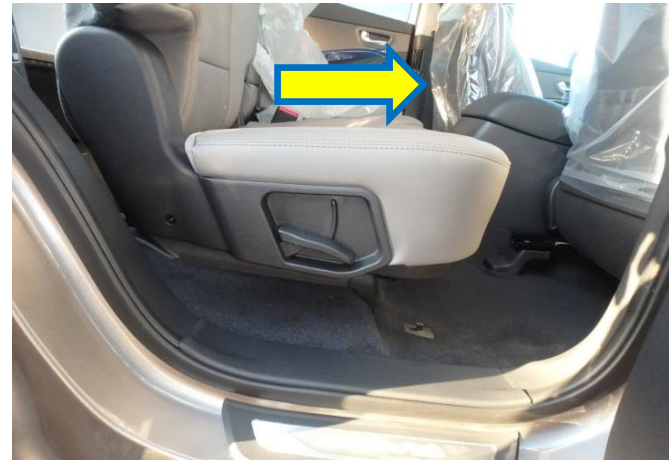
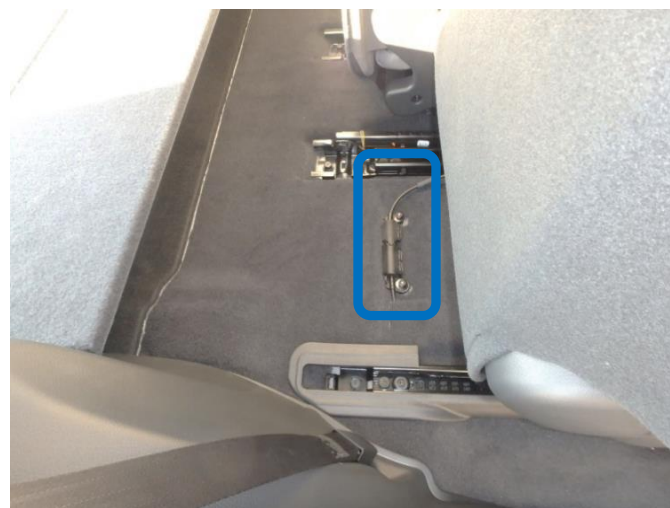
1. To inspect cable attachments, slide the LH & the RH rear seats forward to access the cable connection.

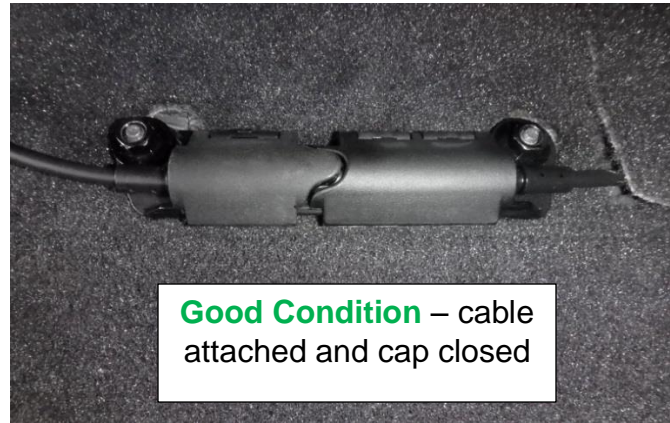
2. Verify that the cable is attached and the cap is secured properly. (see photo)

***If the cable is attached & cap is secured properly, end service procedure here. Use labor Op. 60CA24R0. If not, continue to step 3.**

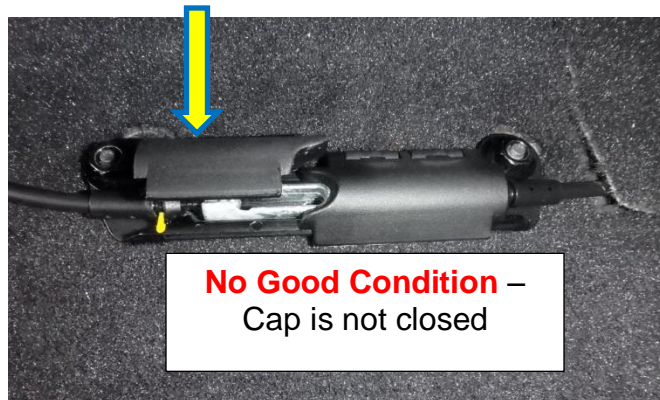
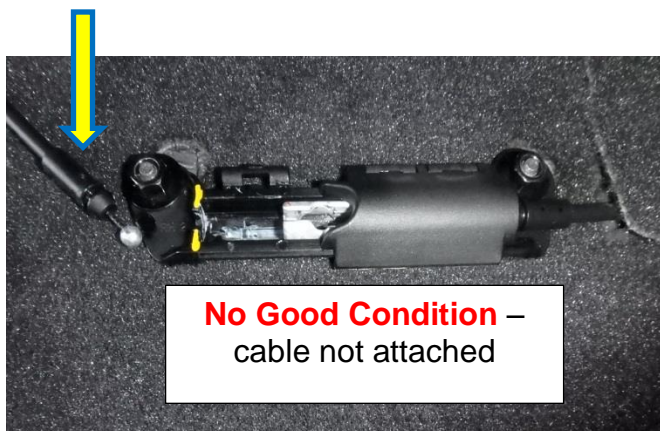
3. Cable should be attached and cap should be closed. If cable is not attached or cap is not closed, re-assemble each component.

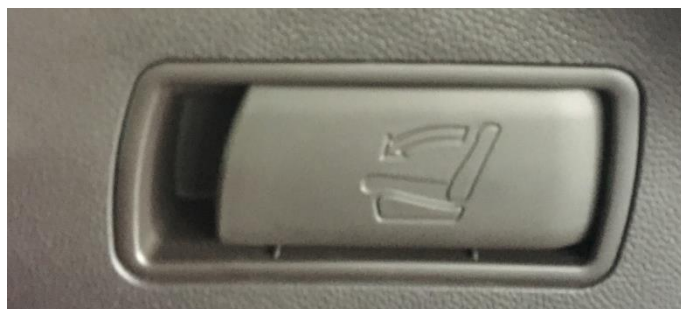
4. Inspect the function of the release.
- With the rear seatback fully raised, pull the release handles on both sides, located in the cargo area.

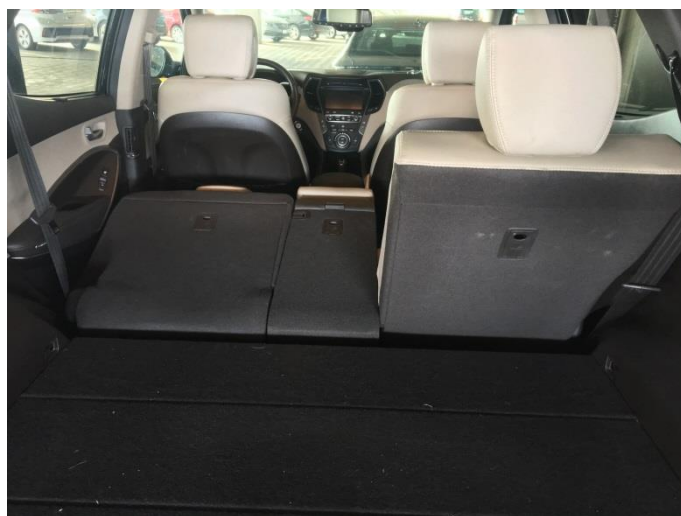
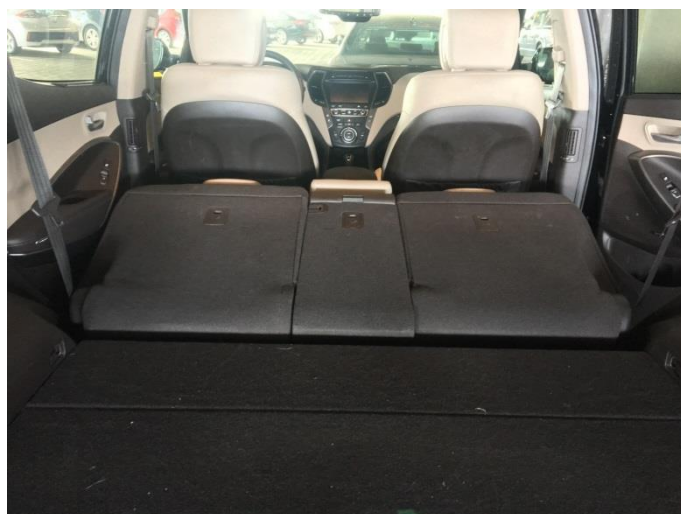
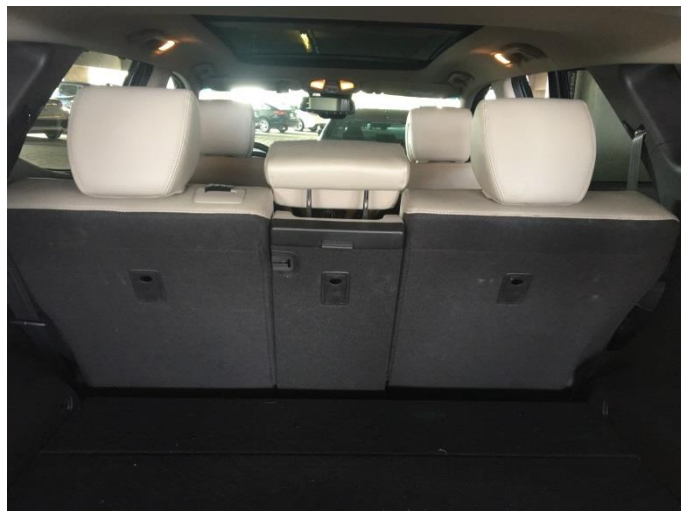
5. If the seatback folds, then the vehicle is okay. If the seatback does not fold, verify the cable condition again according to steps 1-3 of this TSB.

***Once the seatback folds, the service procedure is complete. Use labor Op. 60CA24R1.**
