Customer Satisfaction Notification S57

Front Wiper Arms

2016 (KL) Jeep® Cherokee

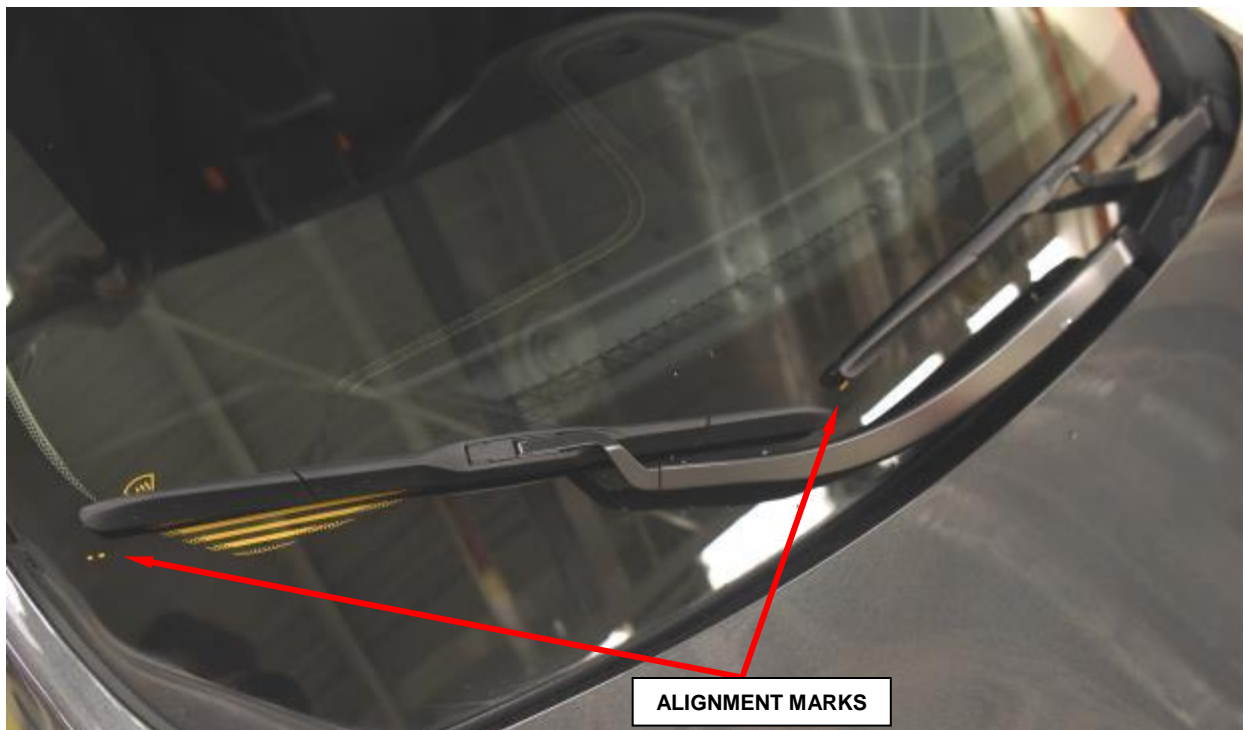
**Figure 1 – Wiper Blade Alignment Marks**

2. With the wiper blades in the park position, manually lift each blade off the windshield and release to ensure the blades are not under wipe load.
3. Verify if the position of the wiper blade tips are within $\pm 10\text{mm}$ of the park position alignment marks on the windshield (Figure 1).

- If the wiper blade tips **are** within $\pm 10\text{mm}$ from the alignment marks, and the wipers operate without contact to the body or contact to each other, and are not loose, **continue with Step 4.**

- If wiper blade tips **are not** within $\pm 10\text{mm}$ from the alignment marks, or if the wiper arms are loose, contact the body or contact each other, **continue with Step 5.**

18. Verify the position of the wiper blade tips are within $\pm 10\text{mm}$ of the alignment marks on the glass (Figure 1).
 - If wiper blade tips **are not** within $\pm 10\text{mm}$ from the alignment marks **repeat Steps 5 through 18.**

- If the wiper blade tips **are** within $\pm 10\text{mm}$ from the alignment marks **return the vehicle to the customer.**

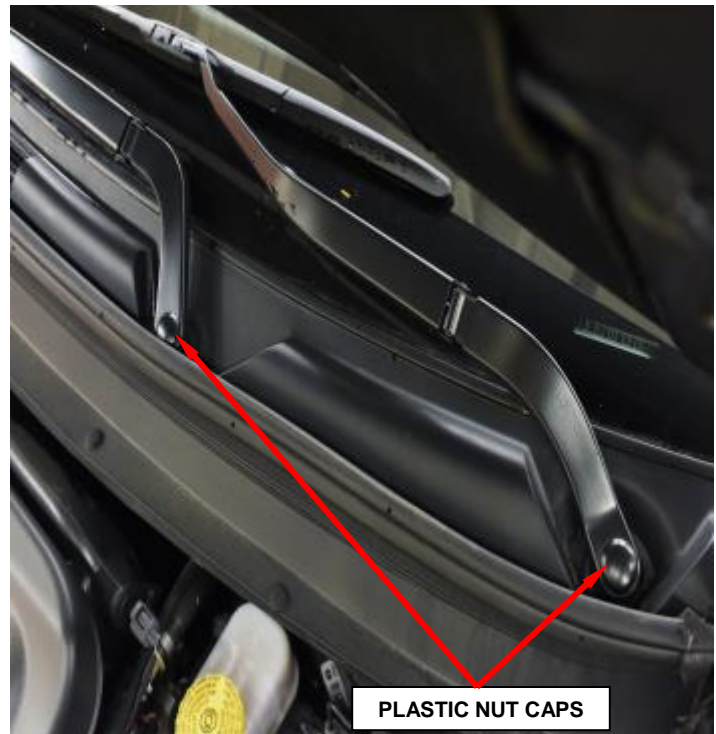
Figure 2 – Plastic Nut Cap and Nut Locations

4. Open the hood and carefully pry the plastic nut caps off of the pivot end of the wiper arms (Figure 2). While holding the wiper arms, tighten the nuts to 20 ft. lbs. (27 N·m) then continue to **Step 15**.
5. Open hood and carefully pry the plastic nut caps off of the pivot end of the wiper arms (Figure 2).
6. Remove the nuts that secure the wiper arms to the wiper pivot shafts.
7. Close the hood and lift the front wiper arm to its over-center position to hold the wiper blade off of the glass and relieve the spring tension on the wiper arm to pivot shaft connection (Figure 3).
8. Use a slight rocking action to disengage the front wiper arm pivot end from the pivot shaft and remove the front wiper arms.

13. Open the hood.
14. While holding the arms in position, install the nuts onto the pivot shafts by hand then tighten to 20 ft. lbs. (27 N·m)
15. Install the plastic caps onto the wiper arm pivot ends.

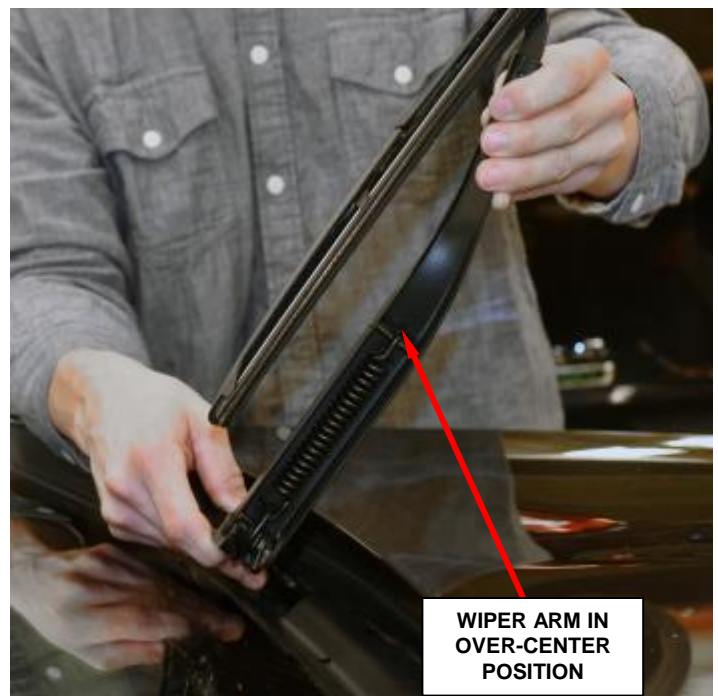
Figure 3 – Wiper Arm Removal

CAUTION: The use of a battery terminal puller or equivalent when removing the front wiper arm is NOT recommended except as a last resort, as this may damage the front wiper arm.
