# Special Bulletin

# SP16-303B

WHEELCHAIR LIFT CABLE WEAR

Prevost vehicles

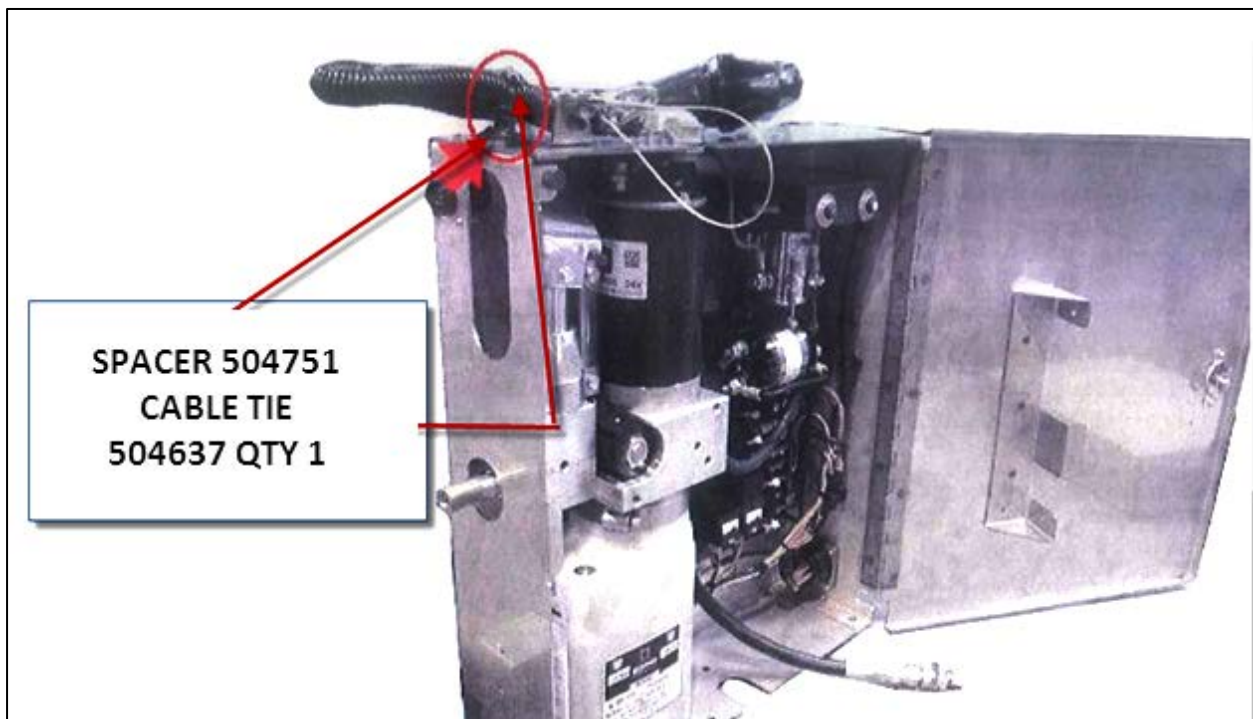
Figure 1

On the vehicles affected by this bulletin, reposition the harness out of the path of an unlocked electrical box door.

- 1) On the WCL control box of the WCL unit:
- 2) Add electric tape 680319 on the cable sheath to secure the electrical wires inside.
- 3) Add a rotary spacer 504751 on the cable over the electric tape.
- 4) Secure with cable tie 504637 qty 1
