## RADIATOR AND A/C DOORS LOWER HINGES REPLACEMENT

Prevost vehicles

On the vehicles affected by this bulletin, perform the proactive replacement of the lower hinges for both service doors.

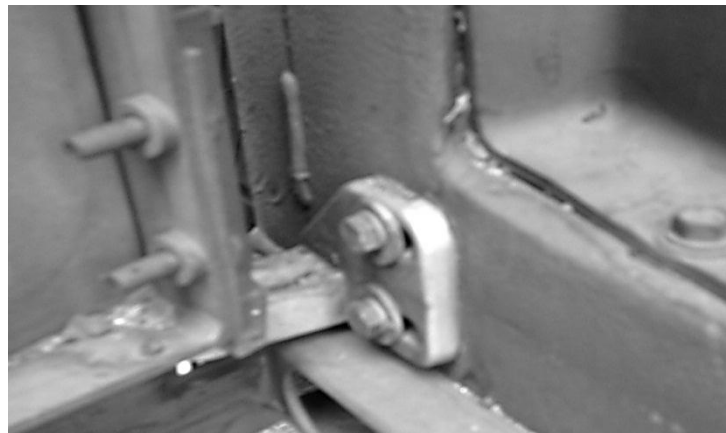
Radiator door

1. Replace the lower hinge on both rear service doors: radiator and A/C.
2. Support door while removing.
3. Remove existing lower hinge and discard.
4. Keep hardware for re-use.

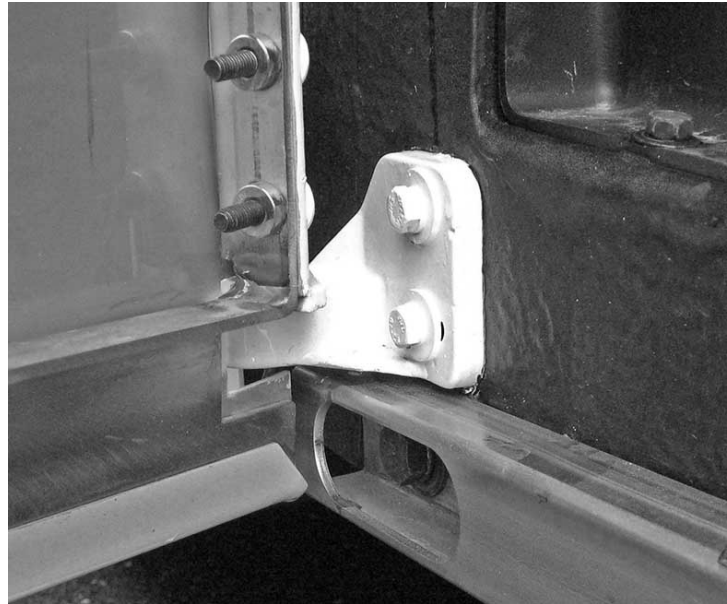
Radiator door

Radiator door, use:

- 288827 Hinge
- 502686 M6X30 hex cap screw
- 502570 Lock washer
- 430406 Flat washer
- 284607 Hinge bushing

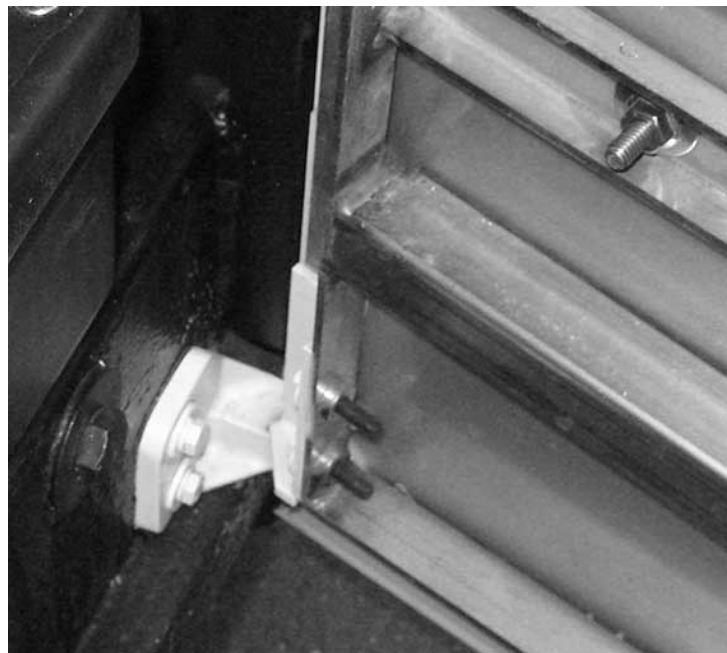
A/C door

A/C door, use:

- 288945 Hinge
- 502737 M6X25 hex cap screw.
- 502570 Lock washer
- 430406 Flat washer
- 284607 Hinge bushing
