# Special Bulletin

# SP16-303C

WHEELCHAIR LIFT CABLE WEAR

Prevost vehicles

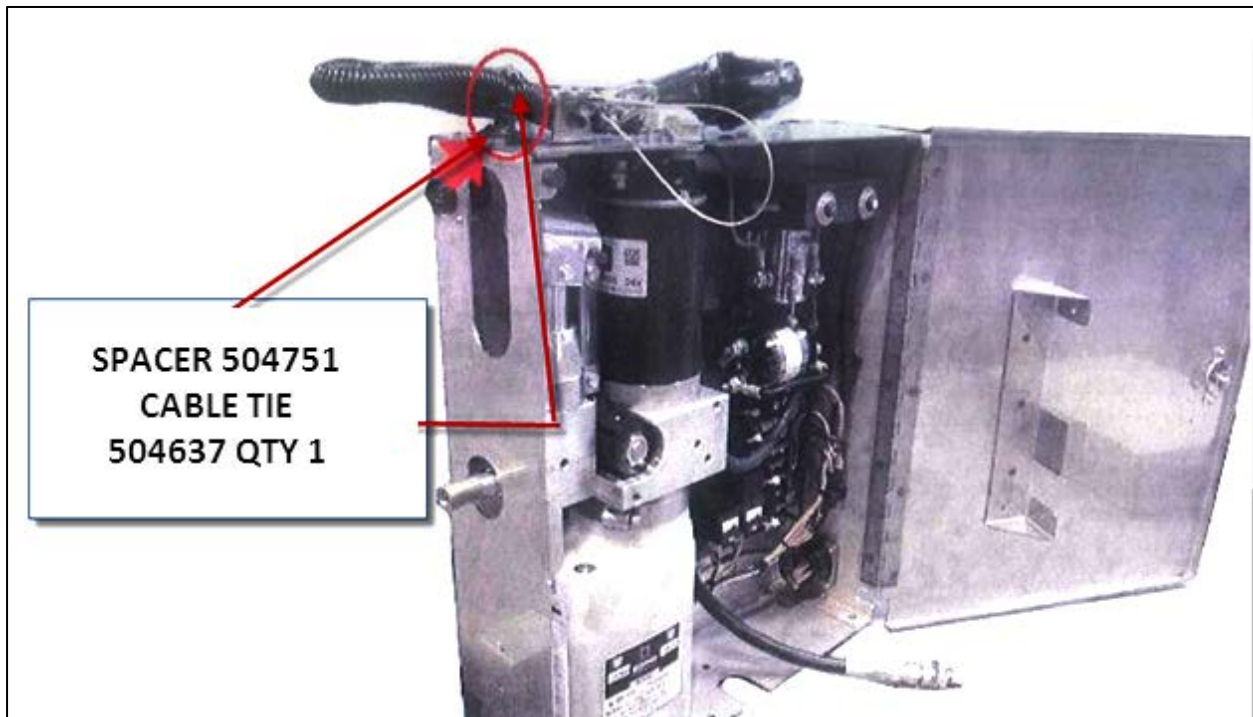
Figure 1

On the vehicles affected by this bulletin, reposition the harness out of the path of an unlocked electrical box door.

- 1) On the WCL control box of the WCL unit:
- 2) Add electric tape 680319 on the cable sheath to secure the electrical wires inside.
- 3) Add a rotary spacer 504751 on the cable over the electric tape.
- 4) Secure with cable tie 504637 qty 1
