## SERVICE BULLETIN

**APPLICABILITY:** 2009-13MY Forester Turbo Models  
2008-14MY WRX and STI Models

**NUMBER:** 15-202-16  
**DATE:** 06/24/16

**SUBJECT:** Turbo Boost Gauge Removal Procedure

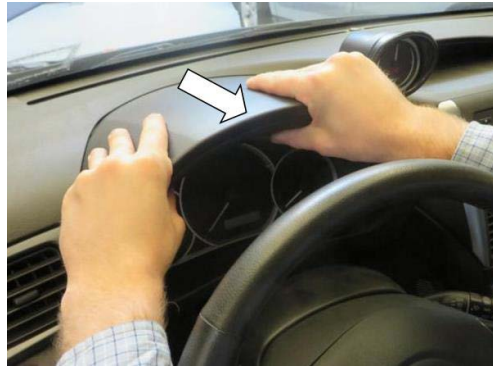
**Step 3:** **CAREFULLY** remove the combination meter hood by pulling it toward the driver.

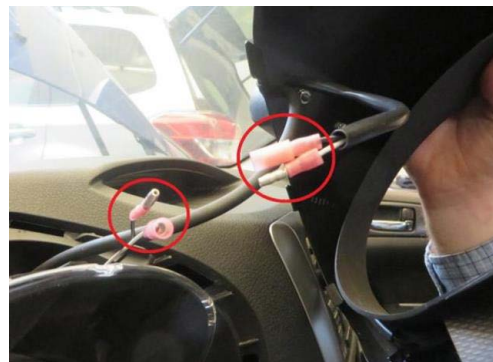
**Step 4:** After removing the combination meter hood, disconnect the boost gauge wiring connectors.

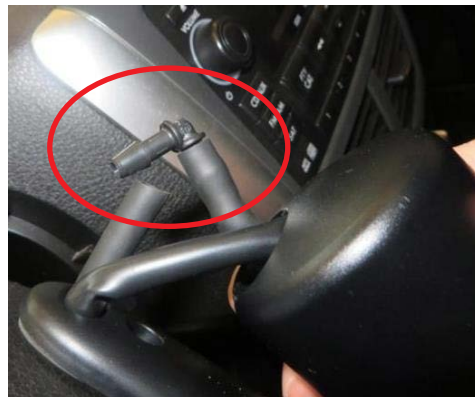
**Step 5:** Remove the vacuum hose from the elbow and pull it through the bottom of the combination meter hood. The hood can now be completely removed.

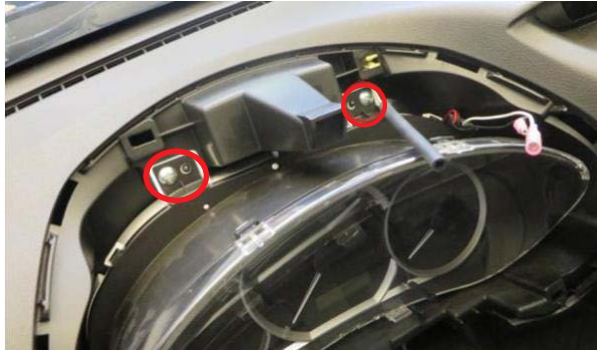
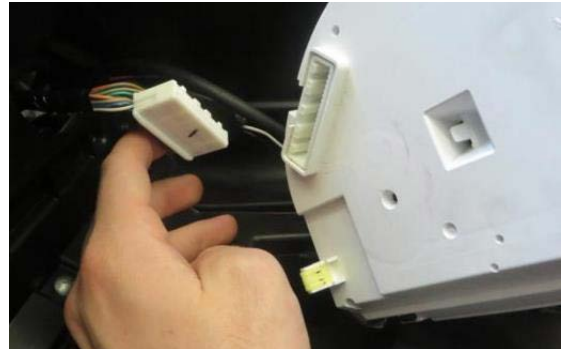
**Step 6:** Remove the 2 screws securing the combination meter to the instrument panel. **CAREFULLY** remove the combination meter enough to access the wiring harness connector. Disconnect it, remove the meter and set aside in a safe place.

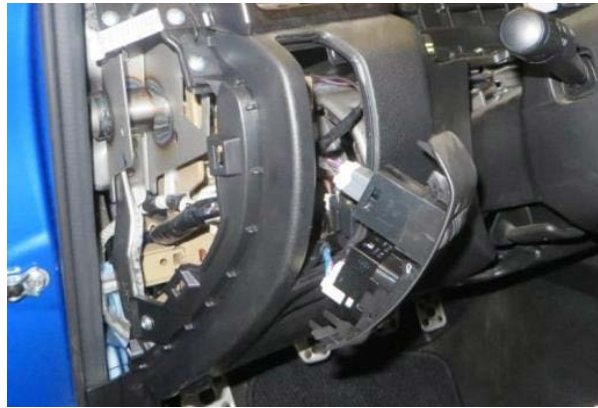
**Step 7:** Using a plastic trim tool, remove the instrument panel end cover trim panel to access and remove the dimmer switch assembly and unplug the related harness connectors.

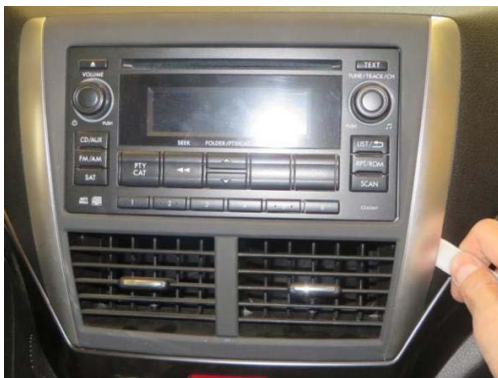
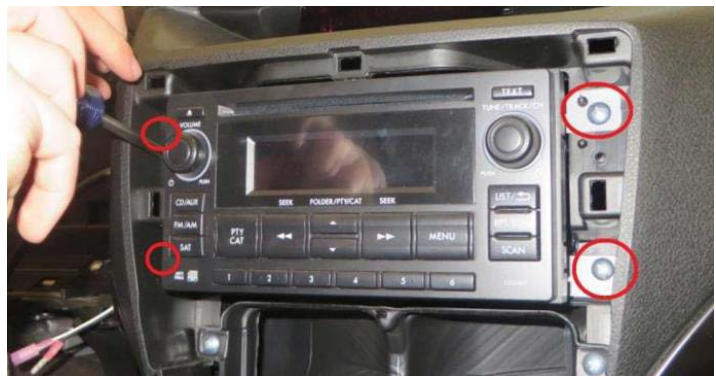
**Step 8:** Using a plastic trim tool, **CAREFULLY** remove the audio unit trim and then the 4 screws securing the unit to the instrument panel. Slide the unit out, disconnect the harness connectors and set the audio unit aside. If equipped, once the audio is removed, also remove the satellite radio receiver.

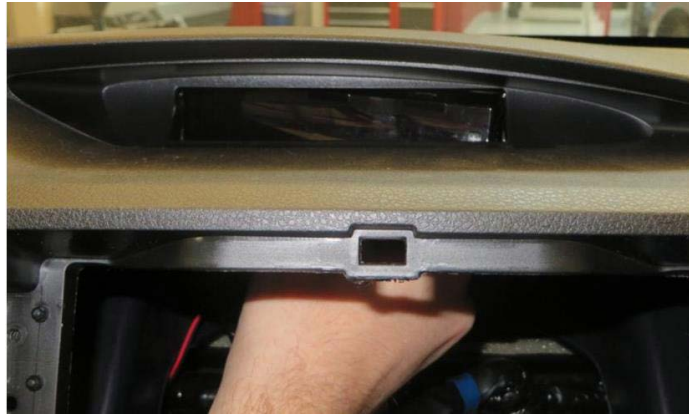
**Step 9:** Remove the clock unit by reaching in and up from the radio opening. Push the two outer retaining tabs apart while pushing the clock inward from the outside.

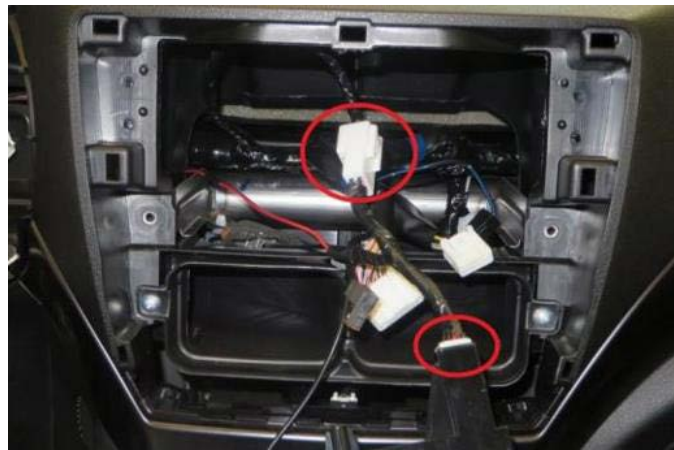
**Step 10:** Remove the boost gauge jumper harness from original clock connector and reconnect original vehicle harness back into the clock. Reinstall the clock (and satellite radio receiver).

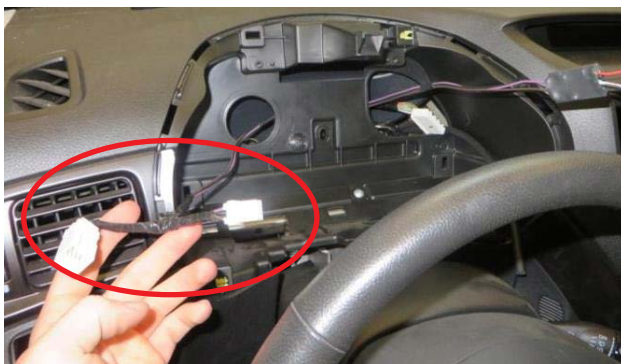
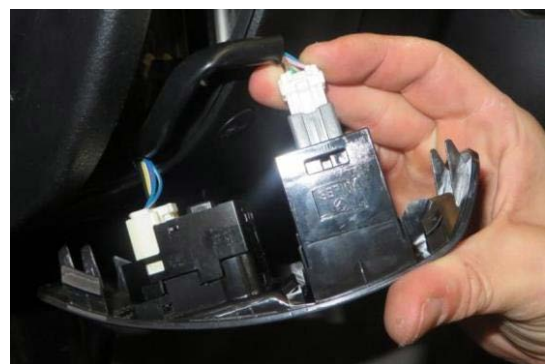
**Step 11:** Feed the boost gauge harness back through the dash. Disconnect the dimmer switch jumper from the dimmer switch, reconnect the original vehicle harness to the switch and refit the switch assembly to the instrument panel. Reinstall the instrument panel end cover trim panel.

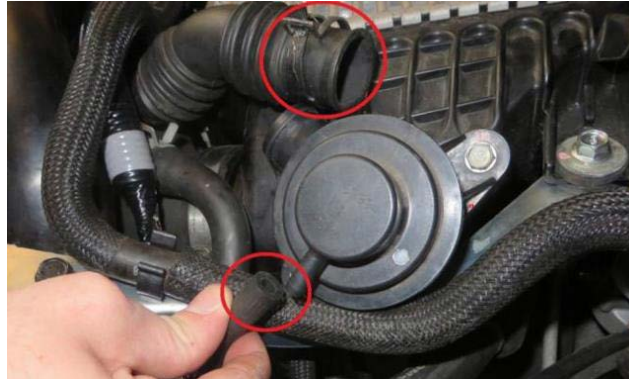
**Step 12:** Disconnect the hose clamp, tube, and vacuum hose from recirculation valve.

**Step 23:** Connect the new vacuum hose to the recirculation valve and reinstall the tube and its (spring) clamp.

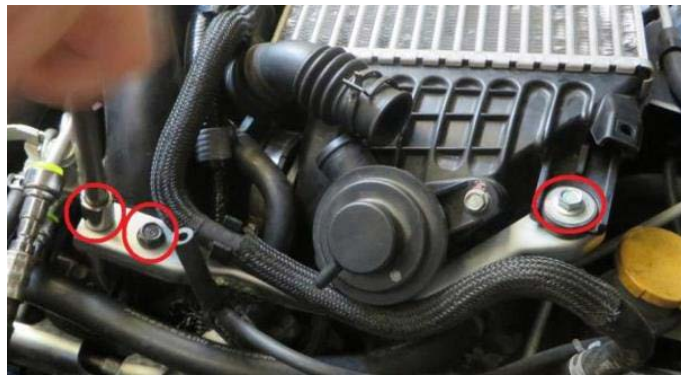
**Step 13:** Remove the 3 bolts securing intercooler support bracket and remove bracket.

**Step 22:** Reinstall the intercooler support bracket and torque the 3 bolts to 11.8 foot-pounds.

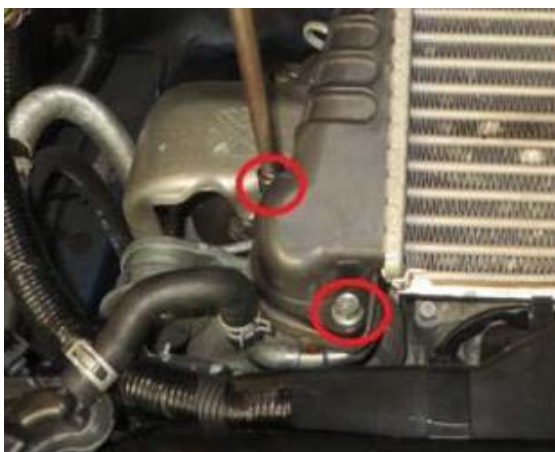
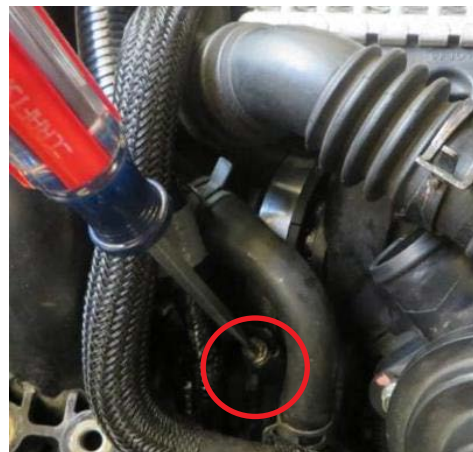
**Step 14:** Remove the 2 bolts securing the intercooler to the turbocharger, loosen the hose clamp and remove the intercooler assembly.

**Step 21:** Reinstall intercooler, tighten the hose clamp to 26.4 inch-pounds and torque the 2 bolts on the turbocharger to 11.8 foot-pounds.

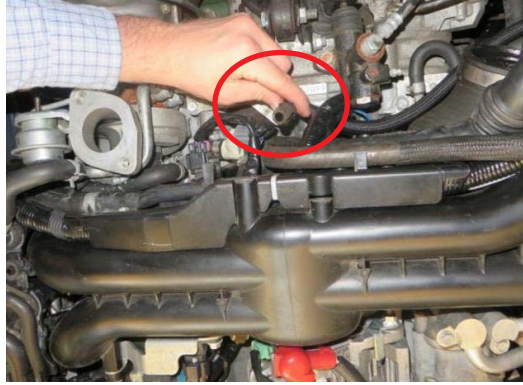
**Step 15:** Follow the vacuum hose coming from recirculation valve and disconnect it from the port where it connects to the engine. **\*\*Note the routing of this hose as it will be used for installation of the new vacuum hose in Step 20.**

**Step 20:** Connect the new vacuum hose to the port on back side of the engine. Route the hose the same way as referenced in **Step 15**.

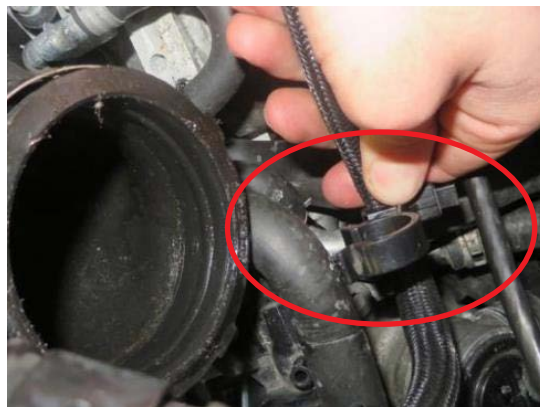
**Step 16:** Remove the hose clip from the existing hose as shown below.

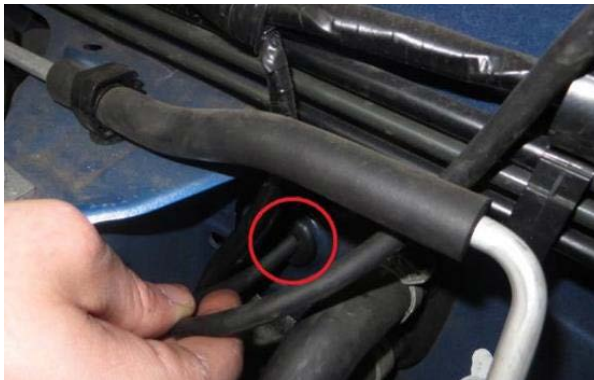
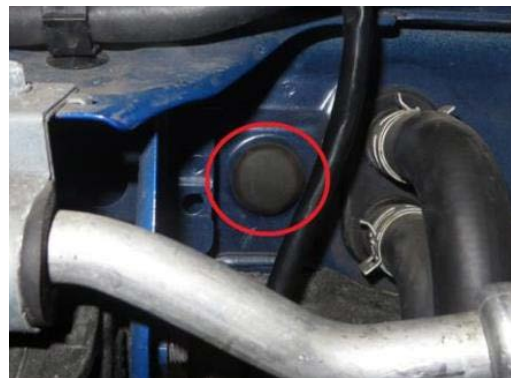
**Step 17:** Follow the boost gauge vacuum hose coming from the t-fitting to the bulkhead. Remove the bulkhead grommet and gently feed the hose through firewall into the engine compartment while ensuring nothing gets caught by the hose on the inside of the vehicle. Install the new bulkhead plug.

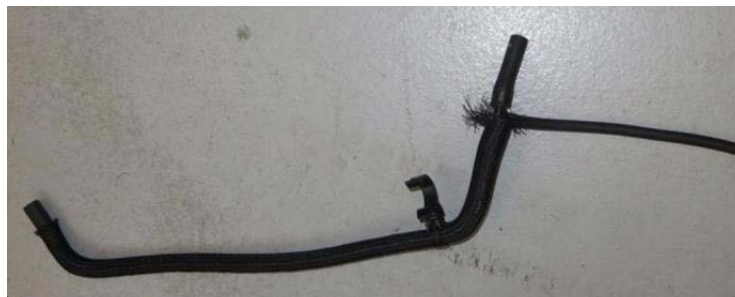
**Step 18:** Cut any wire ties used to secure the boost gauge vacuum hose then remove all hoses connected to the t-fitting.

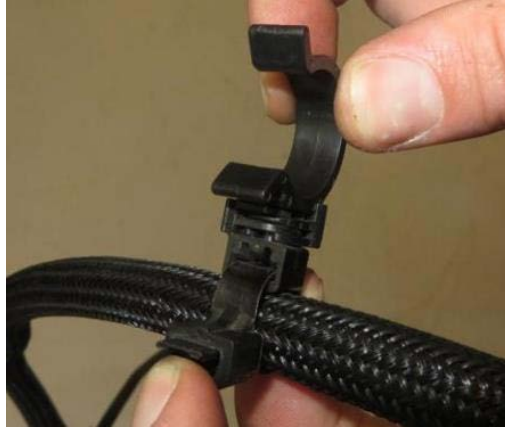
**Step 19:** Release the tab on the hose clip and remove it from the original hose. Reinstall this clip in the same position on the new hose.

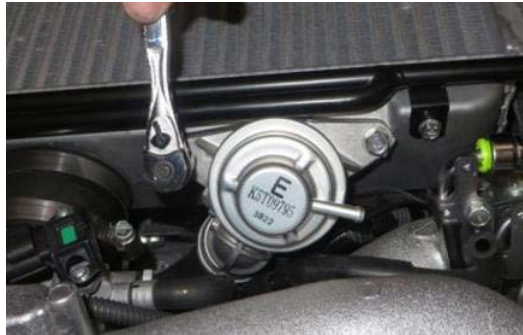
**Step 24:** Remove the hose from the recirculation valve then separate the valve from the intercooler.

**Step 36:** Install the recirculation valve using the new gasket and tighten the 2 bolts to 11.8 foot-pounds.

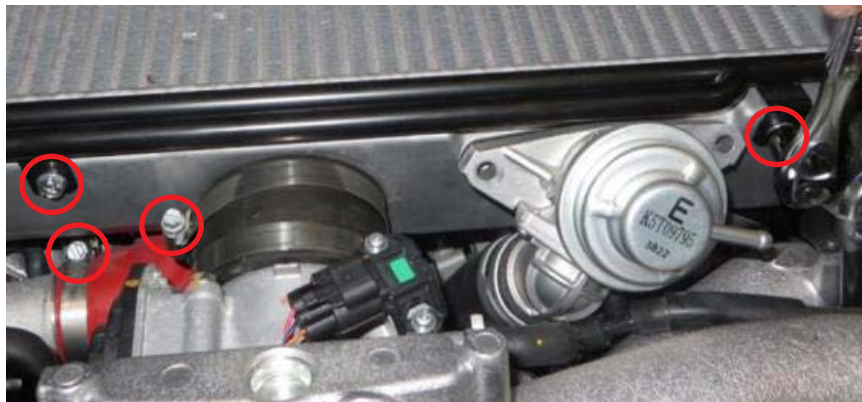
**Step 25:** Remove the 2 bolts securing the PCV pipe to the intercooler. Loosen the 2 hose clamps securing the intercooler to the turbocharger and intercooler to throttle body.

**Step 33:** Reinstall the intercooler, sliding both ports into the appropriate turbocharger and throttle body clamps. Tighten both clamps to 26.4 inch-pounds once intercooler is fully seated.

**Step 35:** Tighten the 2 bolts securing the PCV pipe to the intercooler to 4.1 foot-pounds.

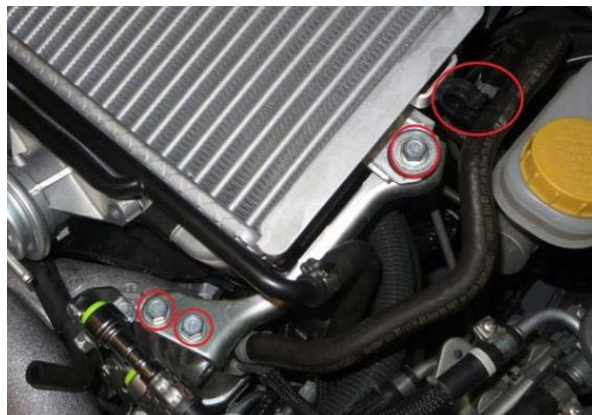
**Step 26:** Remove the hose from the clip on the intercooler. Remove the bolt securing the intercooler to the bracket and the 2 bolts securing the bracket to the engine. The bracket should now be free.

**Step 34:** Reinstall the intercooler bracket by securing with 2 lower bolts and 1 intercooler bolt. Torque the bracket bolts to 11.8 foot-lbs. Secure the vacuum hose back into the clip on the intercooler. Tighten the passenger side intercooler bolt to 11.8 foot-pounds.

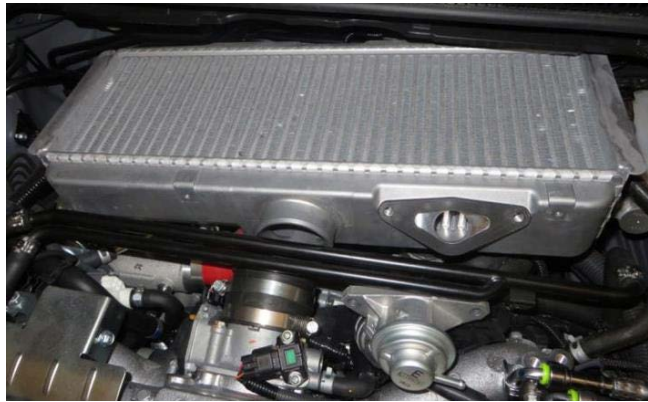
**Step 27:** After removing the bolt securing the passenger side of the intercooler, it should be free. **CAREFULLY** slide the intercooler out from the 2 hose clamps previously loosened while ensuring it does not get caught on PCV piping or recirculation valve.

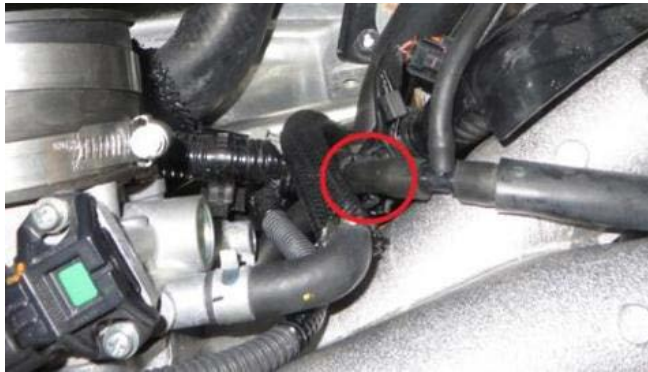
**Step 28:** Release the retaining clip securing the vacuum hose.

**Step 31:** Install the new vacuum hose, connecting one end to the port mentioned in **Step 29** and the other end to the recirculation valve. Re-close the hose clip previously released in **Step 28**.

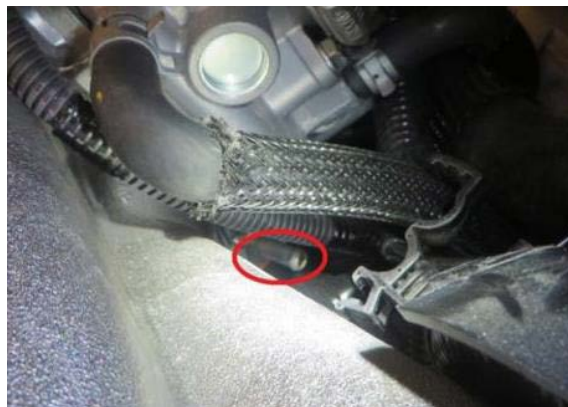
**Step 29:** Pull on the vacuum hose to remove it from the connection on the intake manifold. **\*\*Note** the routing of this vacuum hose as it will be used for installation of the new hose in **Step 31**.
