Tech Tips

TT 91-16-02

2016 Golf, GTI, Sportwagen-MIB 2 Blue Emergency Screen after 91N9 Update

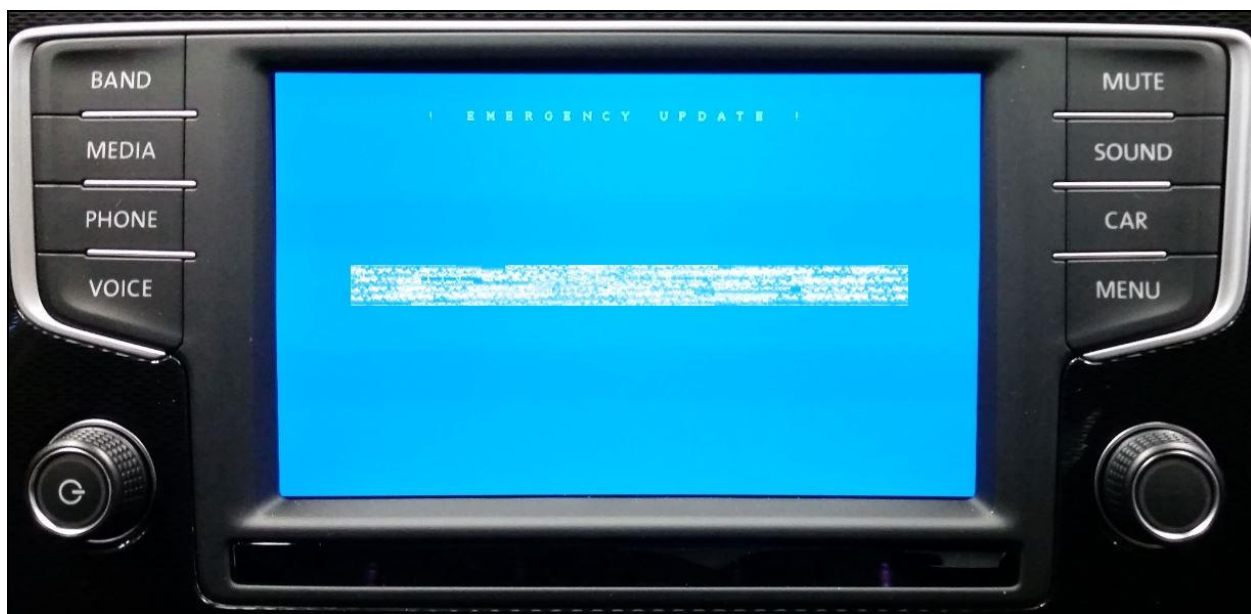
If the Blue “emergency” screen has appeared after the 91N9 update, the unit may be able to be recovered. There are 2 portions of the 91N9 update. The first update fixes any corrupt files that may already be in the radio. It’s possible that when the blue screen comes up, a portion of the download did not fully complete. Please perform the following: Re-insert the SD card from the 91N9 Update, perform a hard reset of the radio by holding the power button down on the radio for 15 seconds and see if more files are written to the radio. After the update completes, reboot the radio again and perform the replacement test plan as outlined in the update.
