UPDATE Technical Bulletin

50C8 UPDATE – A-pillar Seal (NVLW)

Model(s)	Year	Engine Code	Trans. Code
Passat	2016	All	All

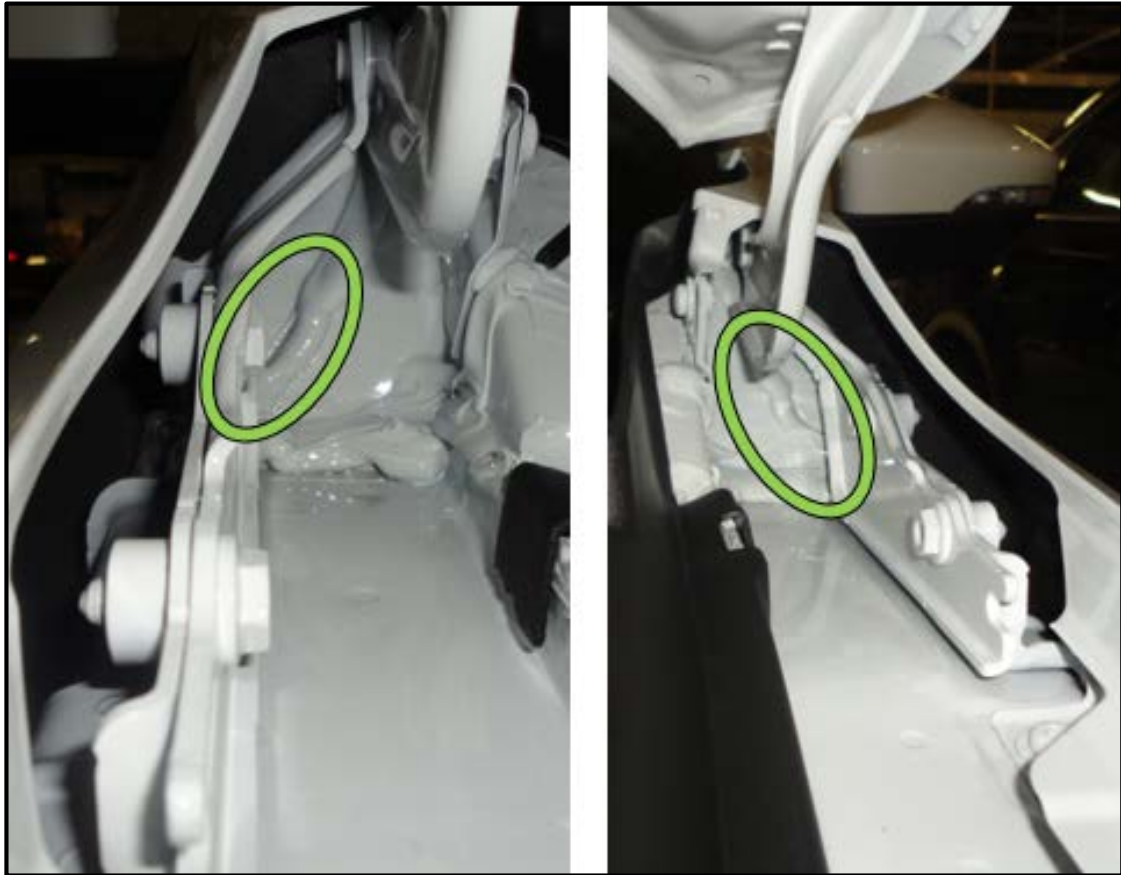
- Open the hood.
- Locate the sealant bead on **both** A-pillars as shown above <circles>.

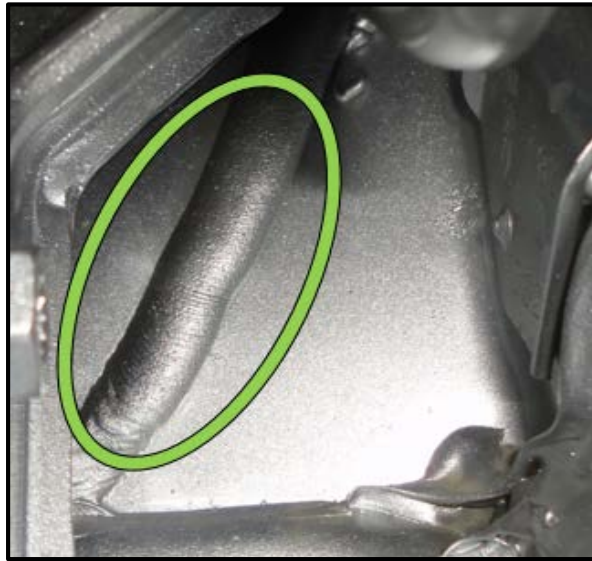
Correct application of the sealant.

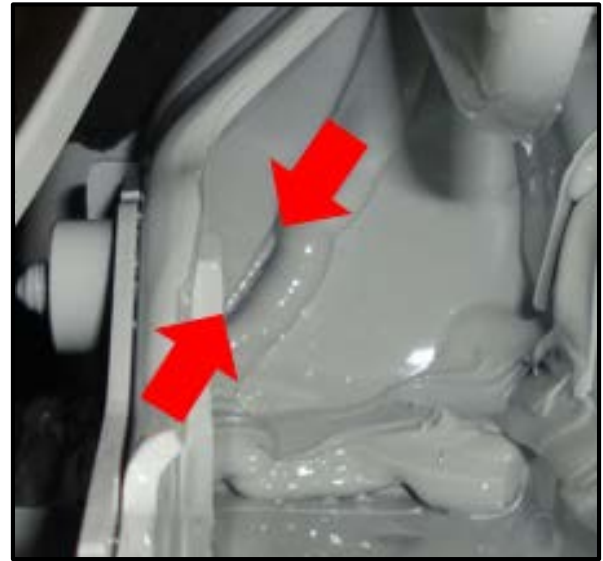
During production, there was an error in sealant application on a portion of the A-pillar seam on one or both sides of the vehicle. Improperly applied sealant can result in customer complaint regarding water ingress.

Incorrect application of the sealant.

- Inspect the sealant bead on **BOTH** A-pillars.
- If the seam is completely covered by the factory installed sealant on **BOTH** A-pillars, the sealant is correctly applied. No further work is required.
- If the seam is visible <arrows> on **EITHER** A-pillar, **proceed to Section C**.
