Tech Tips

TT 01-16-01

2014-2016 Jetta 1.8T Golf - P05A3 Active Grille Air Shutter "A" Control Circuit Range/Performance

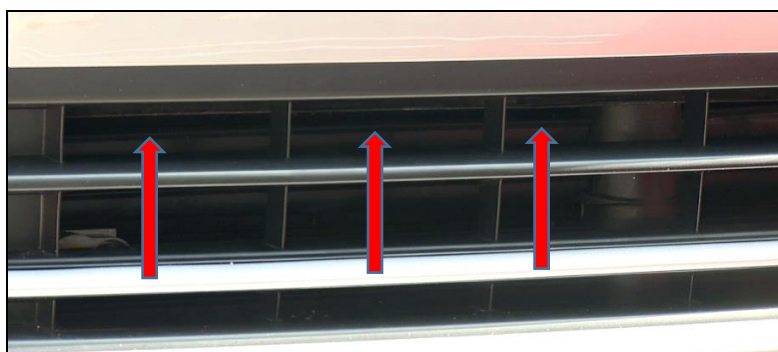
Please inspect the lower grill active shutter for any obstructions i.e. accident damage, snow, ice or debris.

If an obstruction is found, please remove/clean active grill shutters and perform a road test until the vehicle reaches full operating temperature (80°C) to verify operation and recheck for any active DTC.

If obstruction is not found, please check circuit integrity at the V544 T4 as connector:

- Battery voltage on pin 4
- Ground on pin 1
- Check resistance of wire from T91/76 to terminal 3

If the correct readings are achieved, please replace the V544 motor and road test to verify operation.
