COOLANT HOSE CLAMP RE-TORQUE

Prevost vehicles

On the vehicles affected by this bulletin, re-torque the clamps on specific coolant hoses of the cooling system.

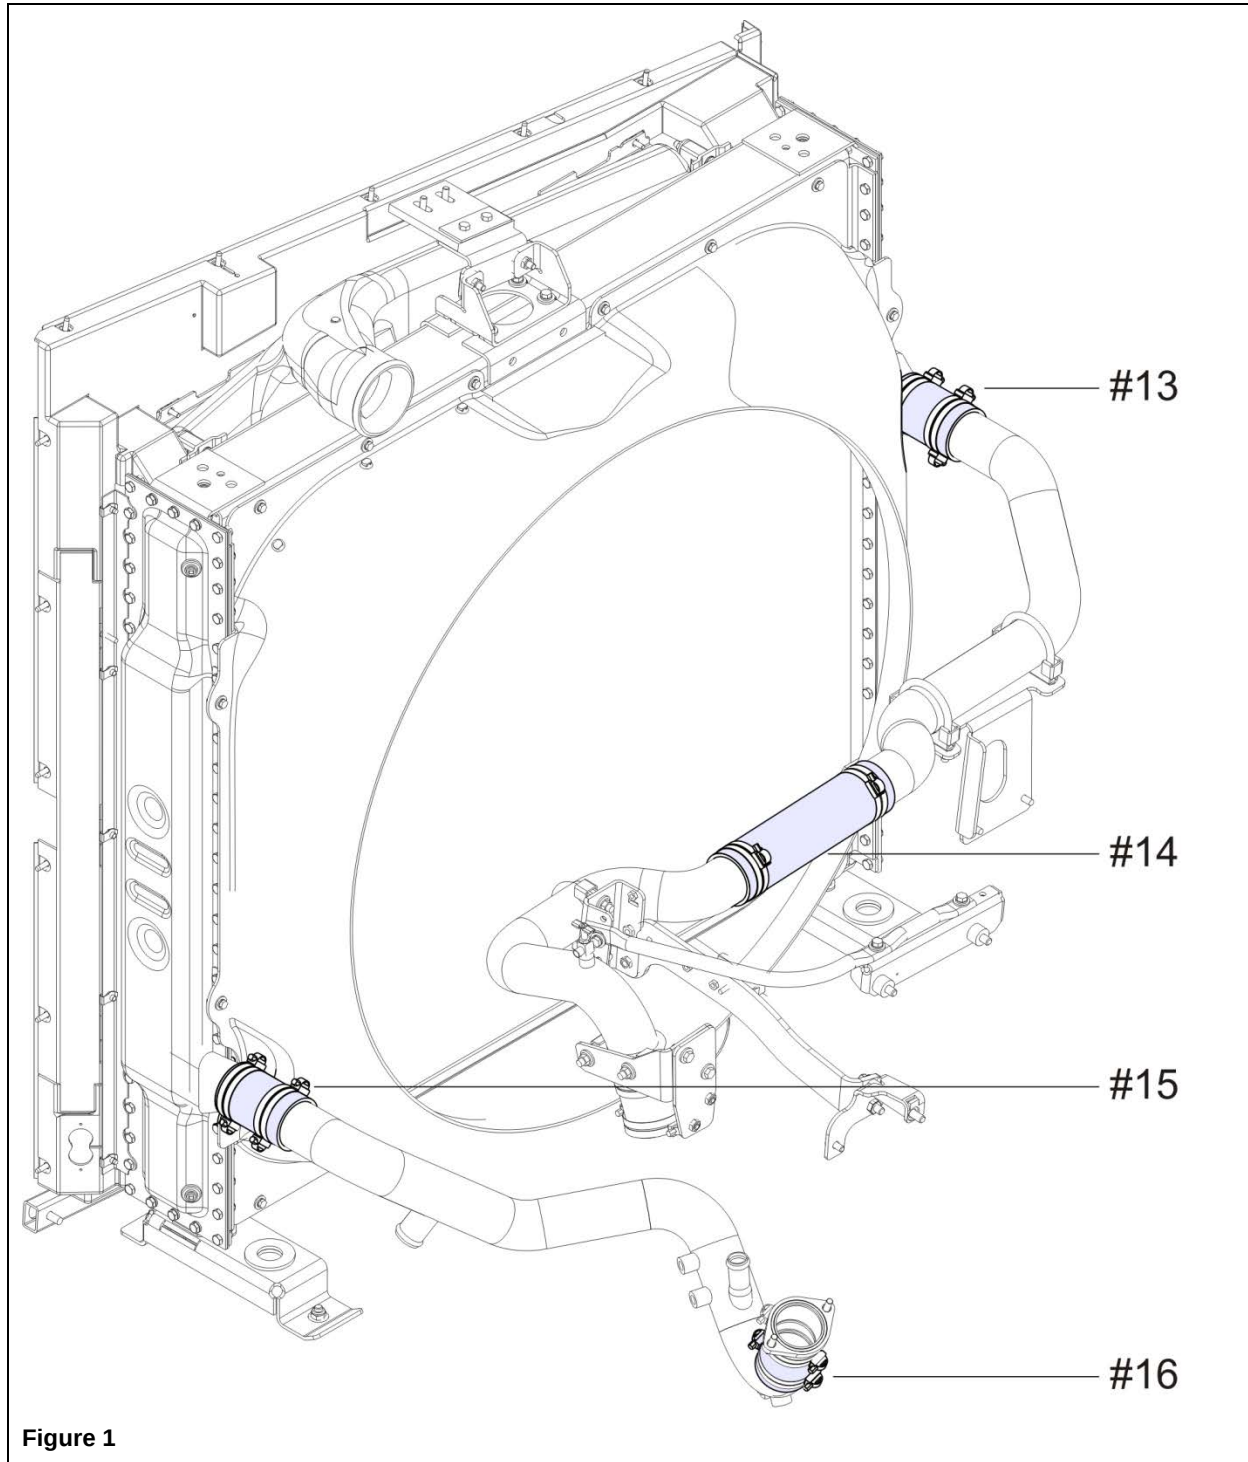
**Figure 1**

Locate flexible hoses below and re-torque clamps to **30 lbf-in.** (Fig. 1 & 2)

Lift vehicle with mobile column lifts.
