Technical Information

84/16 ENU 6620

Macan (95B)

In the Event of a Customer Complaint About Door Cover Sticking Up or Loose: Replacing all four door covers (84/16)

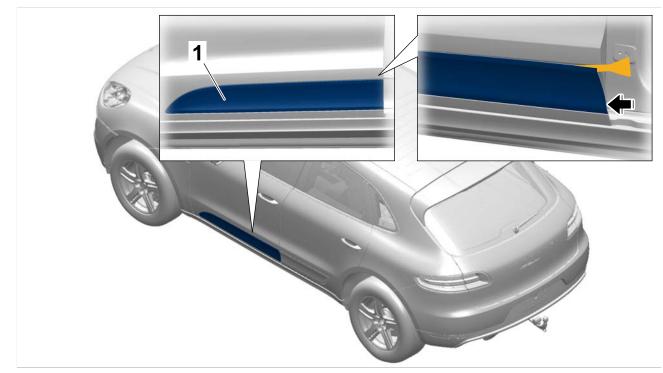
Removing cover for front door

Work Procedure: 1 Remove cover for front door \Rightarrow Removing cover for front door -1- at the left and right. \Rightarrow Workshop Manual '662219 Removing and installing cover for front door'

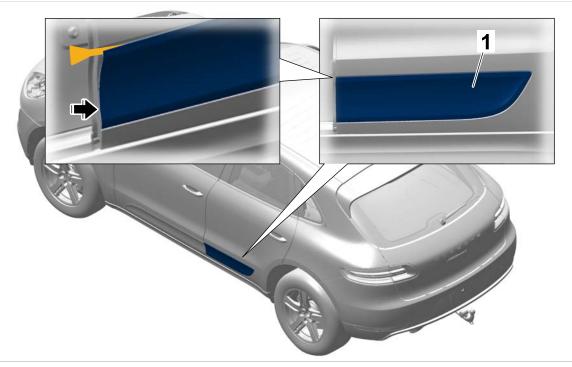
Removing cover for rear door

2 Remove cover for rear door \Rightarrow Removing cover for rear door -1 - at the left and right. \Rightarrow Workshop Manual '664219 Removing and installing cover for rear door'
