Technical Bulletin

58 16 04 December 5, 2016 **2039212** Supersedes Technical Bulletin 581603 dated June 13, 2016 to update the Required Parts Table.

Corrosion on Rear Door in Trim Strip Area

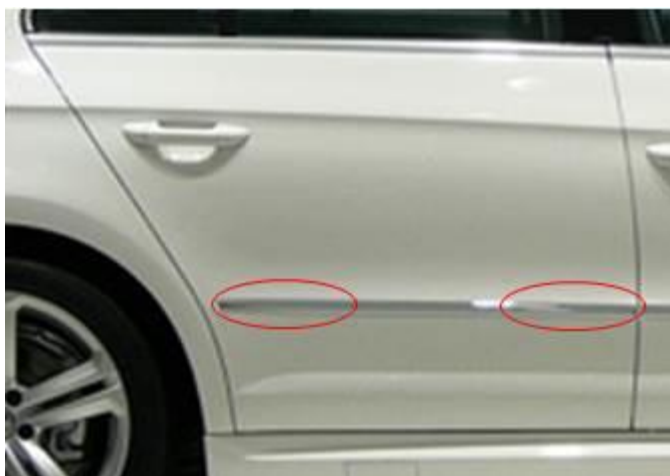
Figure 1 (the red ellipses show the area which can be affected by the corrosion)

Because of incomplete bonding of the trim strip (Figure 2, red circle) water can get between trim strip and door. Because of water ingress, corrosion is possible in the area of the guide holes (Figure 1, red circles).

1a. Repair the rear door as follows:

- Disassemble the door according to the repair manual. See Repair Group 58 in Elsa
- Remove the corrosion on the inner and outer door in the area of the guide holes using a pneumatic brush grinder.

- Apply a VOC compliant epoxy primer as an anti-corrosion treatment and primer to both sides of the door (locally sourced).
- Repaint the rear door according to Volkswagen guidelines.

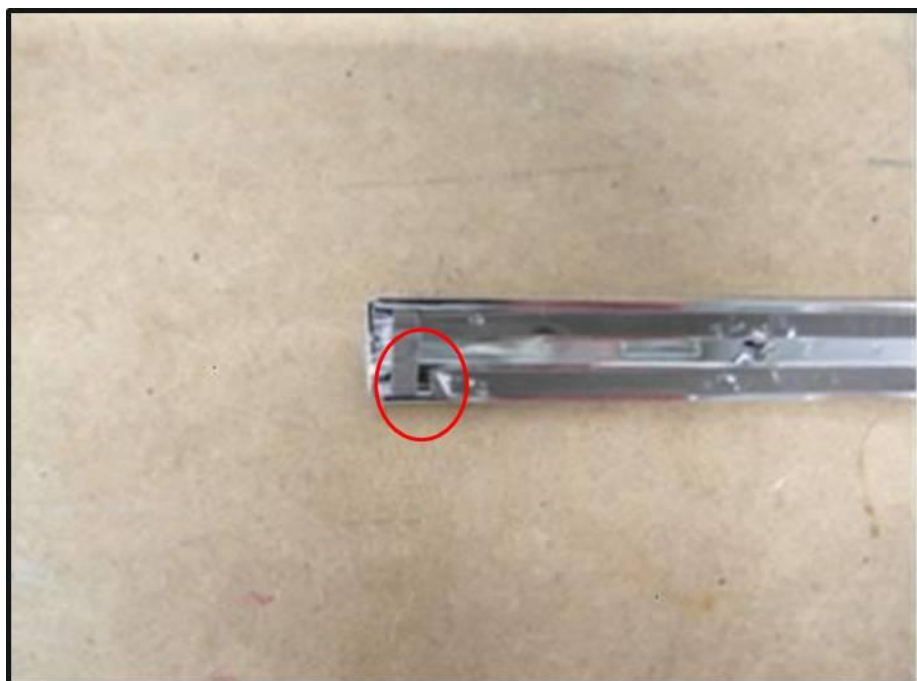
Figure 2 (the red circle shows the opening of the incomplete bonding)

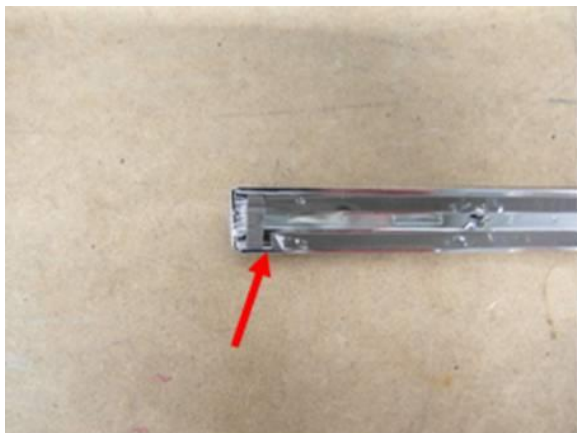
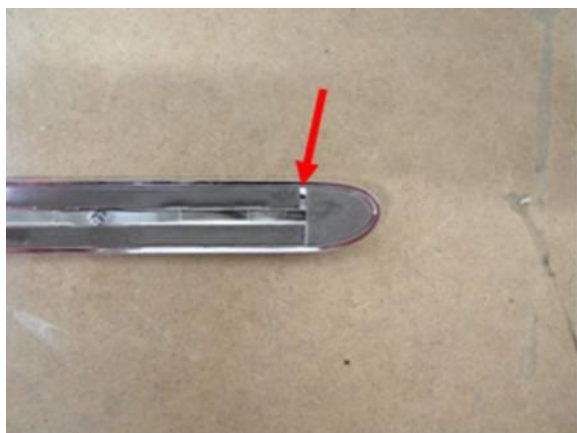
- To avoid repeated water ingress, close the open areas on the trim strips in the end points of the adhesive tape with butyl sealing cord (part number AKL 450 005 05 - Figure 3 and 4, red arrows).

Figure 3 (rear end of a trim strip)

Figure 4 (front end of a trim strip)

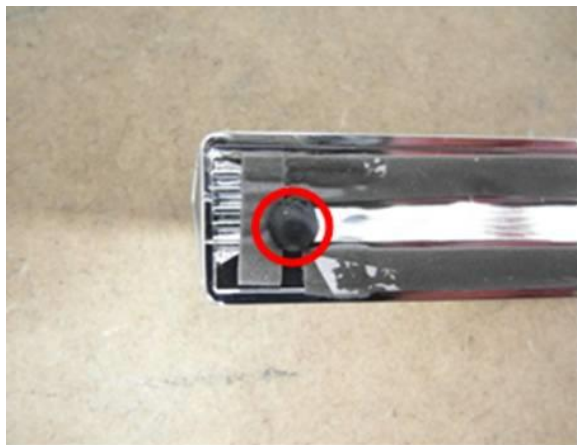
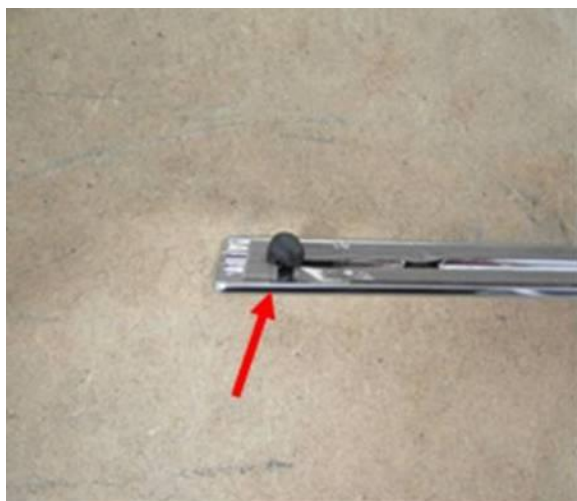
- Form two balls of butyl sealing cord (part number: AKL 450 005 05) per trim strip with a diameter of 4-5 mm. Attach the butyl balls centrally in the end areas of the trim strip from the inside (Figures 5 and 6).

Figure 5 (rear trim strip area)

Figure 6 (rear trim strip area)

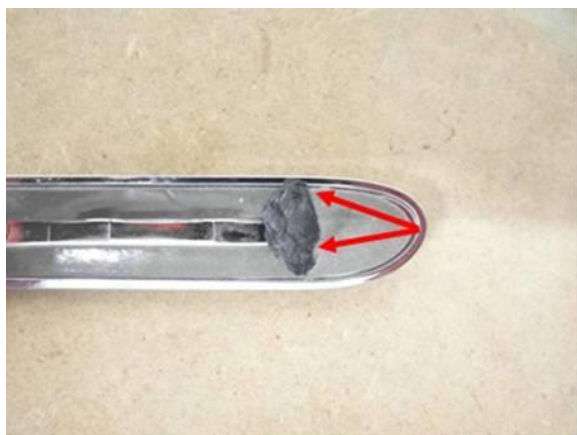
- The open areas of the adhesive tape must be closed by pressing the butyl balls into the gaps of the tape (Figure 7).

Figure 7 (front trim strip area)

- Install the trim strip on the door according to the repair manual. See Repair Group 66 in Elsa.
- Apply cavity wax on the inside of the door around the holes that the trim strip secures.
- Assemble and reinstall the door according to the repair manual. See Repair Group 58 in Elsa.
