# Technical Bulletin

**57 16 08** December 5, 2016 **2038995** Supersedes Technical Bulletin V571607 dated June 13, 2016 to update Required Parts Table.

### Corrosion on the Front Door in Trim Strip Area

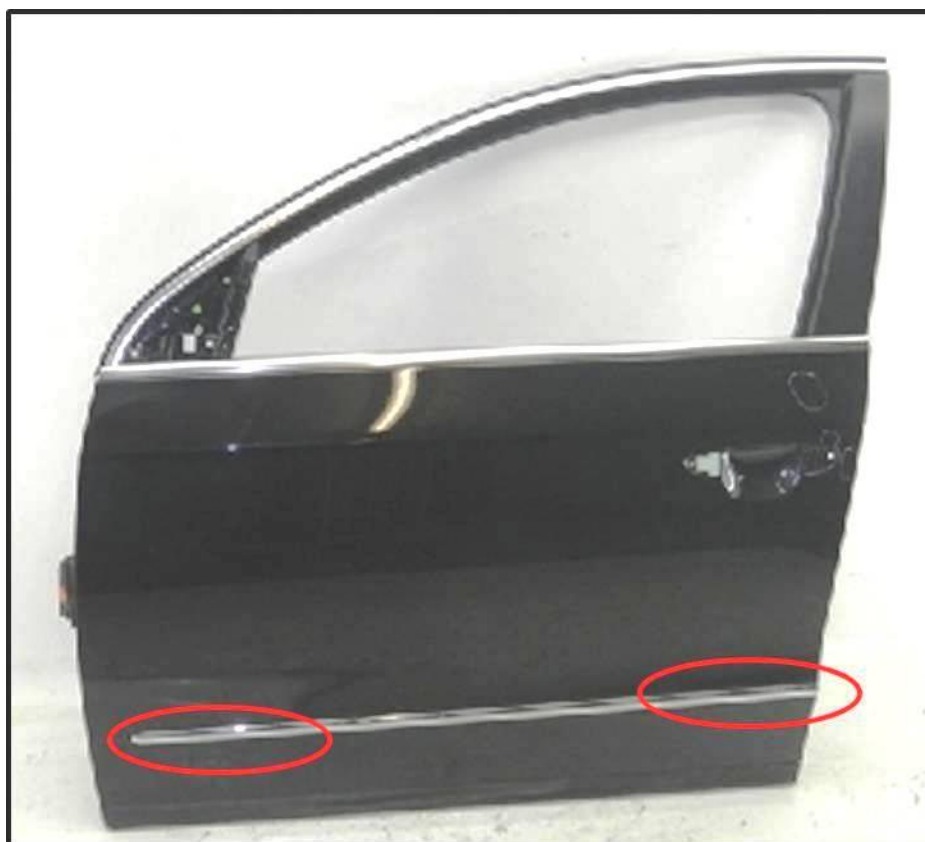
Figure 1 (the red ellipses show the area which can be affected by the corrosion)

Because of incomplete bonding of the trim strip (Figure 2, red circle) water can get between trim strip and door. Because of water ingress, corrosion is possible in the area of the guide holes (Figure 1, red circles).

- Disassemble the door according to the repair manual. See Repair Group 57 in Elsa
- Remove the corrosion on the inner and outer door in the area of the guide holes.
- Apply a VOC compliant epoxy primer as an anti-corrosion treatment and primer to both sides of the door (locally sourced).
- Repaint the front door according to Volkswagen guidelines.

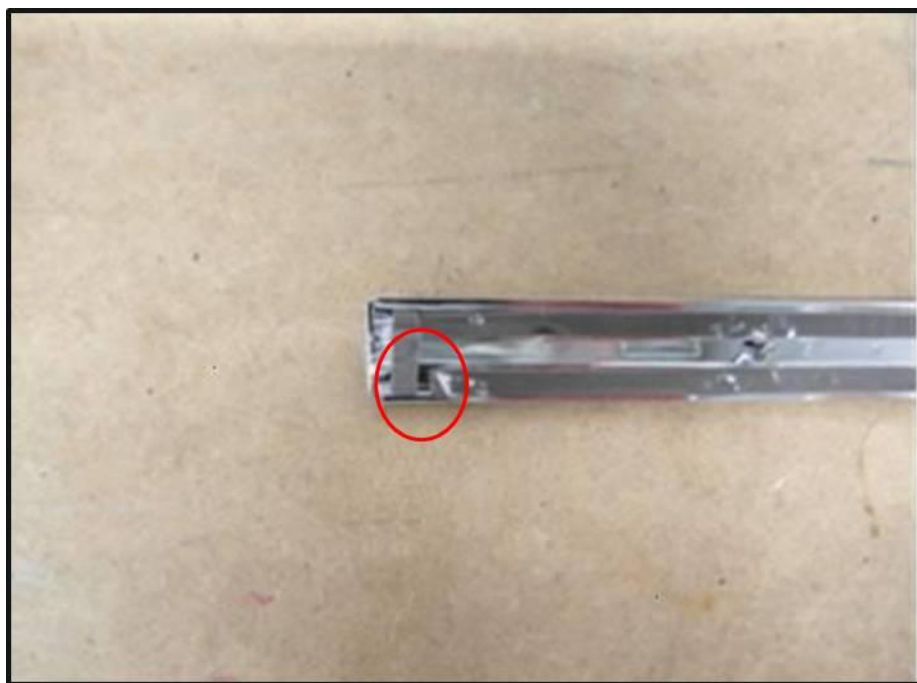
Figure 2 (the red circle shows the opening of the incomplete bonding)

- To avoid repeated water ingress, close the open areas on the trim strips in the end points of the adhesive tape with butyl sealing cord (part number AKL 450 005 05 - Figure 3 and 4, red arrows).

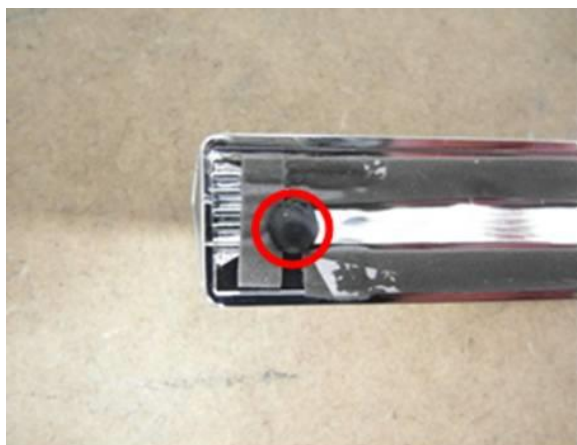
- Form two balls of butyl sealing cord (part number: AKL 450 005 05) per trim strip with a diameter of 4-5 mm. Attach the butyl balls centrally in the end areas of the trim strip from the inside (Figures 5 and 6).

**Figure 5 (rear trim strip area)**

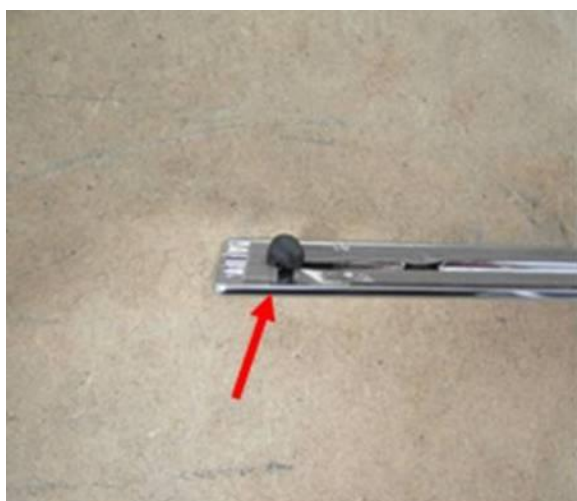
**Figure 6 (rear trim strip area)**

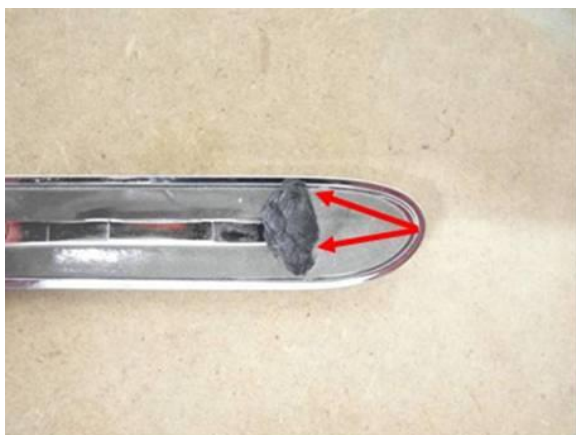
- The open areas of the adhesive tape must be closed by pressing the butyl balls into the gaps of the tape (Figure 7).

**Figure 7 (front trim strip area)**
