TECHNICAL SERVICE BULLETIN

TSB#: 16-035

Inspect sealant around all items mounted on roof and replace when **cracks** are visible.

Technical Service Bulletin Notification TSB #16-035

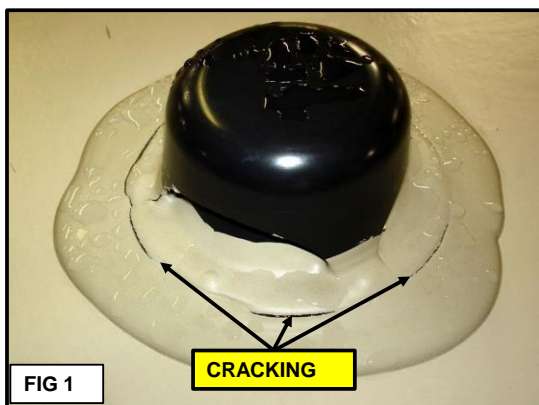
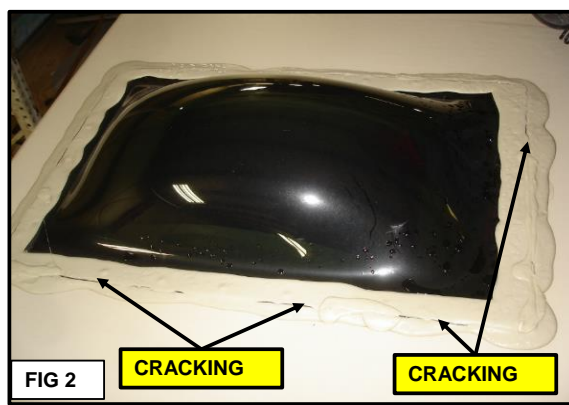
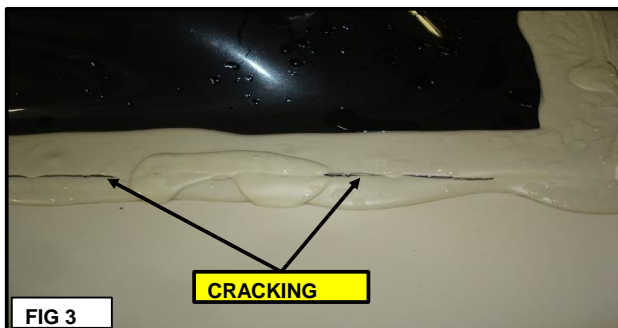
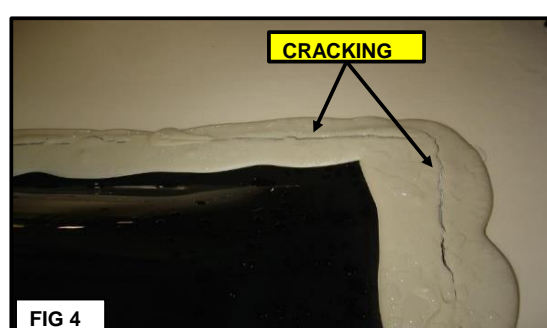
Fig 1-4: Inspect items mounted on the roof for signs of sealant **cracking**.

Some of the areas you may find cracked sealant.

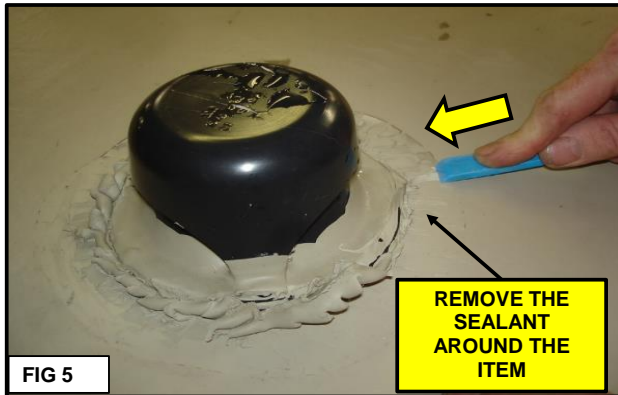
- 1 Fig 5: Remove the sealant, using the plastic putty stick, push the sealant toward the entire item.

DO NOT USE ANY SHARP OBJECTS!

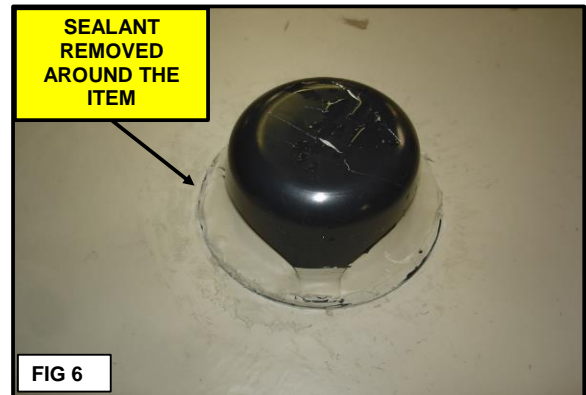
Fig 6: Mounted item with Sealant removed .

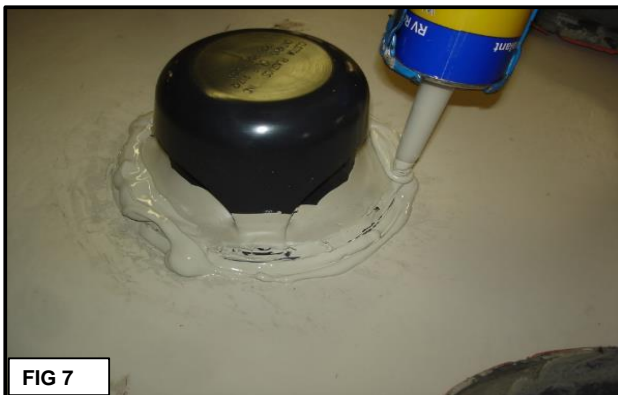
- 2 Fig 7: Apply self leveling sealant around the item liberally over the remaining sealant and onto the roof.

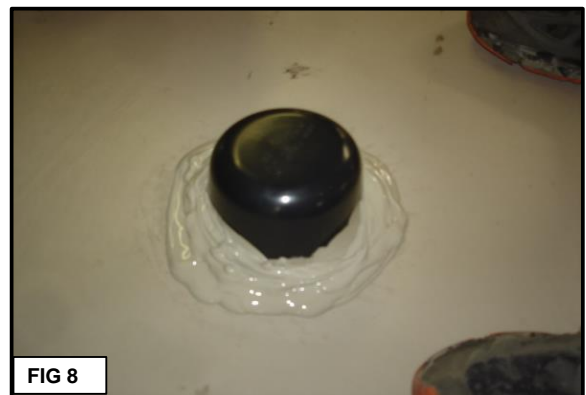
Fig 8: Proper amount of Sealant applied around the item.

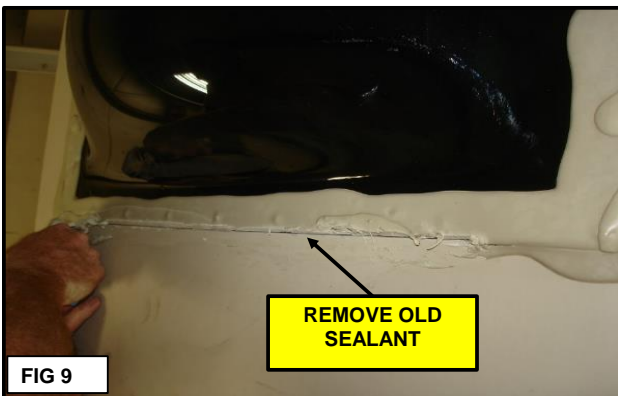
- 3 Fig 9: On larger items like this skylight, remove the sealant material up to the edge of the skylight as done in Fig 5.

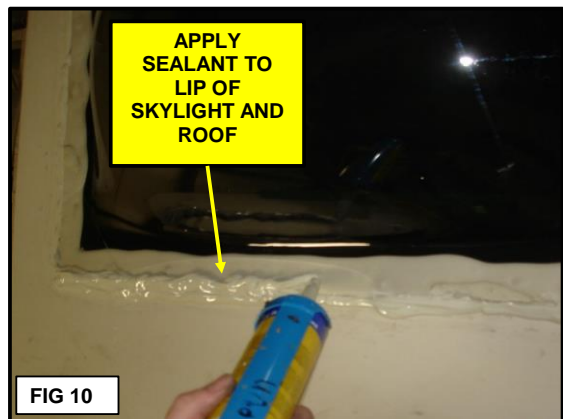
Fig 10: Apply self leveling sealant on the perimeter of the item overlapping the sealant on the edge of item as done in Fig 7.

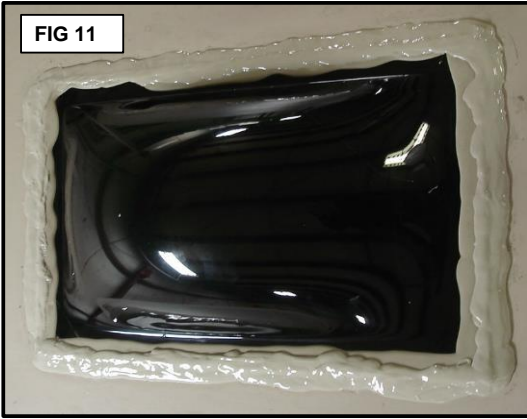
4 Fig 11: Finished skylight with new sealant applied.

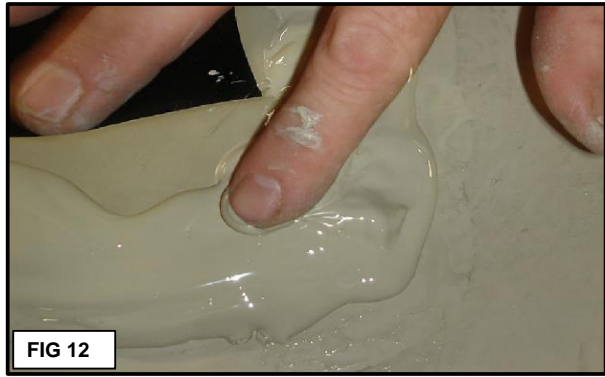
Fig 12: Close voids or pinholes by ***gently*** swirling your finger in a small circular pattern, gradually lifting your finger
