Diagnostic Device Hardware & Windows®

Number: VHW-16-14

Subject: VAS 6154 Diagnostic Interface – In-Use Best Practices

Date: Nov. 7, 2016

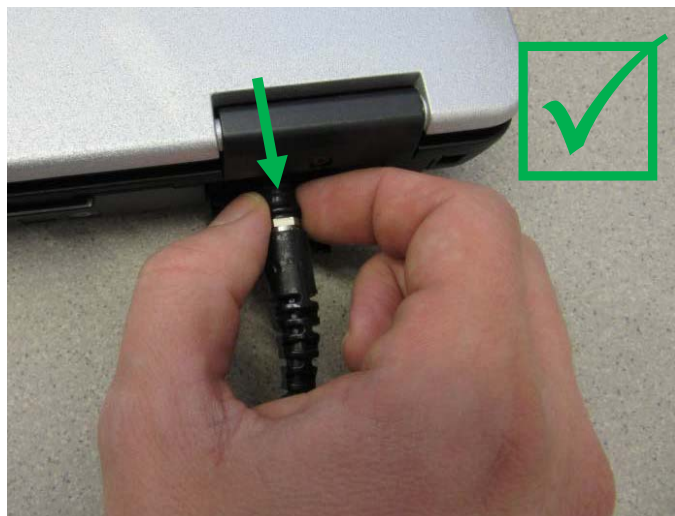
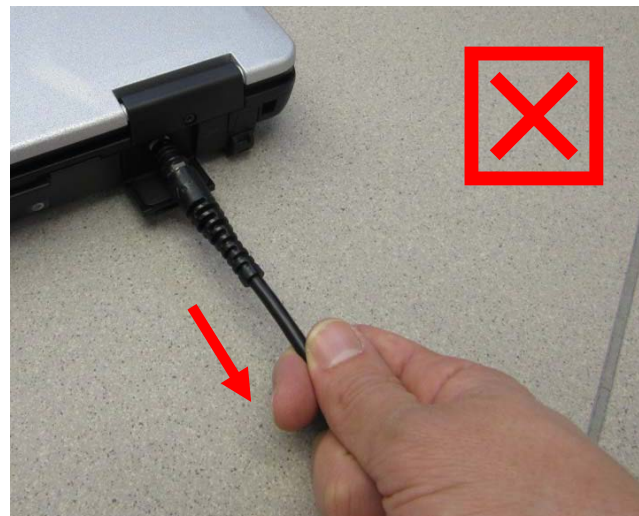
The USB cable connection uses a locking mechanism to prevent accidental detachment during handling. Failure to release the locking mechanism and forcefully disconnecting the USB cable causes non-warrantable cable and connector damage.

**Always slide the locking mechanism collar away from the device before disconnecting the cable.**

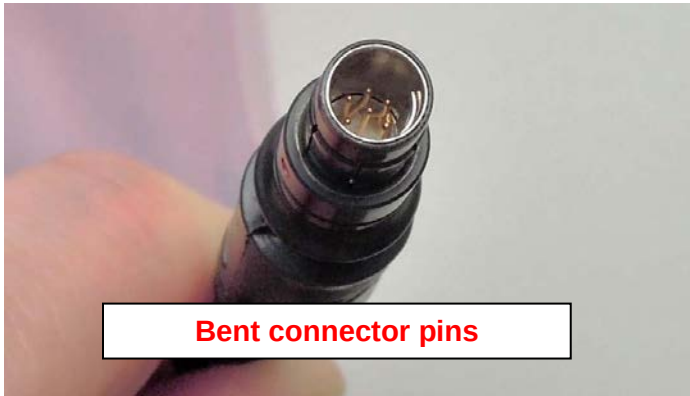
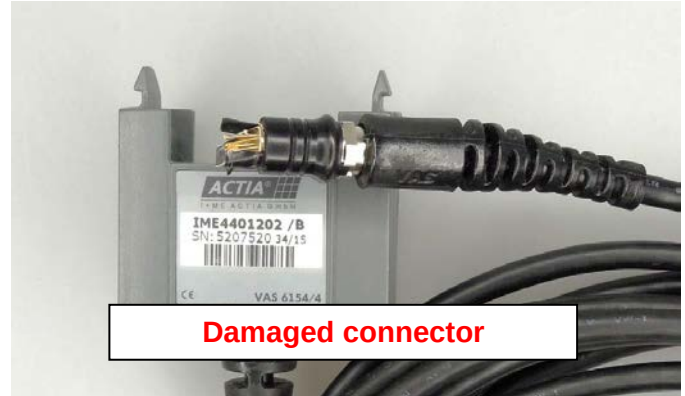
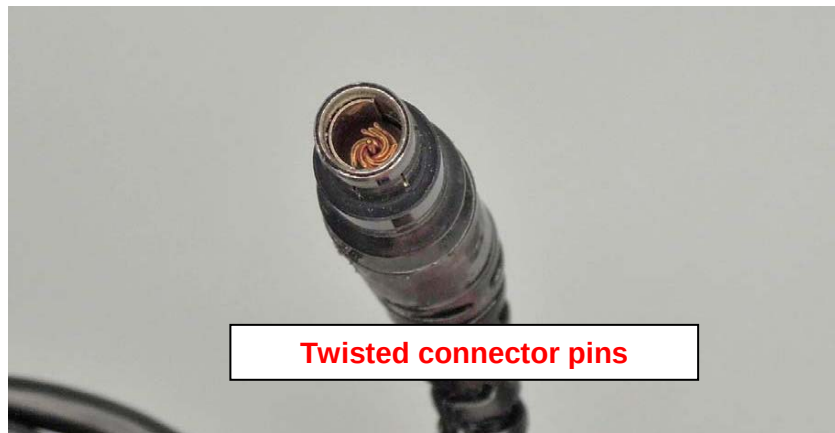
Current examples of non-warrantable USB connection damage:
