## Incorrect Labeling Tag, Coolant Connections

The Coolant Outlet tag on some units may be incorrect. See below for proper coolant connections.

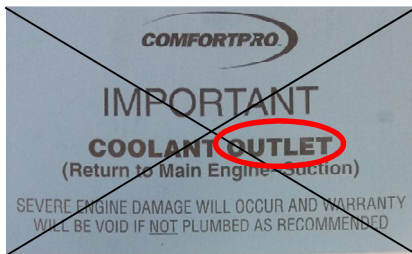
← An **incorrect** label may have been installed on the lower coolant inlet connection to the APU listing it as the outlet

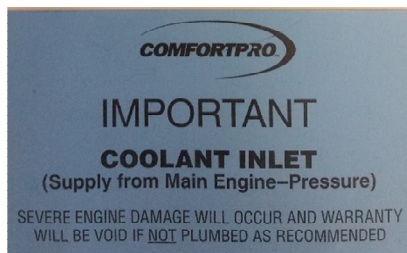
← **Correct** Label. Coolant inlet is the lower connection on the APU and should be connected to the main engine cylinderhead.
