## 16157 Incorrect Grille Bowtie Emblem

Reference Number: N162069880

Release Date: December 2016  
Revision: 00

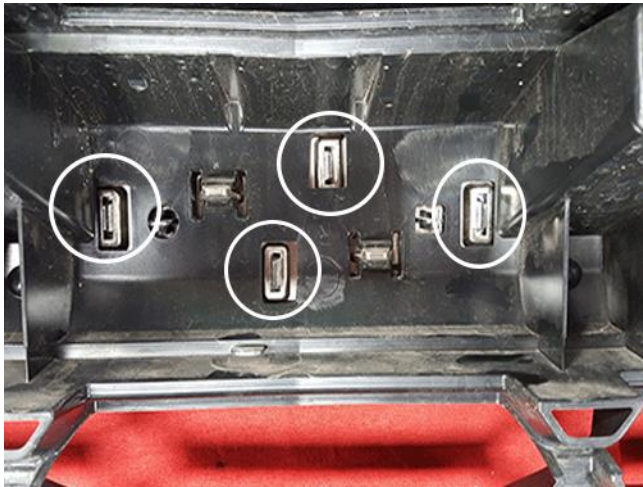
5. Release the 4 tabs as shown and remove the emblem.
6. Turn over the grille and carefully line up the new emblem with the holes and gently snap into place.
7. Install the front grille. Refer to *Front Grille Replacement* in SI.
8. Remove the fender covers and close hood.

- Inspect the front grille emblem:
  - If the vehicle has the black insert with chrome emblem, no further action required.
  - If the vehicle DOES NOT have the black insert with chrome emblem, proceed to step 2.
- Open the hood and install fender covers.
- Remove the front grille. Refer to *Front Grille Replacement* in SI
- Place the grille face down on a surface covered with a fender cover or equivalent to not scratch or damage the grille.
