# Customer Satisfaction Program

## 16158 Rearview Camera Image Reversed

Reference Number: N162060430

Release Date: December 2016  
Revision: 00

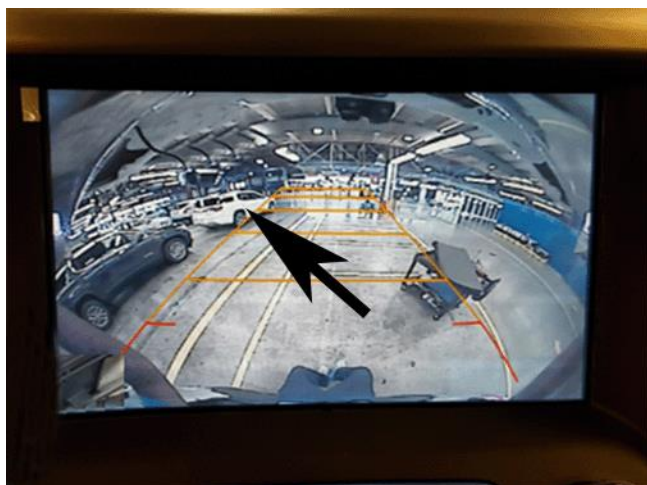
4645340

1. Park the vehicle with an easily identifiable object behind one side of the vehicle, such as another vehicle (a white SUV is parked behind the left side of the subject vehicle in the images below).
2. Set the parking brake.
3. With the foot brake applied, start the vehicle and place the gear selector in reverse gear.
4. Observe the rear view image on the instrument panel display screen.

- If the item (white SUV) appears on the **Left (CORRECT)** side of the screen, no further action is required.

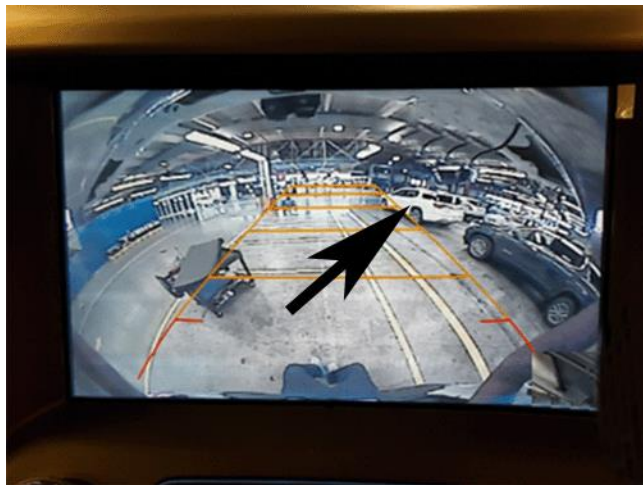
4645342

- If the item (white SUV) appears on the **Right (INCORRECT)** side of the screen, proceed to step number 5.
5. Replace the rear view camera located on the vehicle liftgate trim. Refer to *Rearview Driver Information Camera Replacement* in SI.
