Date: May 09, 2016
Subject: 28380 - Service Update
Rear Suspension Toe Link Cracking
Models: 2016 Chevrolet Camaro
To: All Chevrolet Dealers

28380 Rear Suspension Toe Link Cracking

Reference Number: N162028380
GWM Number: 2028380

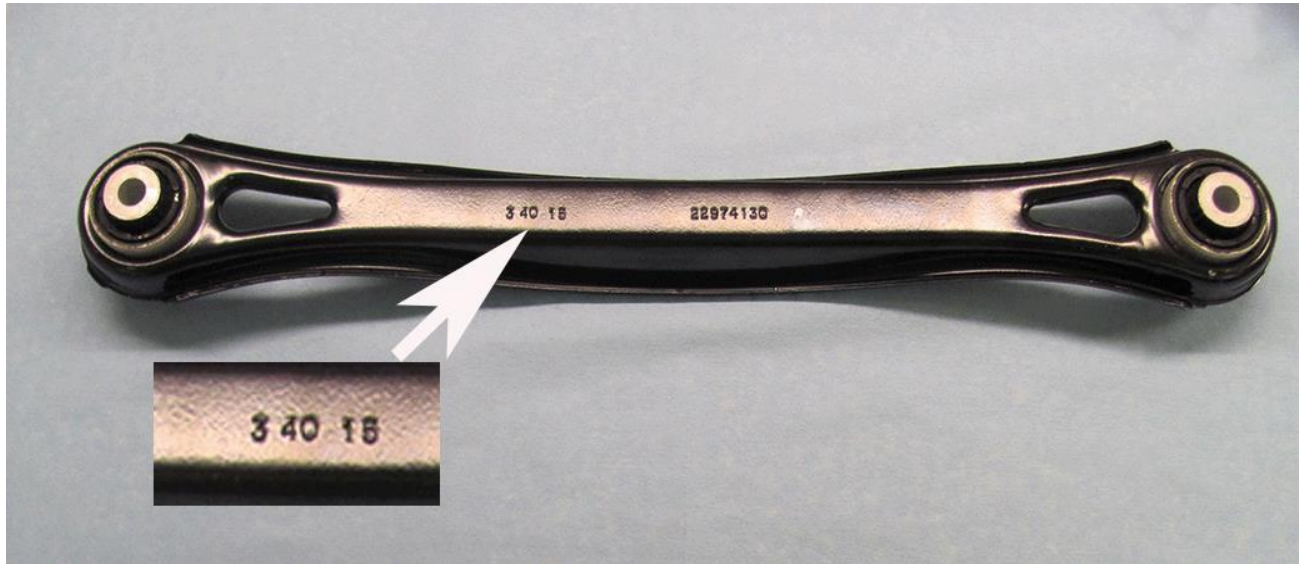
4509400

2. Locate the Julian date code stamping on the forward face of the toe link stamping. This will be a three digit number followed by a space and "15".
 - If the date code is 303 15 or 340 15, the part requires inspection. Proceed to the inspecting the toe link section below.
 - If a code other than 303 or 340 is present, that part does not require inspection. No further action is required.

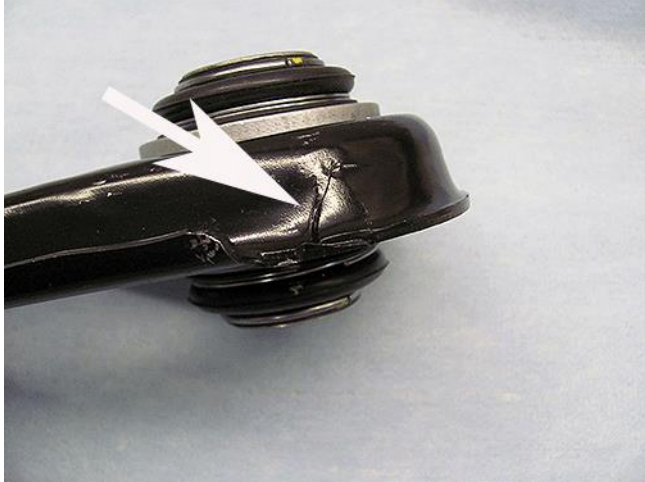
4509403

Large outside crack

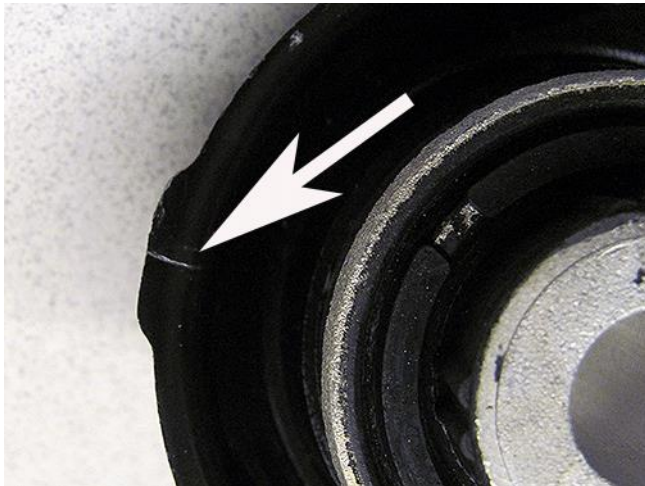
4509406

Small inside crack

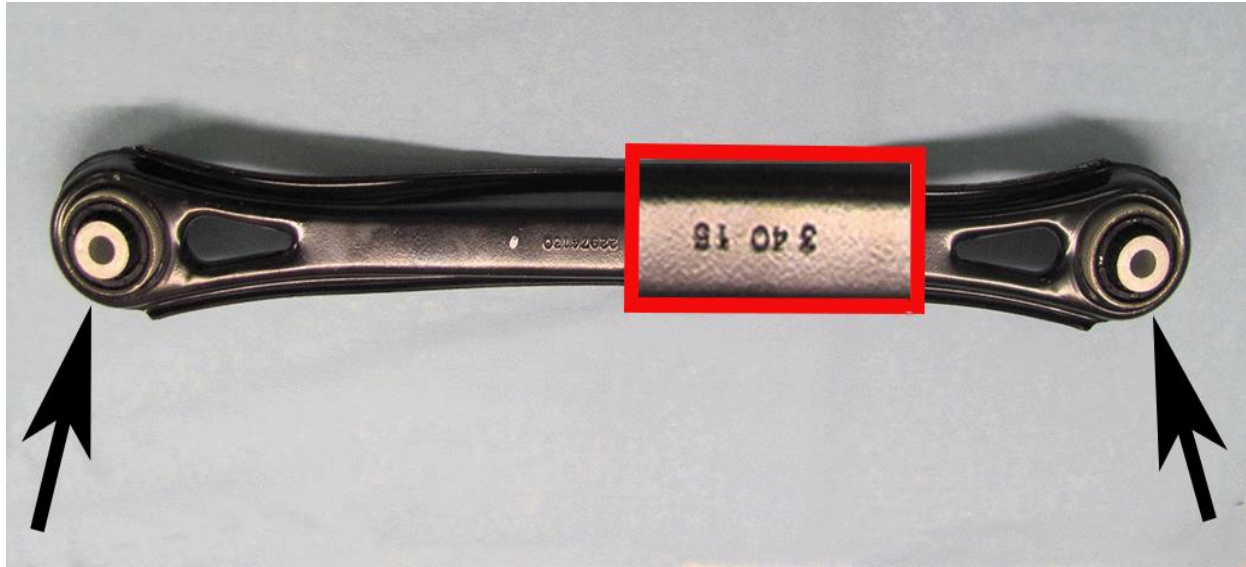
4509408

- If the date stamp is upside down, inspect the lower inner and outer eyelet area for cracking as shown.
- If the date stamp is right side up, remove the link as follows:

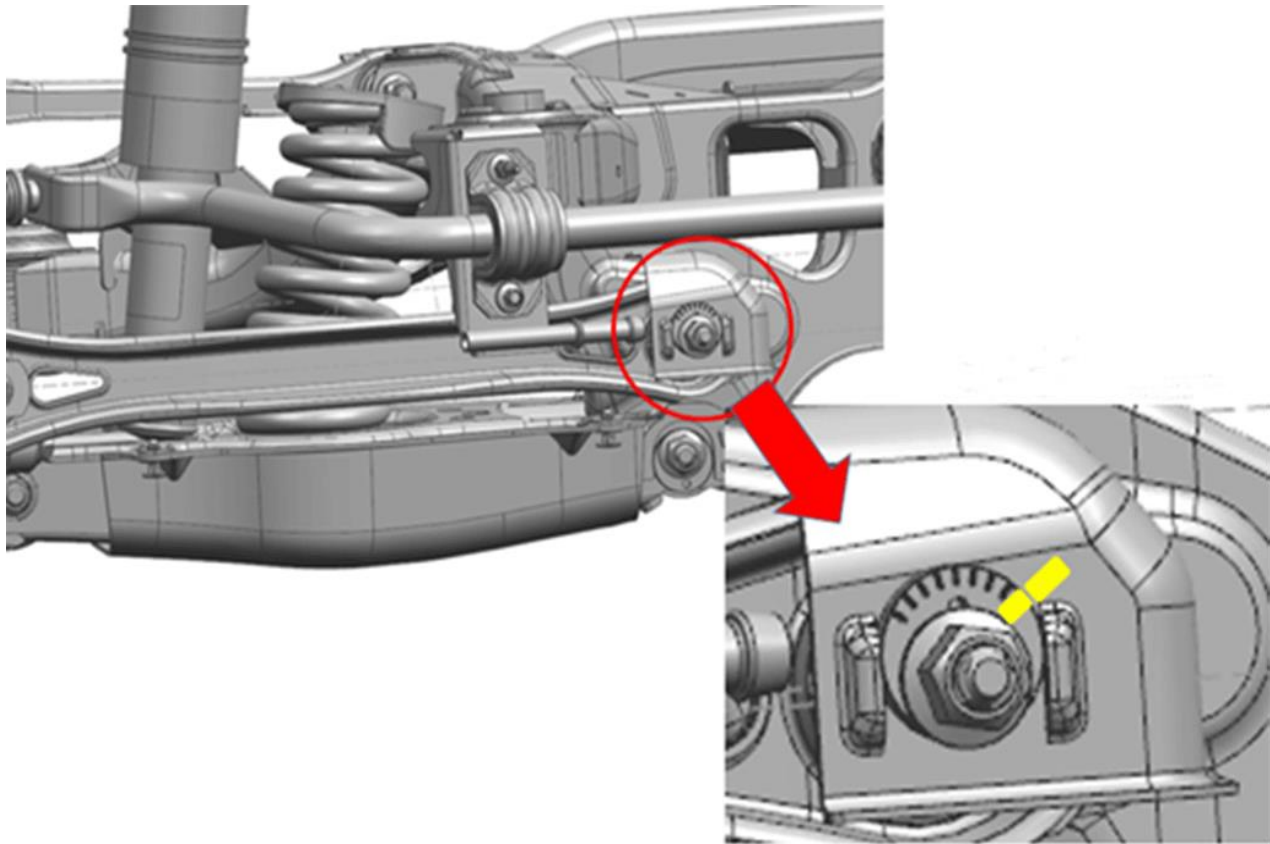
4509411

- Using a paint pen, mark the position of the alignment setting at the inboard joint to the cradle. Mark the face of the cam washer and cradle, these marks will be used during reassembly.
- Remove the inboard and outboard bolts, discard the bolts.

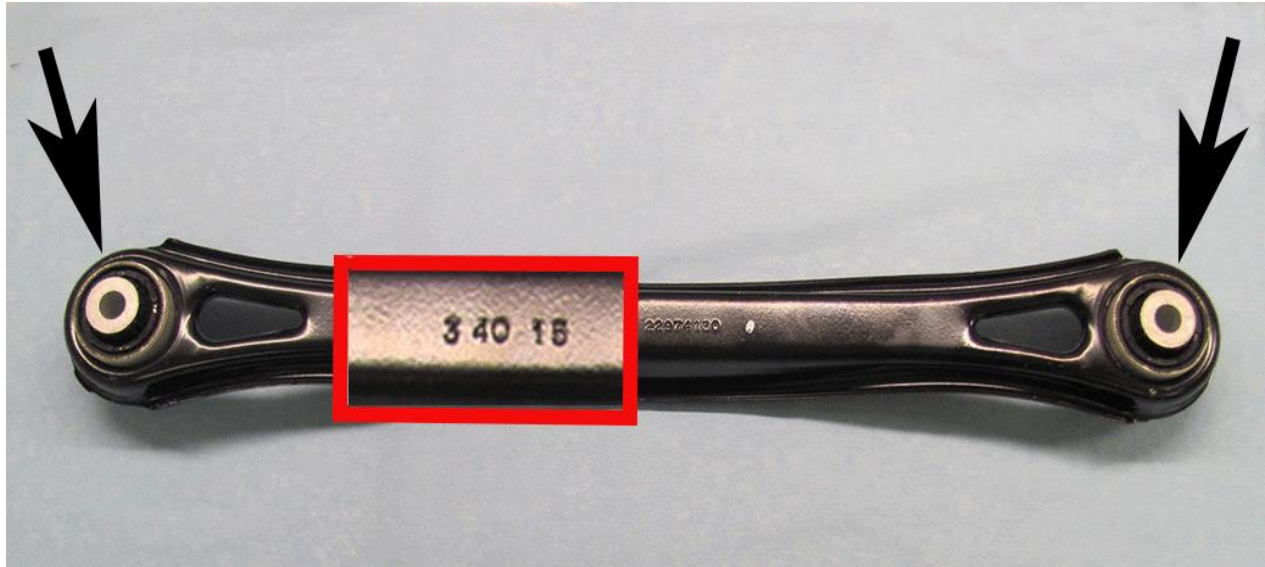
4509415

- Remove the link and inspect the inner and outer eyelet areas for cracking as shown.
 - If no cracks are found, reinstall the adjust link using new fasteners and the alignment marks on the cam washer and cradle. Refer to *Adjust Link Replacement* in SI. No toe setting will be required.
3. Replace any toe links displaying signs of a cracking condition. Refer to *Adjust Link Replacement* in SI.
 4. If no cracks are detected, no further action is required.

Note: When reinstalling or replacing a rear adjust link, insure the rear suspension is at the ride height /curb height position before tightening the fasteners.
