Special Bulletin

SP16-301B

VARIABLE GEOMETRY TURBOCHARGER - ACTUATOR REPLACEMENT (SRA)

Prevost vehicles

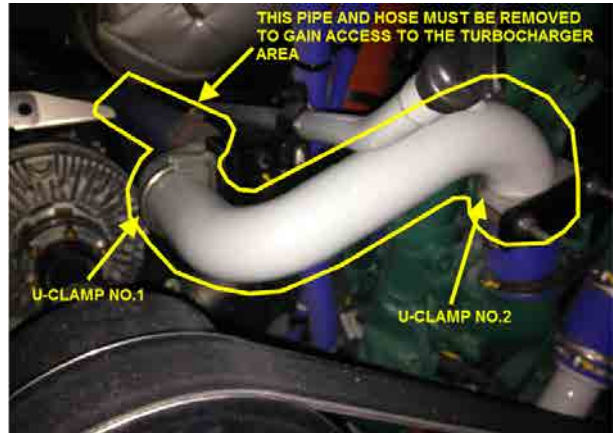
- In order to reach the turbocharger area, the radiator coolant return pipe shown on FIGURE 3 along with the furthest flexible hose must be removed.

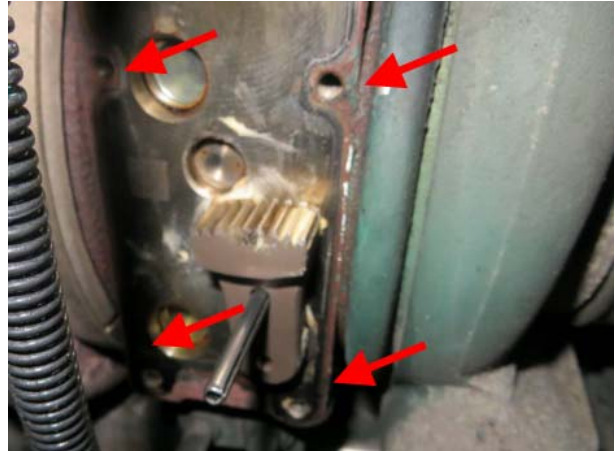
FIGURE 14

IMPORTANT NOTE: Make sure that the actuator and turbocharger housing mating surfaces (where the gasket sits) are clean and smooth (see the mating surface on the turbocharger housing on FIGURE 14).

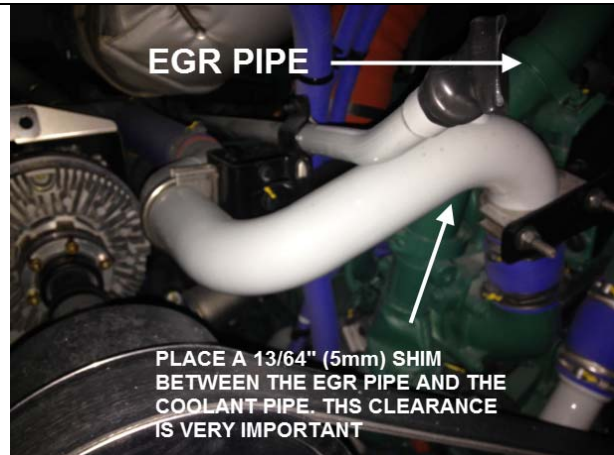
FIGURE 24

30. Place a 13/64" (5mm) shim between the coolant pipe and the EGR pipe so that a functional clearance will remain once the clamps and U-clamps will be tightened (FIGURE 24).
31. Tighten the U-clamps. No specific torque value for this piece of hardware.
32. Tighten the hose clamps to 30 lbf-in.
33. Reinstall the transmission dipstick tube clamp.
34. Replenish the cooling system.
