Technical Bulletin

87 16 21 October 13, 2016, **2043893** Supersedes Technical Bulletin V871605 dated May 25, 2016 to update model years.

Robinair® Printout / A/C Compressor Replacement

The A/C Compressor has been diagnosed as faulty and will be replaced under warranty.

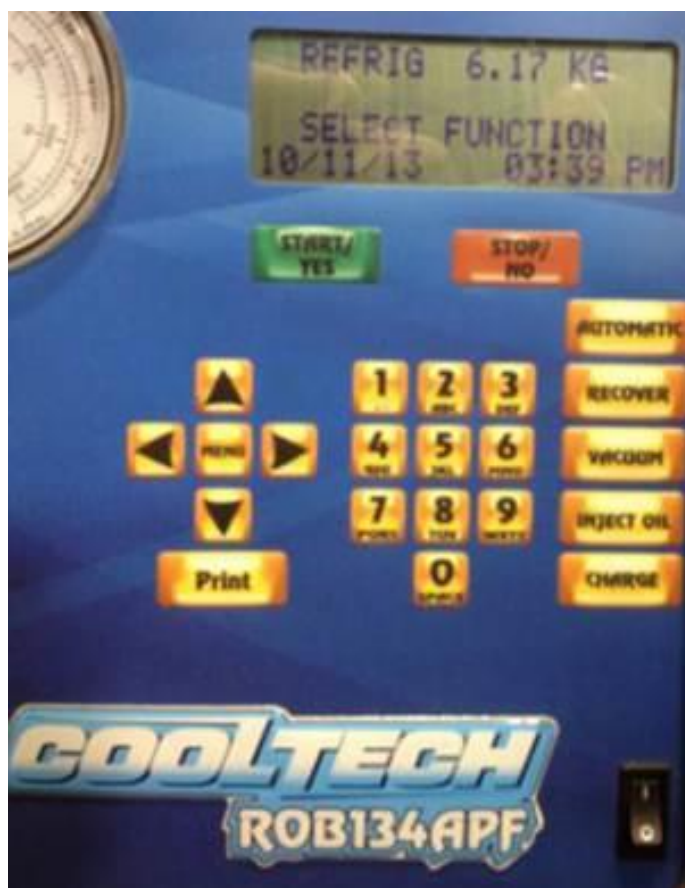
Figure 1: Date and time screen.

1. Ensure that the A/C service unit shows the correct date and time (Figure 1). If the date and time are incorrect, use the menu to program the correct date and time before proceeding.

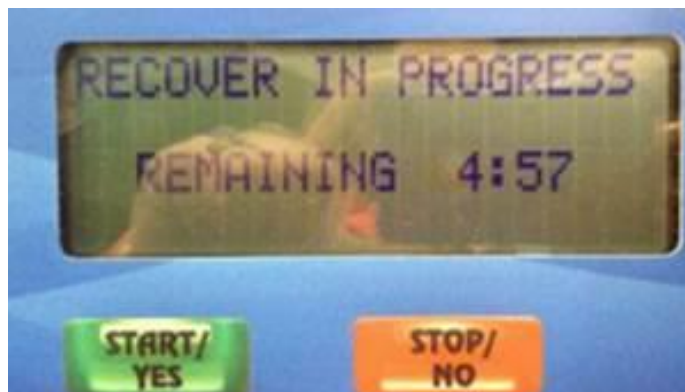
Figure 2: System recover process.

3. Perform a recovery of the system
(Figure 2).

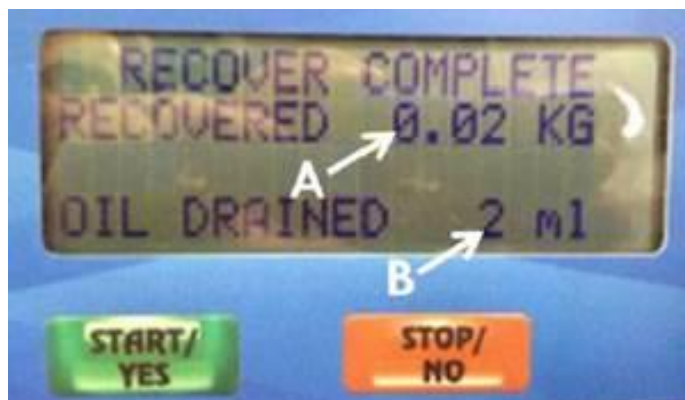
Figure 3: Amount of refrigerant recovered (A), and amount of oil drained (B).

4. Record values for RECOVERED and OIL DRAINED (Figure 3) on the repair order

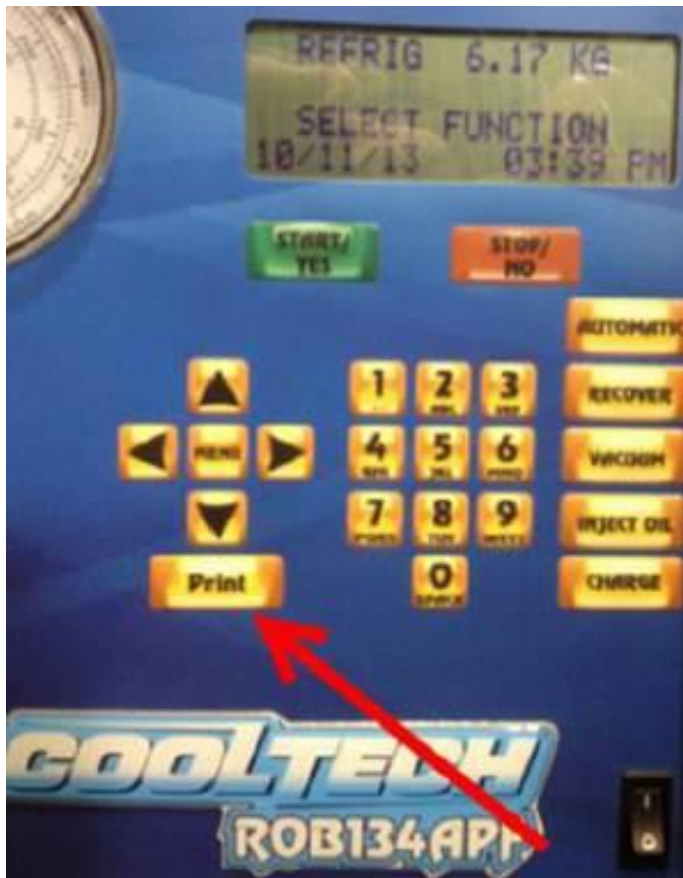
5. Immediately after recovery, select the Print button (Figure 4).

Figure 4: Location of the Print button.

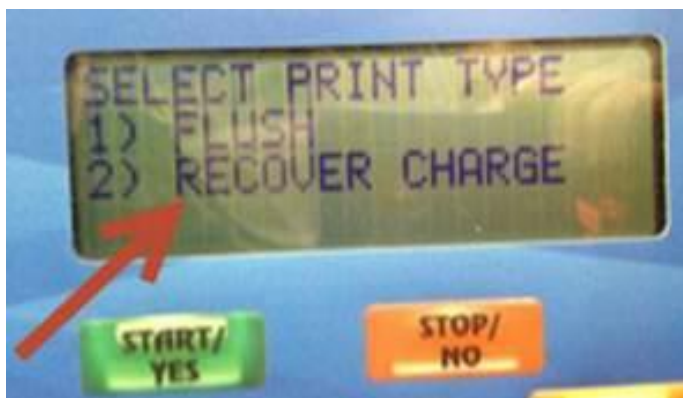
6. When the SELECT PRINT TYPE screen opens, use the keypad to select 2) RECOVER CHARGE

(Figure 5).

Figure 5: Selecting a print type.

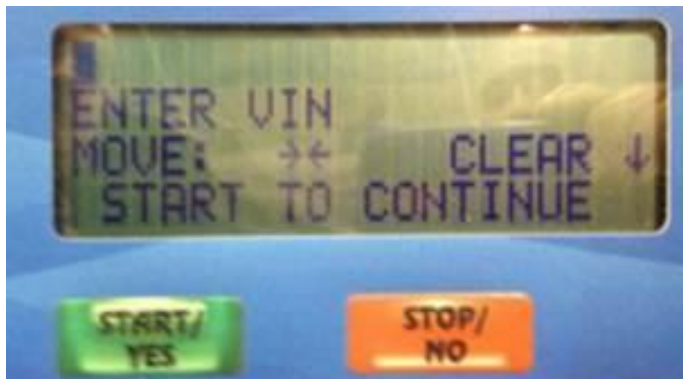
Figure 6: Enter VIN screen.

7. On the next screen, use the keypad enter the last 8 digits of the VIN then press the START/YES key (Figure 6).

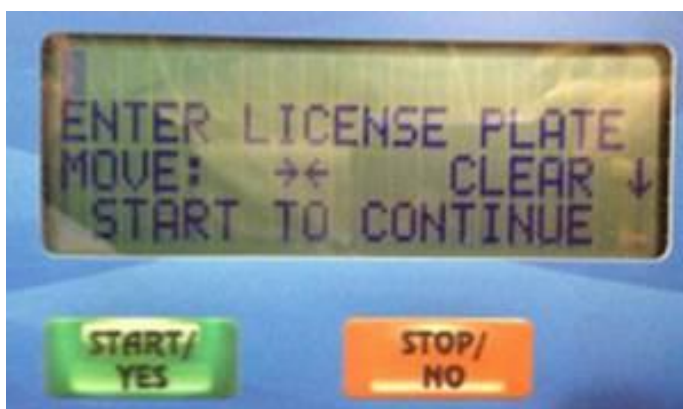
Figure 7: Enter license plate screen.

8. The next screen will request the license plate (Figure 7). Entering the license plate is not necessary. Press the START/YES key to continue.

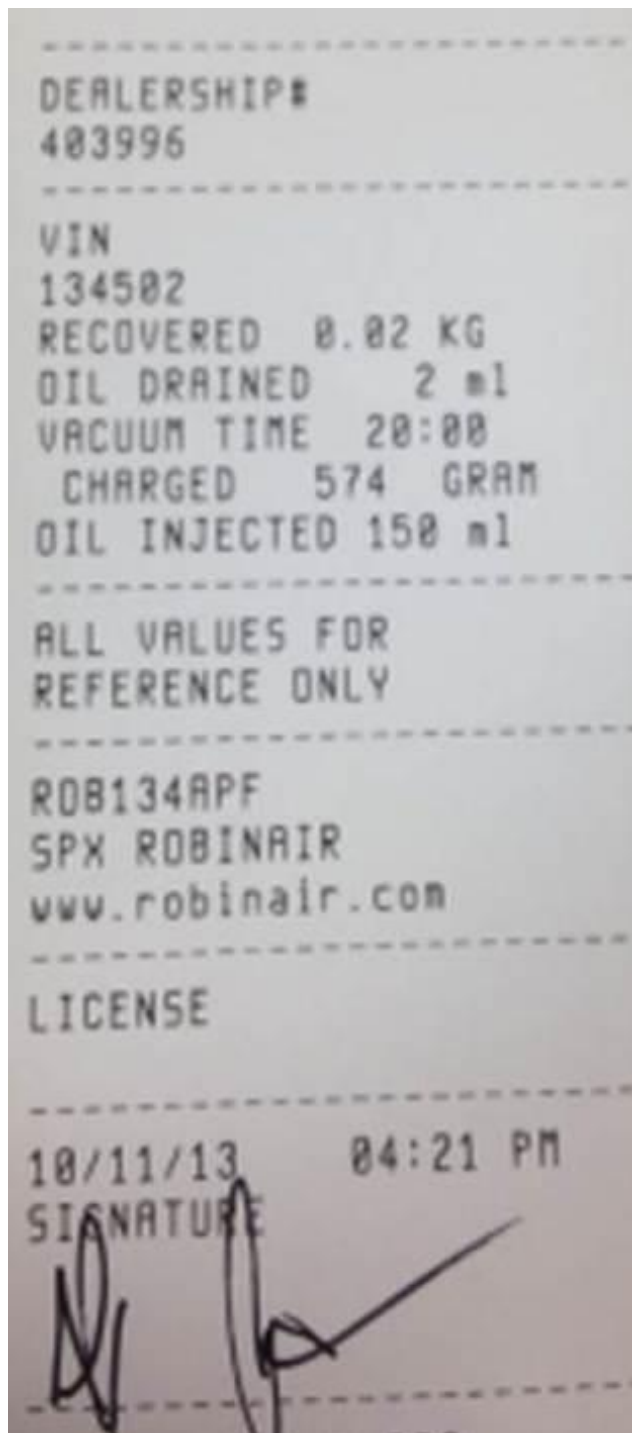
Figure 8: Print Out Example

9. The A/C service unit will create a printed report (Figure 8). Send the printed report with the defective A/C compressor. Package the defective compressor in empty packaging from the replacement compressor.

The printed report should always have the date before the compressor was replaced, the VIN and the amount of refrigerant and oil recovered. Flush procedure prints should also be provided but not substituted for the recovery documentation.
