Technical Service Bulletin

15 Camshaft bridge non-return valve is damaged

15 16 30 2045732/1 October 25, 2016.

Model(s)	Year	VIN Range	Vehicle-Specific Equipment
A6, A7, A8, Q7, R8	2012 - 2015	All	2.0 liter engine
A3, A3 e-tron, A4, A5, A5 cabriolet, Q3, Q5	2008 - 2017	All	2.0 liter engine

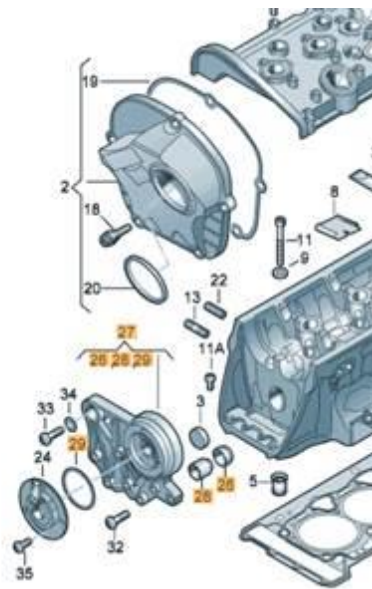
- When removing the camshaft bridge (as part of a repair) and a damaged screen of the non-return valve is detected (Figure 1 and 2).
- The complaint/repair is unrelated to the damaged screen.
- The non-return valve is not damaged (ball is in valve seat).

Figure 1. Camshaft bridge (ETKA example).

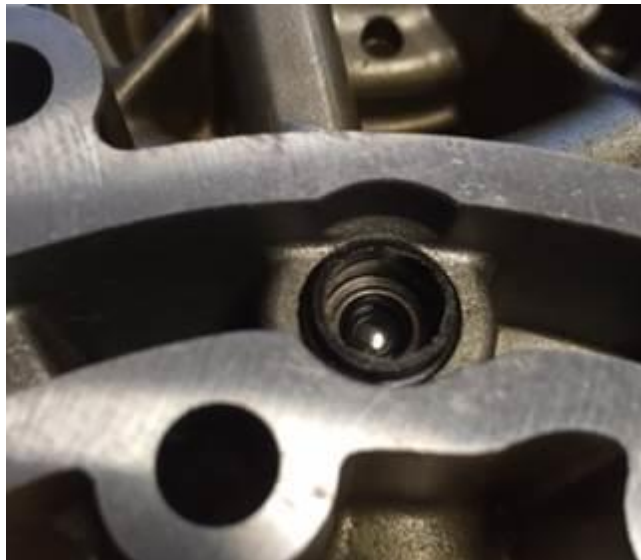
Pulsations in the oil circuit can cause the screen on the non-return valve to fail.

Figure 2. Damaged screen of the non-return valve in camshaft bridge.

If you detect during a repair that the screen of the non-return valve is damaged, remove the housing of the screen as follows:

3. In the case of a defective screen, the camshaft bridge does not have to be replaced.

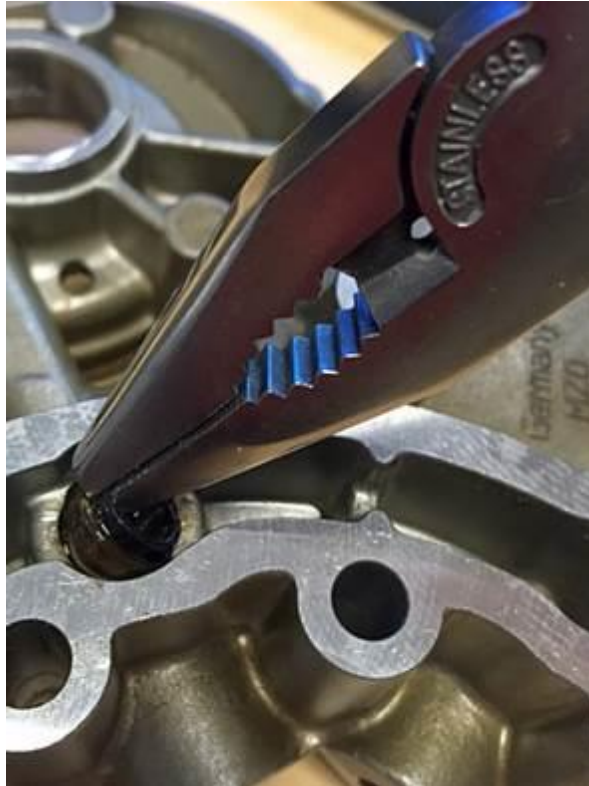
Figure 3. Removal of screen housing.

1. Grip the protruding edge of the screen housing, e.g. with long-nose pliers and pull it out of the camshaft bridge (Figure 3).

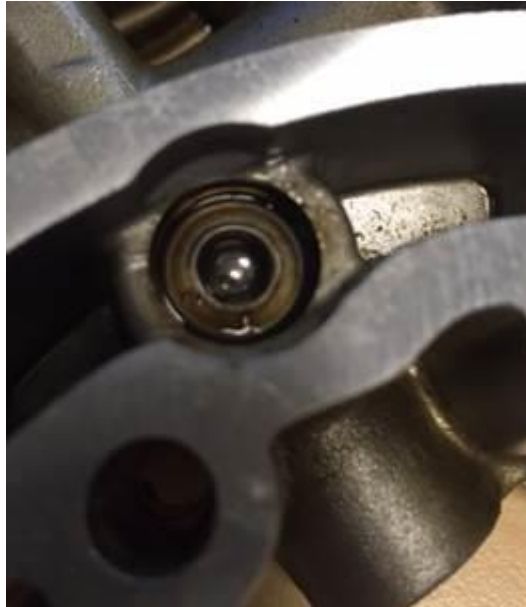
Figure 4. Non-return valve with removed screen housing.

2. Thoroughly remove any screen remnants from the non-return valve (Figure 4).
