Subject: Upcoming Service Action 80B8 – Coolant Shut-off Valve (N82)
USA: Certain 2011-2013 Model Year Audi A8 Vehicles
Canada: Certain 2010-2013 Model Year Audi A8 Vehicles

Service Action

Code: 80B8

Subject	Coolant Shut-off Valve (N82)
Release Date	October 6, 2016
Affected Vehicles	U.S.A.: 2011-2013 MY Audi A8 CANADA: 2010-2013 MY Audi A8 <i>Check Campaigns/Actions screen in Elsa on the day of repair to verify that a VIN qualifies for repair under this action. Elsa is the <u>only</u> valid campaign inquiry & verification source.</i> <ul style="list-style-type: none">✓ Campaign status must show "open."✓ If Elsa shows other open action(s), inform your customer so that the work can also be completed at the same time the vehicle is in the workshop for this campaign.
Problem Description	The coolant shut-off valve N82 may sporadically stick. If this happens, the heating output of the air conditioner will be reduced.
Corrective Action	Replace the coolant shut-off valve (N82).
Parts Information	Parts will be allocated for dealer inventory only. If allocated parts have been used and your dealership is at the weekly Upper Order Limit, please submit requests for additional parts via email

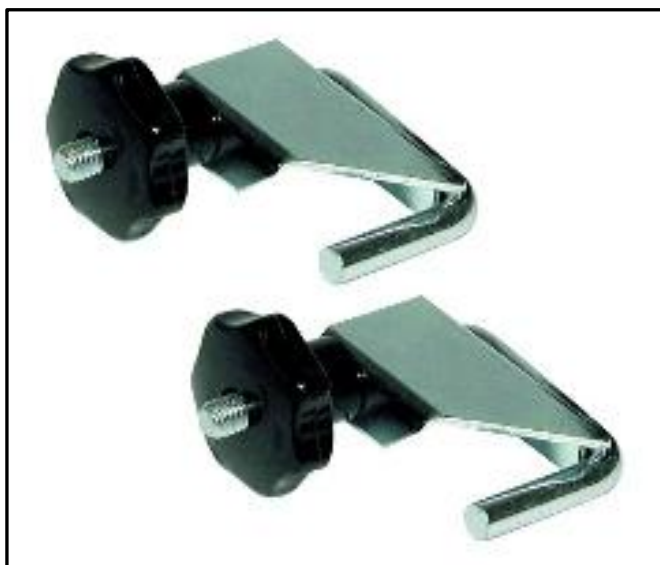
- Hose Clamps – Up To 25mm - 3094 (or equivalent)

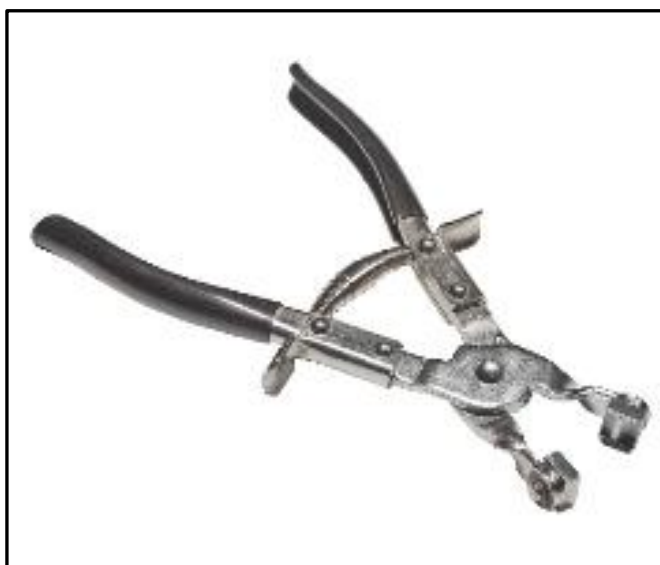
- Hose Clip Pliers -VAS6362- (or equivalent)

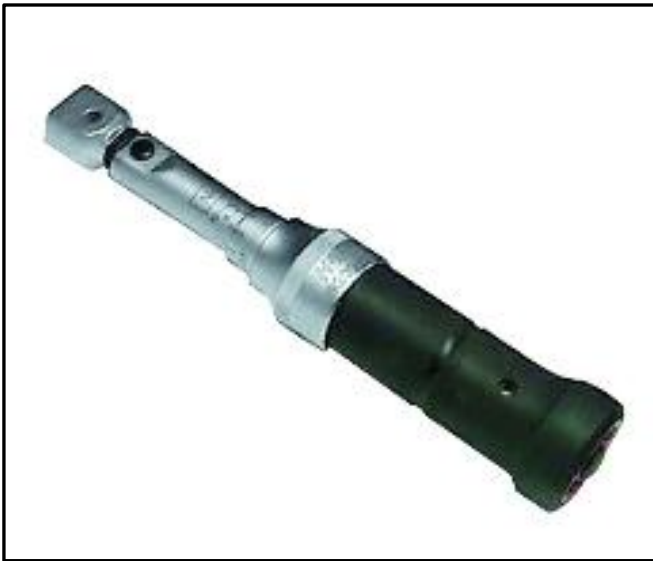
- Torque Wrench 2-10 Nm – VAG1783 (or equivalent)

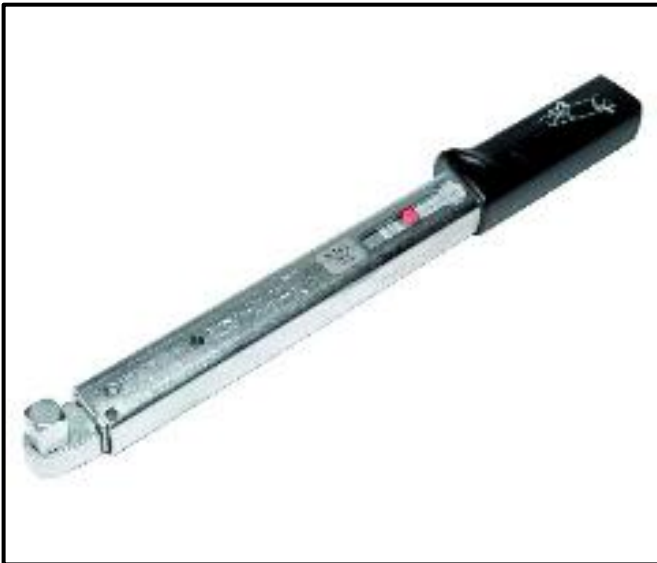
- Torque Wrench 5-50 Nm – VAG1331 (or equivalent)

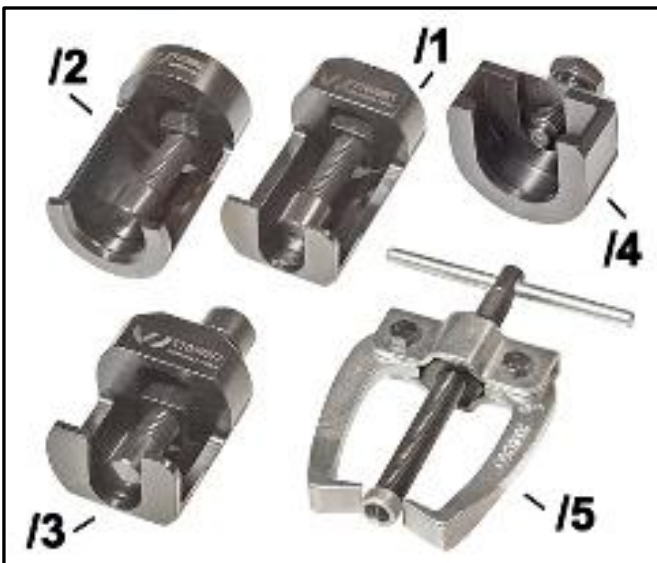
- Puller – Wiper Arm Kit – T10369

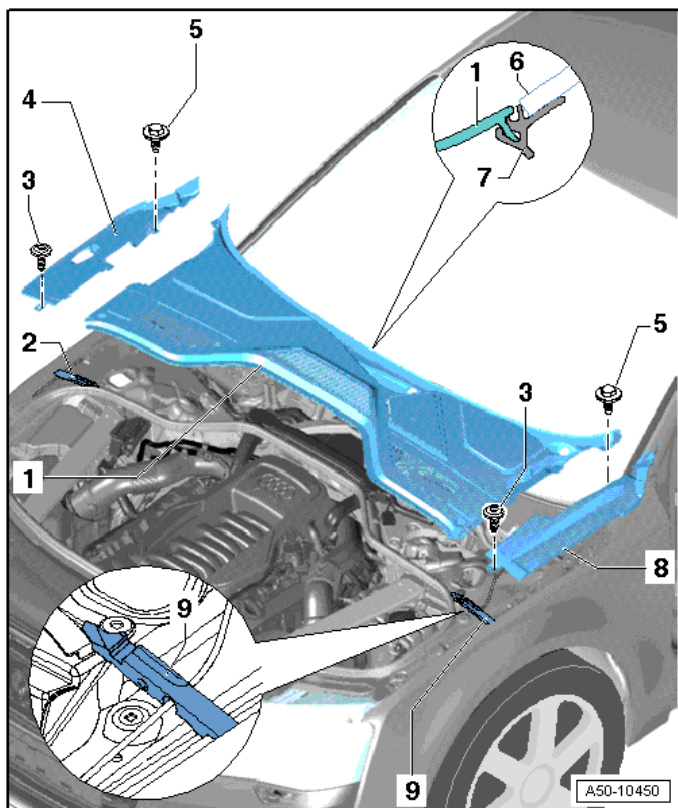
- Turn recirculation on the HVAC.
- Switch off the ignition.
- Open hood.

- Remove windshield wiper arms using T10369/2.
- Remove the hood seal in the area around the plenum chamber cover.
- Remove trim panel upward diagonally from edge frame beginning at window edge.
- Unclip the plenum chamber cover from the side covers starting on the left and right sides and then remove it.
- Remove the Air Quality Sensor –G238– (with the humidity sensor in fresh air intake duct – G6570) <A> by rotating 90° and remove it from the fresh air intake <E>.

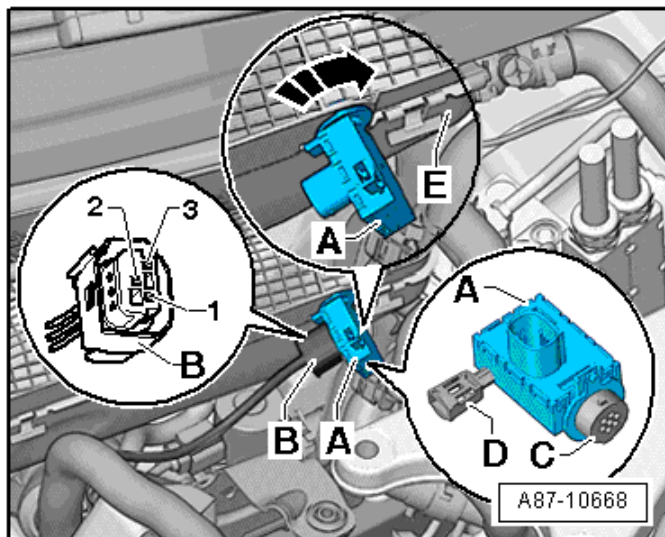
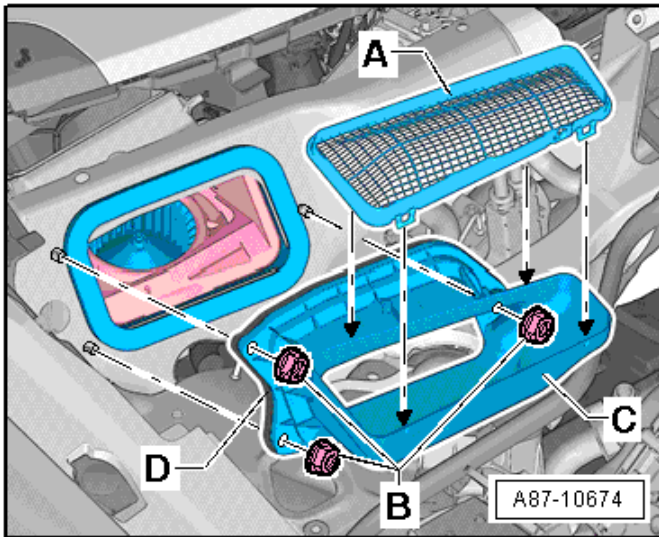
- Remove intake grill <A>.
- Remove the nuts .
- Remove the fresh air intake <C>.

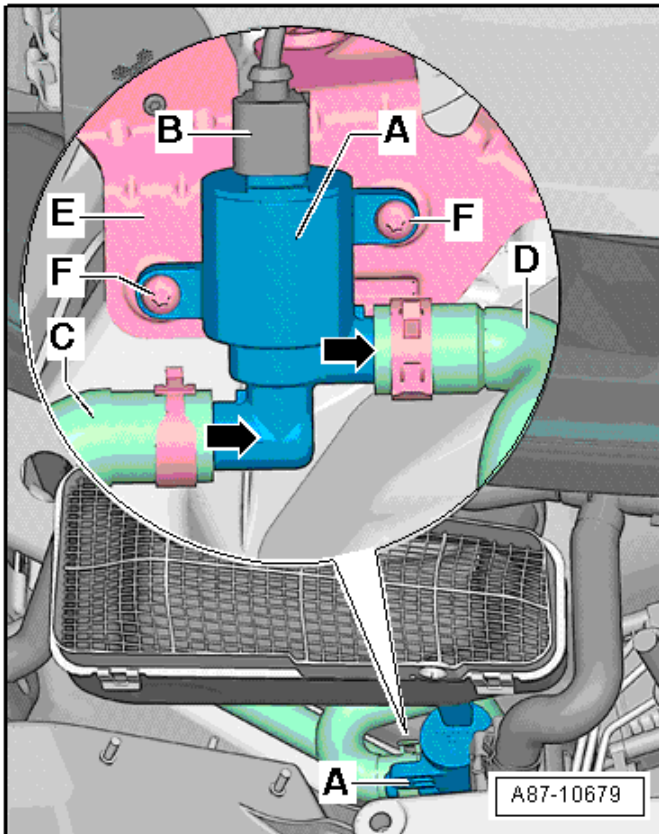
- Label the arrangement of the coolant hoses <C and D> at the coolant shut-off valve -N82- <A>.

⚠ CAUTION
 Make sure the layout of the coolant hoses <C and D> at the coolant shut-off valve –N82– is correct.
 If the coolant hoses are interchanged, there may be no heating in the passenger compartment.

- Open the coolant reservoir cap.
 - Remove the bolts <F> from the coolant shut-off valve -N82- <A>.
 - Cover the area under the heater coolant shut-off valve -N82- <A> with an absorbent rag.
 - Loosen the hose clamps <arrows>.
 - Clamp off the coolant hoses <C and D> with the hose clamps -3094-.
 - Remove the hoses <C and D>.
 - Disconnect the connector .
-
- Install new coolant shut-off valve -N82-.

- Reconnect the connector to coolant valve.

- Reconnect the coolant hoses <C and D> to the coolant valve at the locations marked earlier.

- Position clamps <arrows> in the original location and orientation.
- Remove the Hose Clamps -3094-.
- Reinstall bolts <F> and torque to 9 Nm.

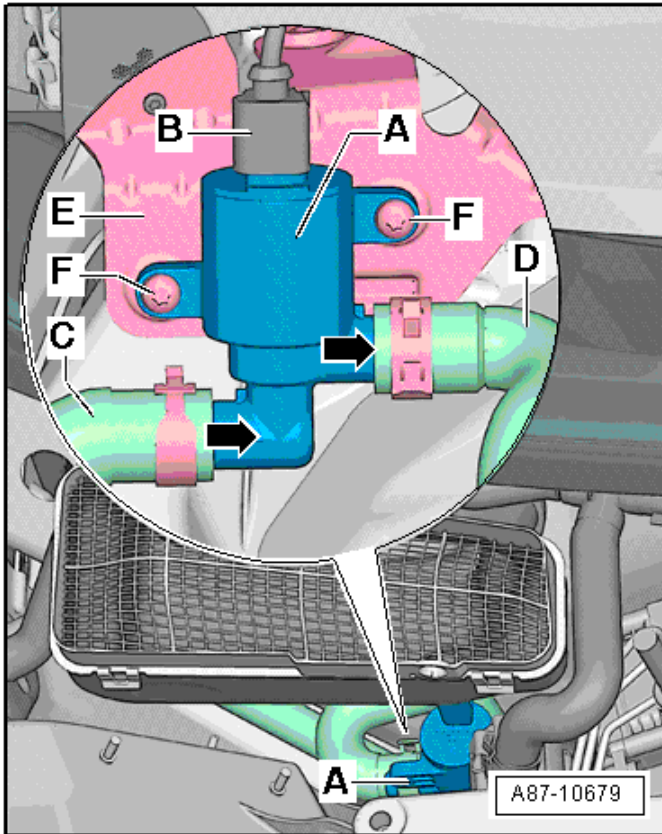
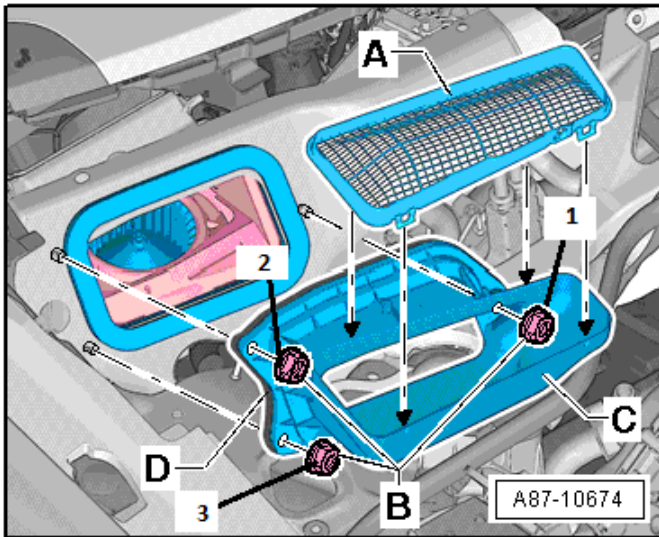
- Reinstall the fresh air intake <C>.
- Reinstall the nuts tightening to 3.5 Nm in the following order.
 - Inner nut <1>
 - Outer top nut <2>
 - Outer bottom nut <3>
- Reinstall the intake grill <A>.

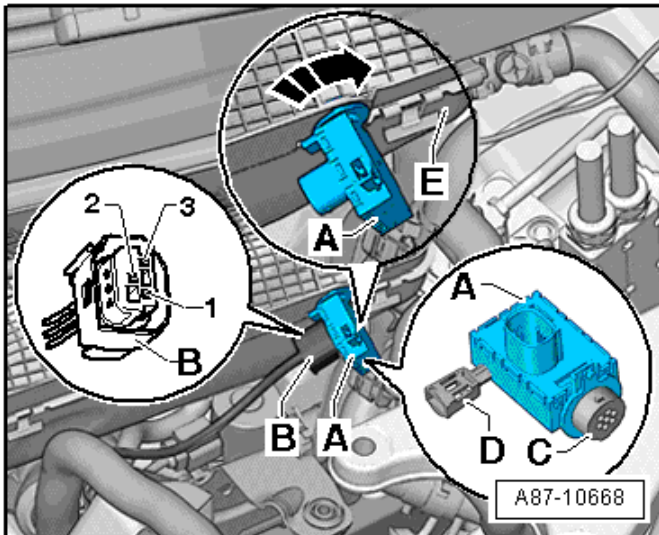
- Reinstall the Air Quality Sensor -G238- (with the humidity sensor in fresh air intake duct – G6570) <A> in the fresh air intake <E> by rotating 90°.

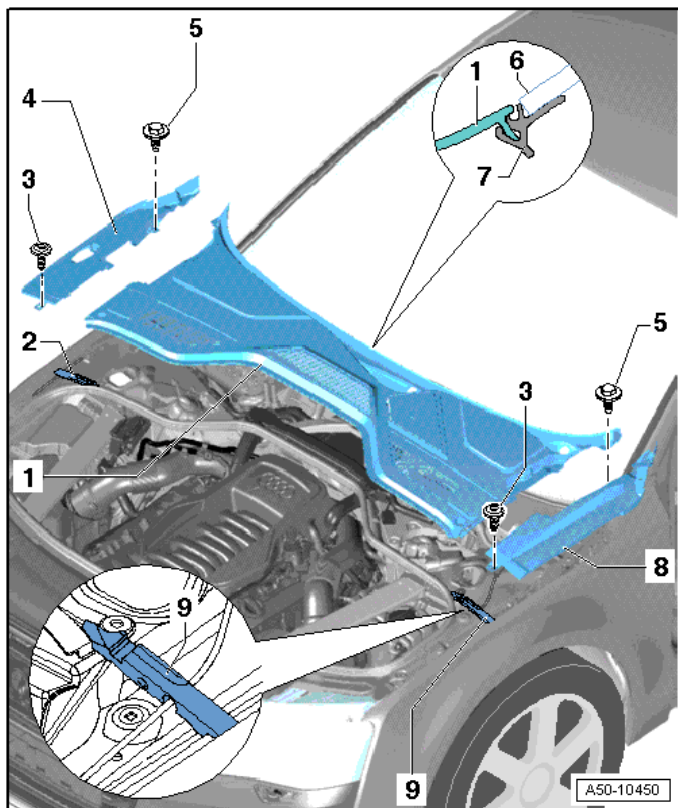
- Reinstall the plenum chamber cover.

CAUTION
 Risk of windshield breaking during installation. Do not hit the trim when installing. Carefully press in trim sideways, beginning in the edge frame. Windshield damage will not be covered under this action.

- Reinstall the windshield wiper arms tightening to 21 Nm.
- Check the coolant level and top off as required.
