Technical Bulletin

Model(s)	Year	Eng. Code	Trans. Code	VIN Range From	VIN Range To
Touareg	2004 – 2010	All	All	7L_4D000001	7L_AD005286

58 16 01 June 13, 2016 **2039001** Supersedes Technical Bulletin V581501 dated July 21, 2015 to update Claim Processing statement.

Corrosion, Rear Inner Doors in Door Fold Area

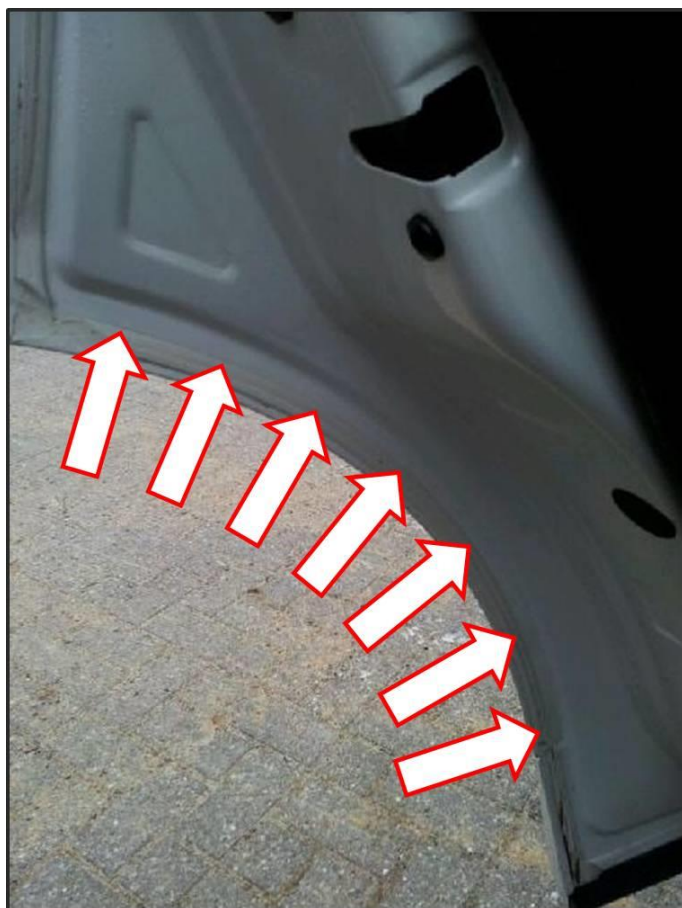
Corrosion in the fold of the rear door.

Figure 1) Arrows show the area affected by corrosion

1. Fine seam sealing in the area of the rear door fold not optimal.
2. Bonding of the rear door in the metal fold not optimal.
3. Incorrect or no cavity coating.

1. Repair the rear door fold **Only perform this operation if the total repair cost is 80% or less of the total replacement cost.**

2. Replace the rear door

If the door fold is only lightly corroded (no through-corrosion), proceed as follows:

- Protect the outer door area against damage by covering the door fold area with masking tape.
- Remove corrosion and fine seam sealing in the damaged area using a pneumatic brush grinder.

- Apply a VOC compliant epoxy primer as an anti-corrosion treatment and primer (locally sourced).
- Restore the fine seam sealing according to the repair manual.
- Restore the paint structure according to Volkswagen guidelines.

- Replace the door according to the repair manual. See Repair Manual Group 58 in Elsa.
