Technical Bulletin

Model(s)	Year	Eng. Code	Trans. Code	VIN Range From	VIN Range To
Passat Wagon	2007-2010	All	All	All	All

55 16 06 June 8, 2016 2038997 Supersedes Technical Bulletin V551408 dated December 16, 2014 to update Claim Processing comment.

Corrosion on Rear Lid around the License Plate Light Area

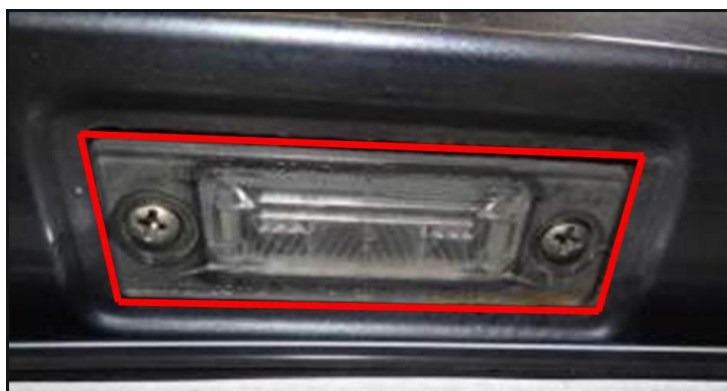
Corrosion on the rear lid around the license plate light (Figure 1, red outline).

Figure 1 – Corrosion on and around the license plate light (Screw fastened light)

Water ingress through the seal of the license plate light.

1a. Replace the rear lid.

1b. Repair the rear lid. *Only perform this operation if the total repair cost is 80% or less of the total replacement cost.*

2a. Replace screw fastened license plate light (Figure 1)

If the license plate light area in the rear lid exhibits through-corrosion (perforation), DO NOT repair, install a new rear lid.

Before the repair, check the license plate light / handle assembly area in the rear lid. If the license plate light / handle assembly area exhibits through-corrosion (perforation), DO NOT repair, install a new rear lid.

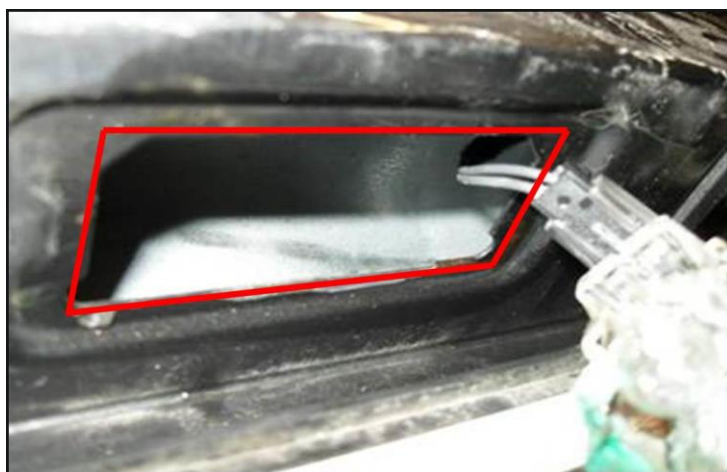
Edge corrosion on the rear lid in the contact area of the license plate light (Figure 2, red outline).

Figure 2 – Corrosion on opening for license plate light (Clipped-on light)

2b. Replace clipped-on license plate light (Figure 2)

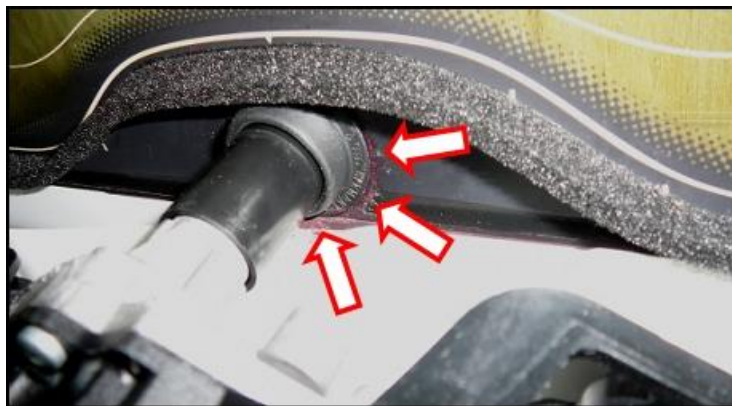
In some cases the seal for the rear wiper shaft can leak (Figure 3, red arrows) and water can get into the rear lid.

Figure 3 – Seal for the rear wiper shaft leaks

3. Replace seal for rear wiper shaft.

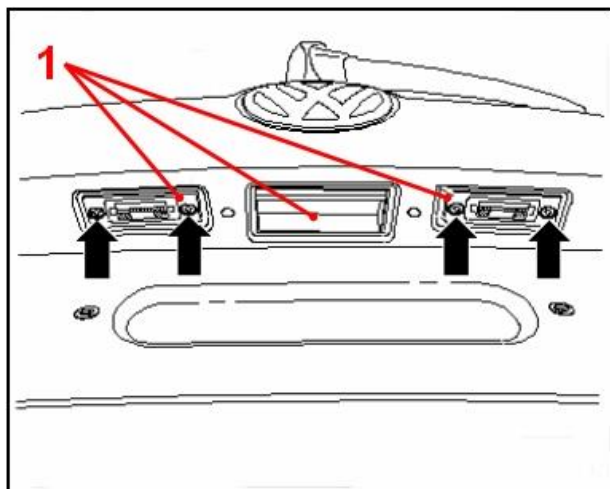
- Take off all trim pieces as well as the license plate light / handle assembly (Figure 4, number 1) necessary to remove the corrosion from the rear lid. See Repair Group 70 and Repair Group 55 in Elsa.

Figure 4: License plate light / handle assembly

- Remove the corrosion with a pneumatic brush grinder. Make sure that the edges of the rear lid do not get damaged.

- Apply a VOC compliant epoxy primer as an anti-corrosion treatment and primer (locally sourced).
- Re-paint the rear lid according to the Volkswagen guidelines.
- Install the rear lid. See Repair Group 55 in Elsa.
- Proceed to step 2a or 2b.

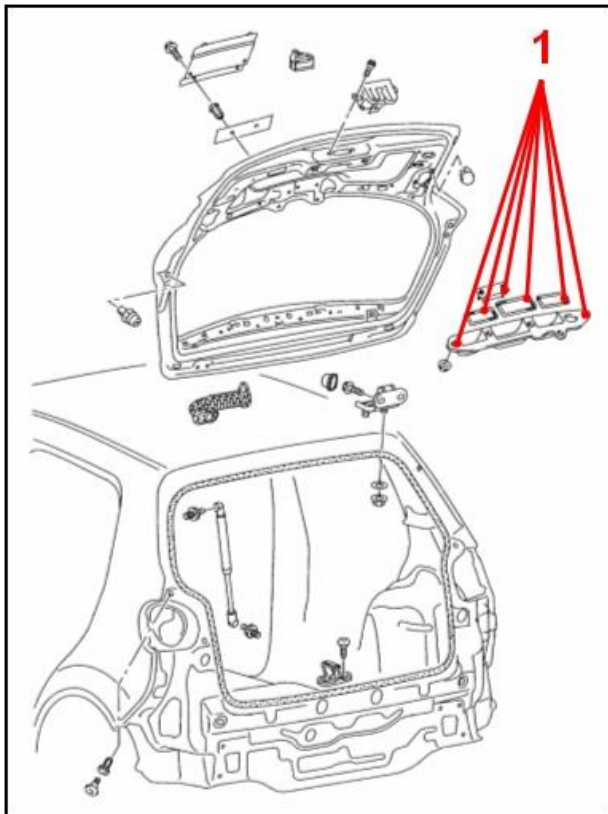
The license plate light / release handle assembly (Figure 5, number 1) must always be completely replaced.

Figure 5: License plate light / release handle assembly

Replace the license plate light / release handle assembly and seal off the contact area with butyl sealing cord.

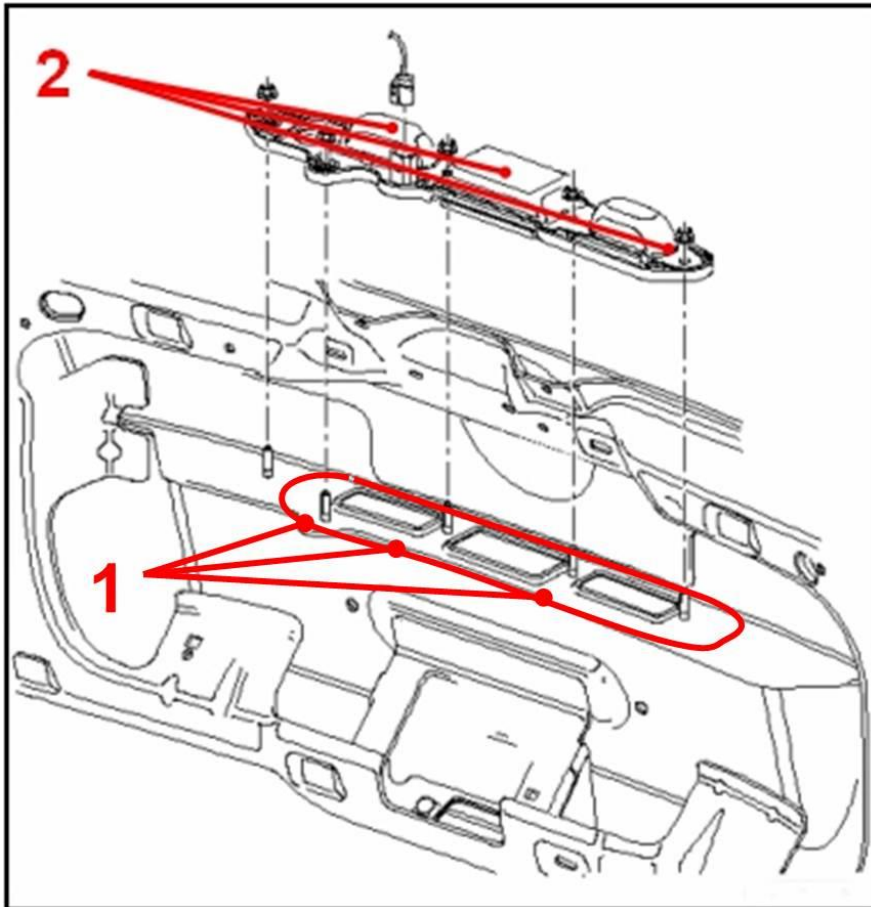
- Install the new license plate light / release handle assembly (Figure 6, number 2). See Repair Group 55 in Elsa.
- Center the handle to ensure a symmetrical fit.

Figure 6: Screw fastened license plate light

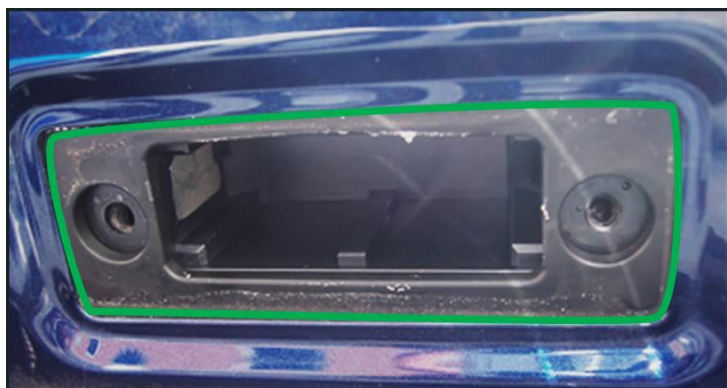
- Before installing the license plate light glass, seal off the contact surface with butyl sealing cord (part number AKL 450 005 05, Figure 7).

Figure 7: License plate light sealed off with butyl sealing cord

DO NOT over torque the mounting bolts of the license plate lights. Excessive torque may cause the glass to break.

- Install the new license plate lights. See Repair Group 94 in Elsa.
- Remove any excess butyl sealing cord.
- Proceed to step 3.

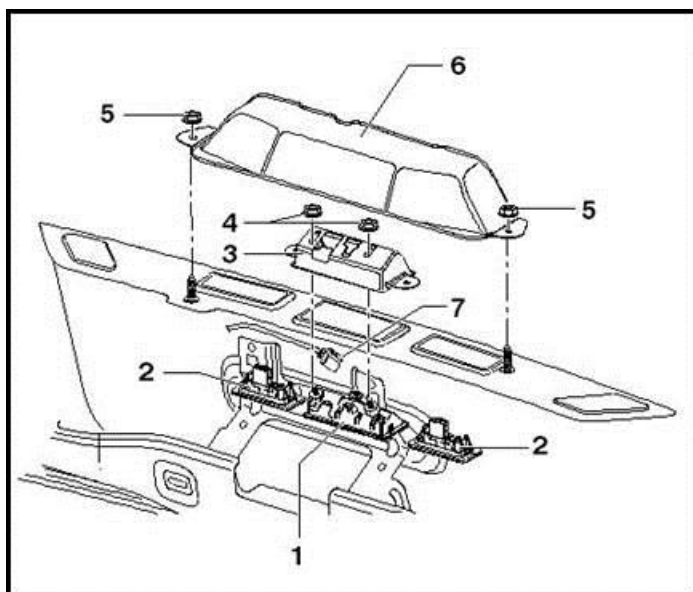
- Install the new release handle (Figure 8, number 1), handle cover (Figure 8, number 3), and assembly cover (Figure 8, number 6). See Repair Group 55 in Elsa.

Figure 8: Clipped-on license plate light

Replace the license plate light / release handle assembly and seal off the contact area with butyl sealing cord.

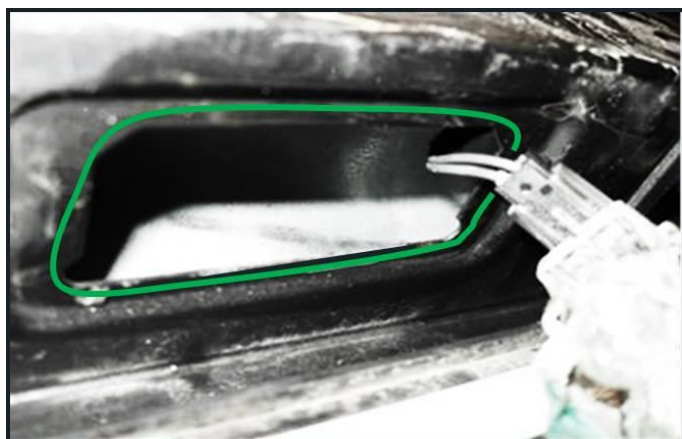
- Before installing the license plate lights, seal off the contact surface of the license plate light with butyl sealing cord (part number AKL 450 005 05, Figure 9, green mark).

Figure 9: License plate light sealed off with butyl sealing cord

- Remove any excess butyl sealing cord.
- Install the new license plate lights. See Repair Group 94 in Elsa.

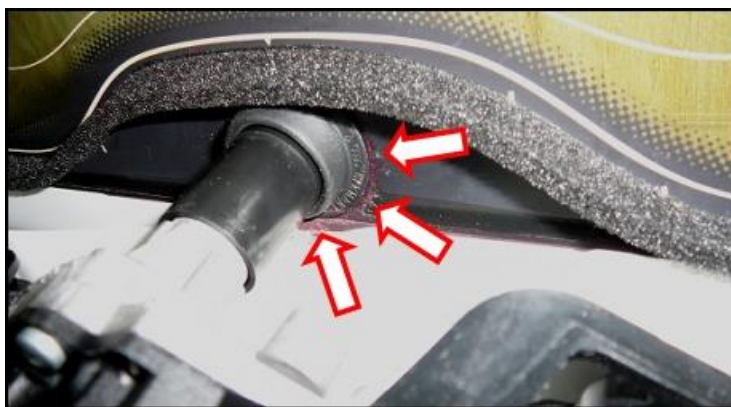
- Replace the rear wiper shaft seal (Figure 10, red arrows) with part number 6Q6 955 758 A. See Repair Group 92 in Elsa.

Figure 10: Seal for rear wiper shaft

- Install all remaining parts / trim pieces previously removed. See Repair Groups 92, 70 and 55 in Elsa.
- Adjust the rear lid fit according to the repair manual. See Repair Group 55 in Elsa.
