## Pushout Window Latch Switch Screw Adjustment

# UPDATE

**Models Affected:** All 2015 Model Year and Newer Buses with Pushout Sash Windows.

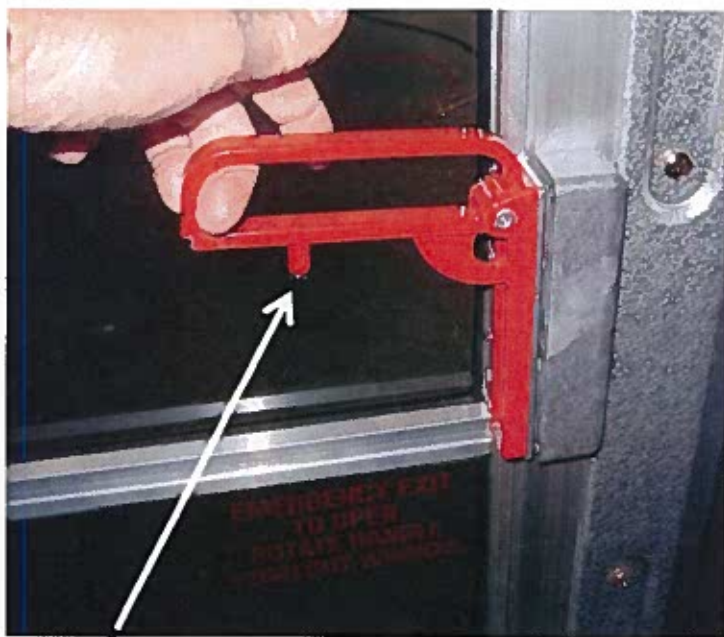
Adjustment is in the handle, see  
adjustment procedure on attached page

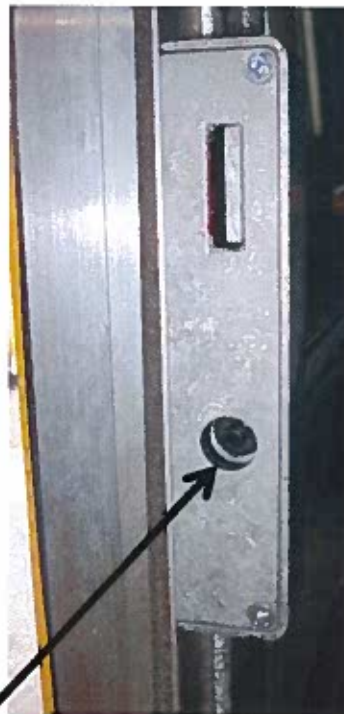
Switch is not adjustable

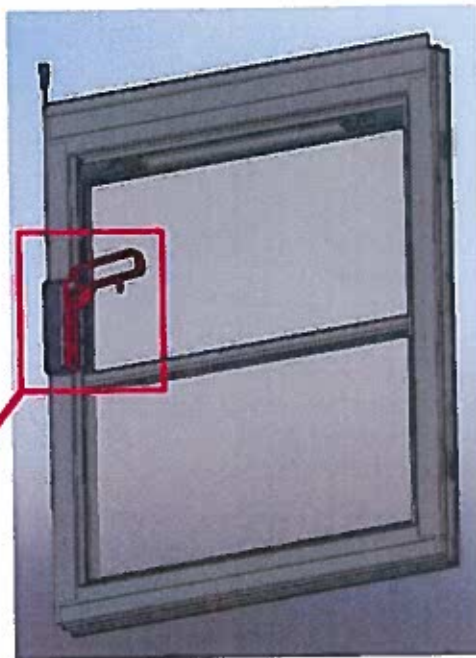
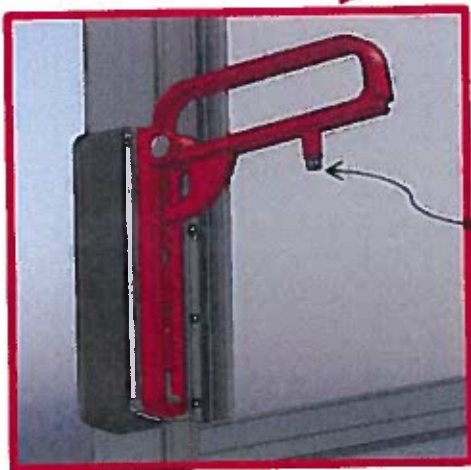
If the variation is enough to cause the latch not to engage the alarm switch a simple adjustment of the screw can correct the issue.

Lift the Push-Out Latch Handle to reveal the Hex. Head Adjustment Screw.

With a wrench turn the screw counter-clockwise to adjust the screw out until it properly engages the alarm switch when the handle is closed. Adjust in one-half turn increments, closing the latch handle to check continuity. Note that the screw has a lock patch to keep it in position after adjustment.
