**S16YW**

**Subject:** S16YW  
Side Emergency Door Heater Pipe

**Models Affected:** Model Year: Certain 2016-2017  
Model: Vision and All American

Certain 2016 through 2017 model year Blue Bird Vision and All American School and Non-School Buses equipped with optional Side Emergency Doors manufactured from October 21, 2014, through July 14, 2016, will require inspection of the heater pipe installation at the side emergency door.

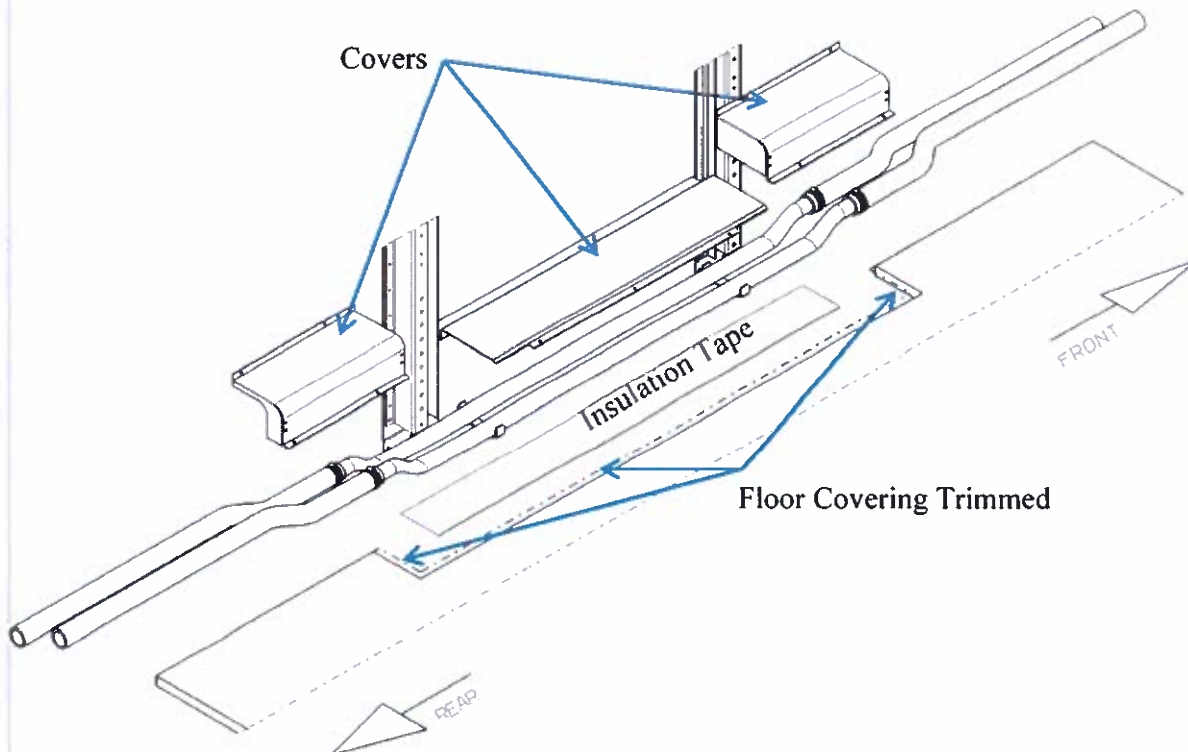
1. Park bus on level surface, turn off engine, remove ignition key, and chock wheels.
2. Remove heater pipe covers.

3. Inspect rubber floor covering at notched plywood.
4. Floor covering should be trimmed to overlap plywood by .375 of an inch.
5. It should NOT extend under the heater pipes.
6. If rubber floor mat is trimmed properly, re-install covers.

Side Emergency Door heater piping may not be installed properly. Floor covering material may not be trimmed properly forcing heater pipe to be too high.

Inspect for proper installation. Trim rubber floor covering, if needed.

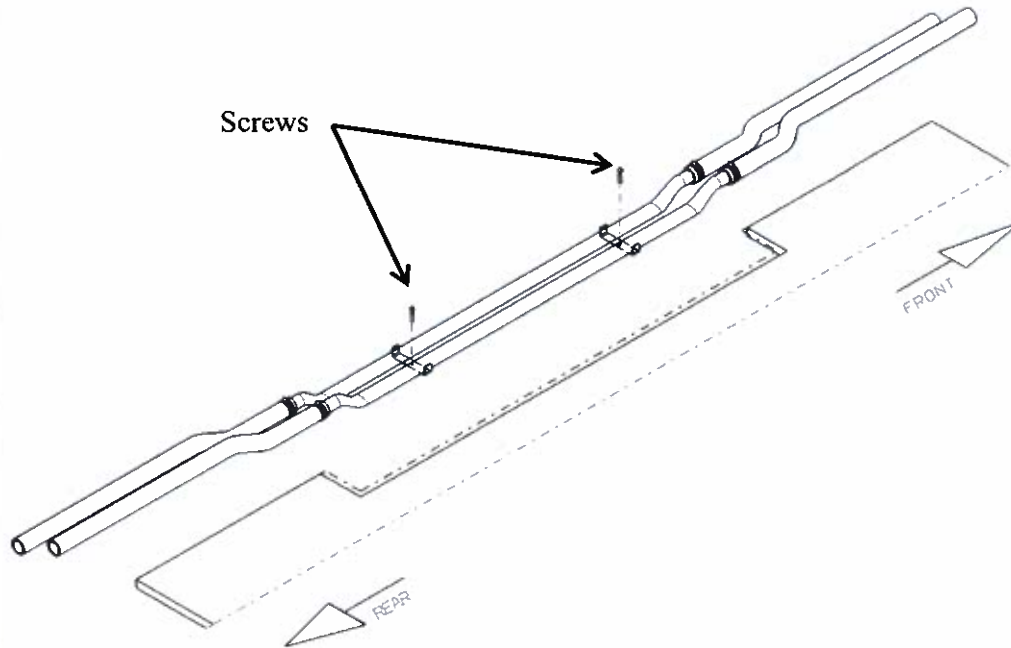
7. If floor mat is not trimmed, remove the two screws securing heater pipes to floor (do not remove hose clamps).

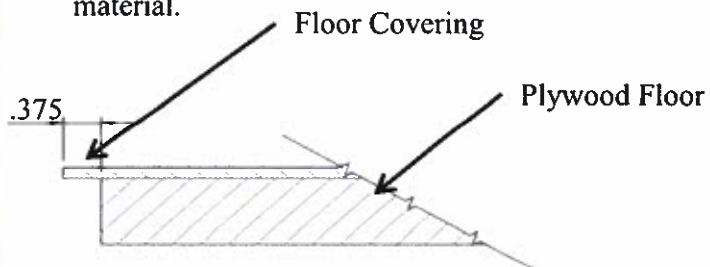
8. Raise the heater pipes to provide access to trim floor covering.
9. Trim the floor covering to overlap plywood by .375 and discard excess floor covering material.

10. Insure insulation tape is installed under the heater pipes.
11. Re-install the heater pipes to the floor.
12. Re-install heater pipe covers.
