Model(s)	Year(s)	Engine Code	Trans Code	VIN Range From	VIN Range To
All (Except Routan)	2009- <mark>2017</mark>	All Gasoline Engines	All	All	All

20 16 02 November 21, 2016 **2034072** Supersedes Technical Bulletin V201306 dated July 18, 2013 to include current model years and engine codes.

Activated Charcoal Filter System, Solenoid Valve 1 -N80- (Canister Purge Valve) Diagnosis

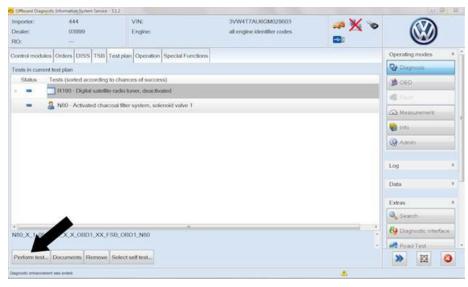
• Highlight the Activated charcoal filter system, solenoid valve 1 -N80- test plan and select "Perform Test" (Figure 3).

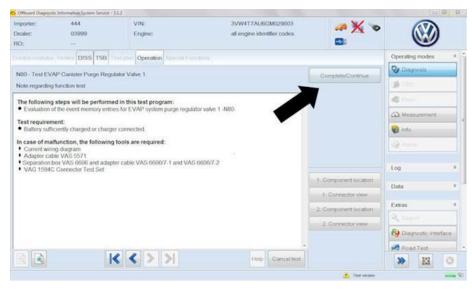
Figure 4

• Answer on screen prompts to start the -N80- test (Figures 4 and 5).

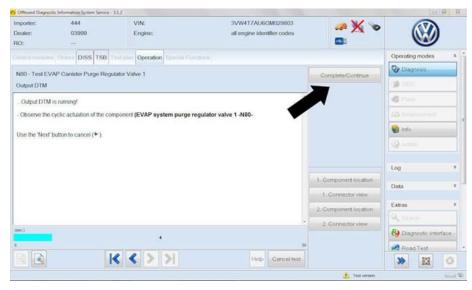
Figure 6

When the test starts, the -N80- Canister Purge Valve will be activated via the output diagnosis test mode, listen and/or feel for an audible "click" sound coming from the -N80- purge valve. The audible "click" sound may be heard easier if the vehicle hood is open.

- If audible "click" noise <u>is</u> heard, the -N80- Activated Charcoal Filter System Solenoid Valve is operational (Figure 6, 7 and 8), and a vacuum check must be performed to verify if the valve is sealing properly.
- If audible "click" noise <u>is not</u> heard this bulletin does not apply, continue Guided Fault Finding based diagnosis.

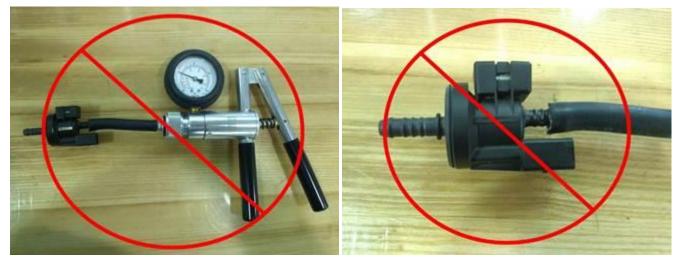
Figure 9

When performing a vacuum check on the canister purge valve please ensure to hook the vacuum pump up correctly for the valve (Vacuum should be applied to the side the flow indicator is pointing). If the vacuum pump is installed incorrectly, the seal will be pulled open, causing a false leak.

Incorrect Installation of VAS6213 vacuum pump on the Canister Purge Valve (N80). This will create a false leak resulting in unnecessary replacement (Figure 9, Bosch valve shown below).

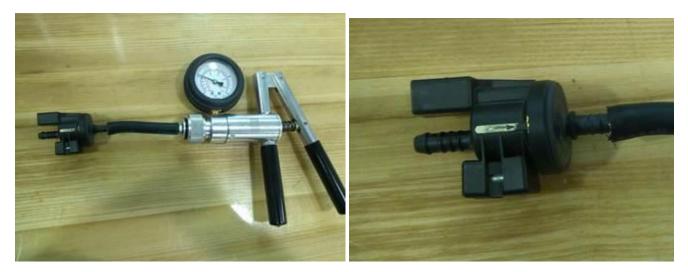
Figure 10

• Correct installation of VAS6213 vacuum pump on the Canister Purge Valve -N80- (Figure 10, Bosch valve shown below).

- If the valve holds vacuum, <u>do not</u> replace -N80- Activated charcoal filter system, solenoid valve. The canister
 purge valve is not causing the fault codes to store. This bulletin does not apply. Continue Guided Fault
 Finding based diagnosis for faults.
- If the valve does not hold vacuum, replace -N80- Activated charcoal filter system, solenoid valve. Perform leakage test to verify there are no further issues.
- Clear any DTCs that were caused by disconnecting the canister purge valve electrical connector during the test.

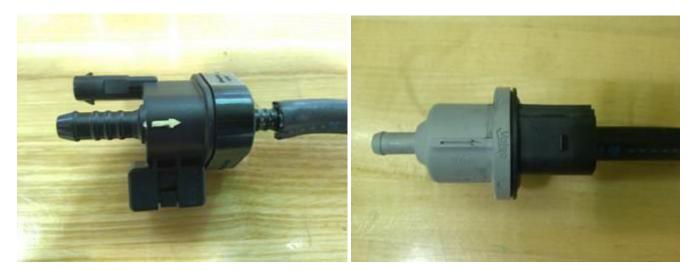
Figure 11

• Correct installation of VAS6213 vacuum pump on the Canister Purge Valve -N80- (Figure 11, Freudenberg and Valeo valves shown below).

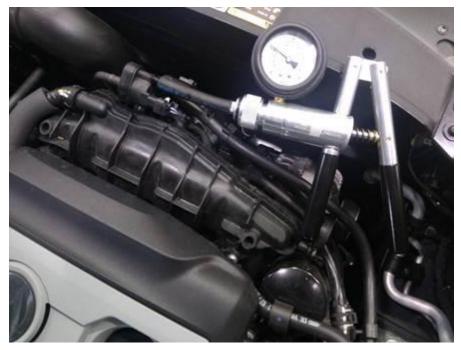
Figure 12

- With the engine OFF, remove rubber hose from EVAP Canister side of -N80- Canister Purge Valve.
- Install VAS6213 vacuum pump to the -N80- purge valve as shown below (Figure 12).

- Disconnect the electrical connector from the purge valve.
- Start the engine and allow it to idle.
- Monitor the reading on the vacuum gauge.

The reading should be at 0 PSI or higher (no vacuum should be measured).

- If there is no vacuum present at the vacuum gauge, <u>do not</u> replace -N80- Activated charcoal filter system, solenoid valve. The canister purge valve is not leaking and is not causing the fault codes to store. This bulletin does not apply. Continue Guided Fault Finding based diagnosis.
- If vacuum is present, replace -N80- Activated charcoal filter system, solenoid valve. Perform leakage test to verify there are no further issues.
- Clear any DTCs that were caused by disconnecting the canister purge valve electrical connector during the test.

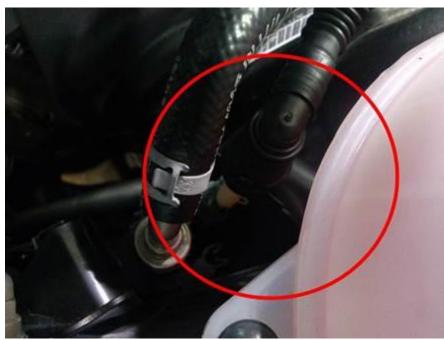
Figure 13

• With engine off, disconnect EVAP line connection to -N80- purge valve beneath coolant expansion tank shown below (Figure 13).

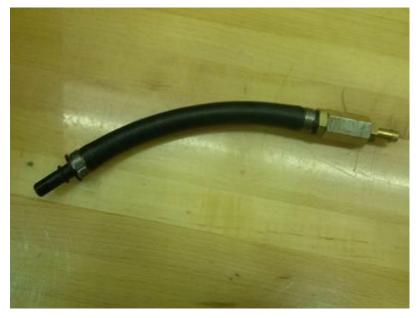
Figure 14

• Use the VAG1318 pressure gauge kit to assemble an adaptor using tool numbers VAG1318/24, VAG1318/11, and the female to female adaptor for the pressure gauge as shown below (Figure 14).

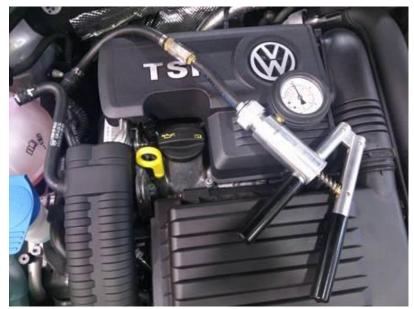
Figure 15

• Install the adaptor to the EVAP line connection to the -N80- purge valve and connect VAS6213 vacuum pump to the adaptor as shown below (Figure 15).

- Disconnect the electrical connector from the purge valve.
- Start the engine and allow it to idle.
- Monitor the reading on the vacuum gauge.

The reading should be at 0 PSI or higher (no vacuum should be measured).

- If there is no vacuum present at the vacuum gauge, <u>do not</u> replace -N80- Activated charcoal filter system, solenoid valve. The canister purge valve is not leaking and is not causing the fault codes to store. This bulletin does not apply. Continue Guided Fault Finding based diagnosis.
- If vacuum is present, replace -N80- Activated charcoal filter system, solenoid valve. Perform leakage test to verify there are no further issues.
- Clear any DTCs that were caused by disconnecting the canister purge valve electrical connector during the test.
