## Service Information Bulletin

SUBJECT	DATE
GHG17 Diesel Oxidation Catalyst Face Cleaning	May 2016

## 2 GHG17 Diesel Oxidation Catalyst Face Cleaning

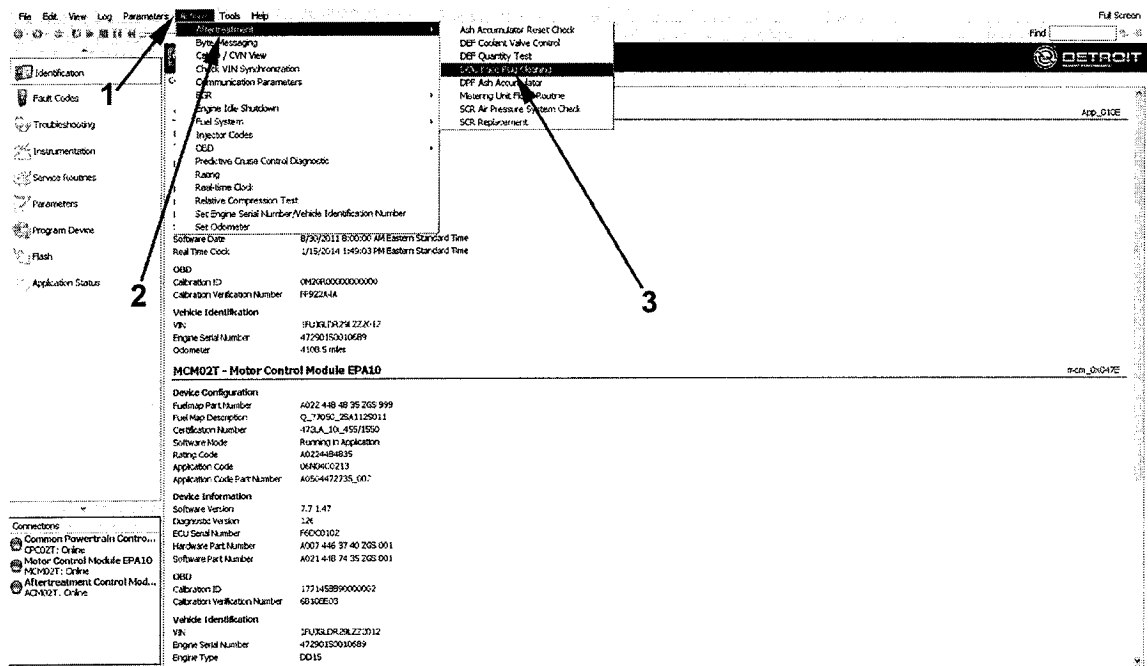
d500229

1. Start the engine and allow it to idle at base (600 rpm) idle speed.
2. Connect DiagnosticLink 8.3 with Service Pack 1 (or higher).
3. Navigate to the Actions menu (1) / Aftertreatment (2) / DOC Face Plug Cleaning (3).

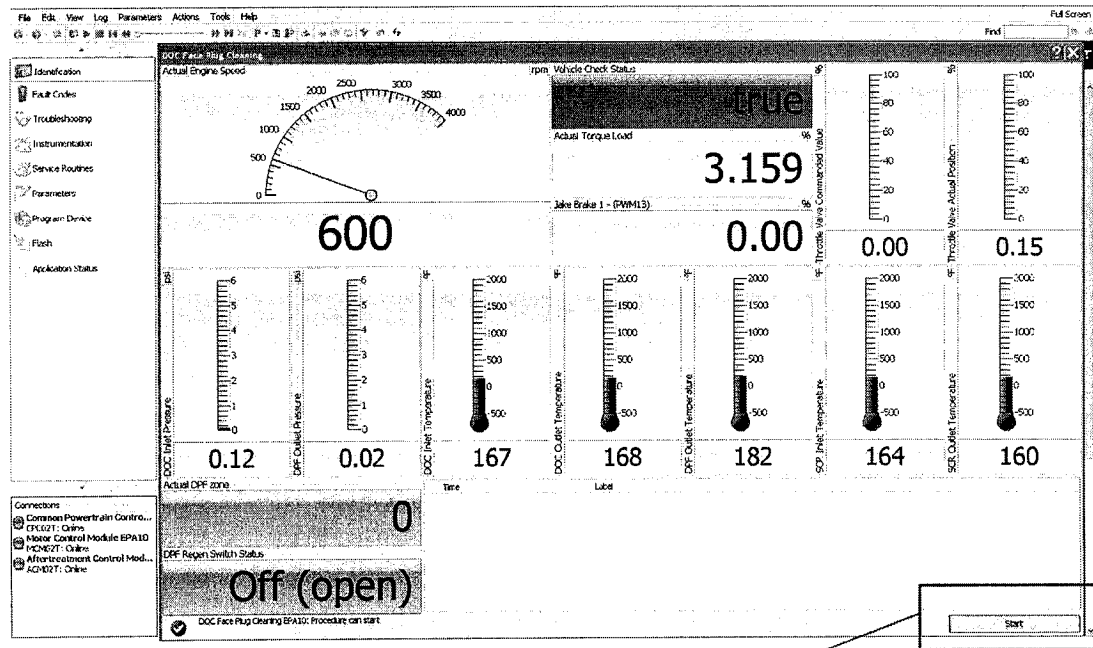
d500230

4. Once the panel opens, click on the Start button (1) in the bottom right hand corner to start the routine.

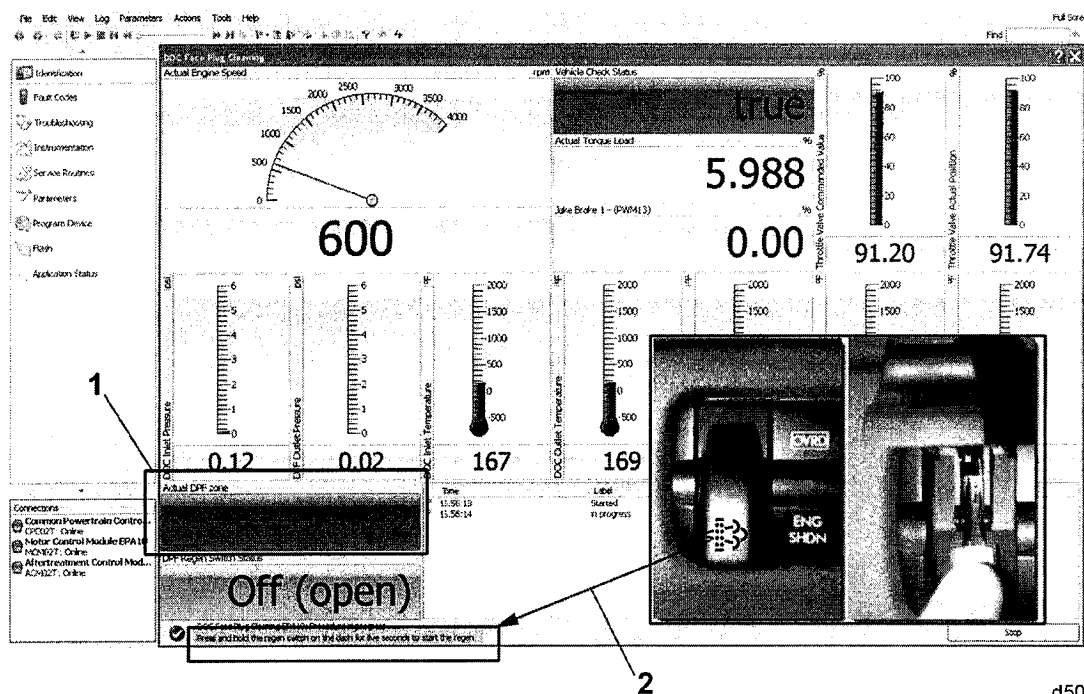
d500231

5. Once the Start button is clicked 'On', the Actual DPF zone will shift in to zone 2 (1).

6. Read the dialog prompt message in the button left hand corner. Press and hold the regeneration dash switch located on the dash for five seconds (2). See figure above.
7. When the regeneration dash switch is depressed, the DPF Regen Switch Status Box will turn green.

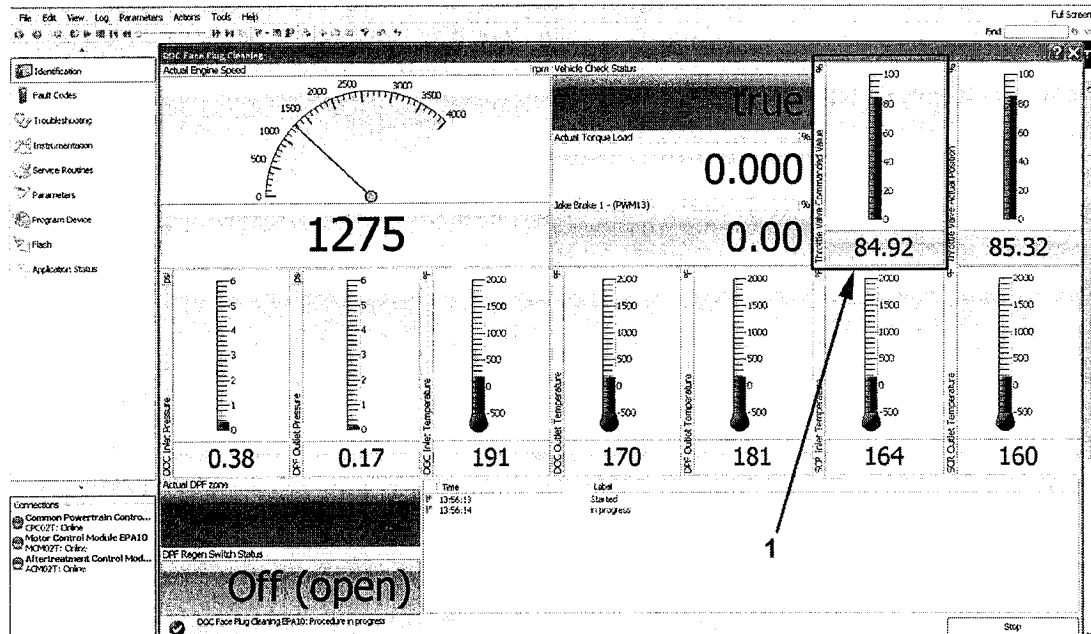
d500233

8. Once the switch has been depressed for five seconds, the engine rpm will ramp up to about 1250 rpm.
9. The Intake Throttle Valve (ITV) (if applicable) and Jake Brake 1 (PWM13) may begin cycling (temperature dependent) to raise DOC Inlet Temperature. This will cause engine rpm to fluctuate. The engine will run and sound abnormal during this transition point but this condition is **COMPLETELY NORMAL**.

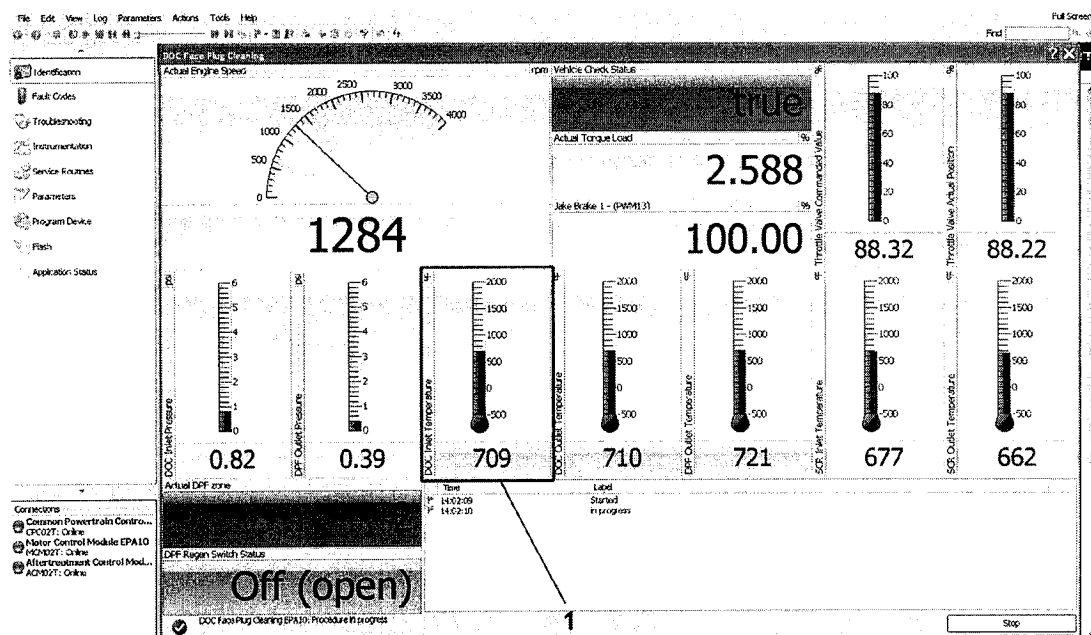
d500235

10. After the engine warms up, the ITV (if applicable) should become steady. The Jake Brake 1 (PWM13) will be steady at 100%. Engine rpm should then become stable about 1250 rpm.
11. Monitor DOC inlet temperature (1). The DOC inlet temperature should be greater than 400°C (750°F). Ambient temperature will have a large impact on DOC inlet temperature. If it is not above 400°C (750°F), block off part of the radiator. Be careful that coolant temperature does not go high enough to cause a Check Engine Light. If 400°C (750°F) DOC inlet temperature is not reached, the service routine will abort. See Figure below. Note the DOC inlet temperature (1) is too low in this picture.

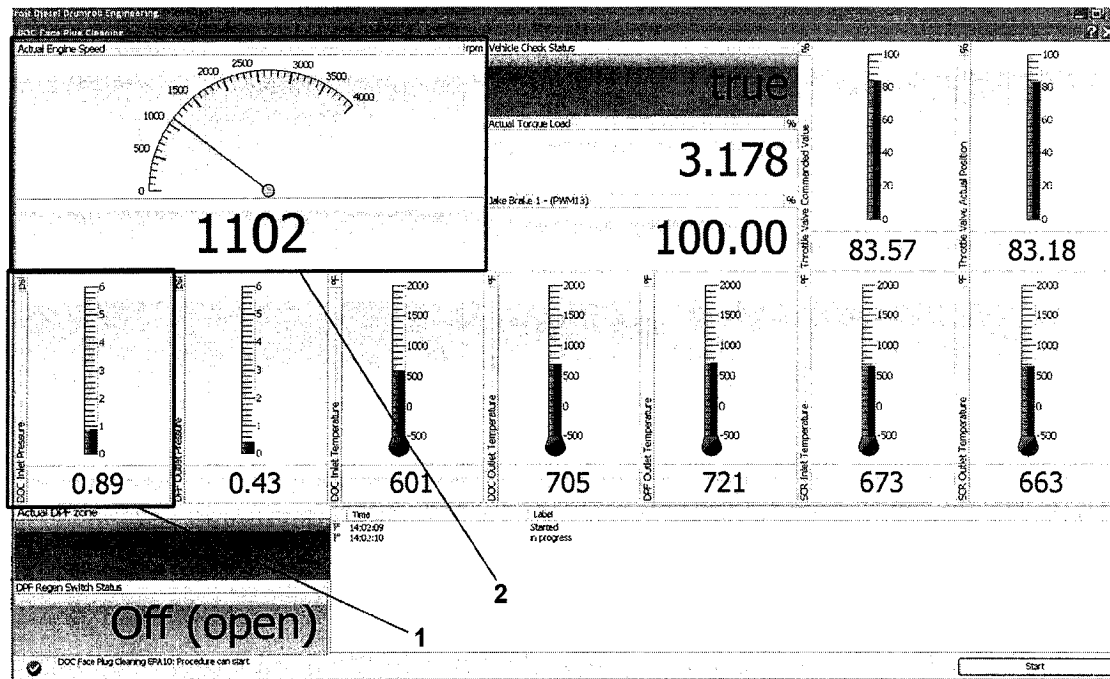
d500236

12. After four hours of run time, the engine rpm will change to 1100 - 1250 rpm (2) and a standard DPF Parked Regeneration will occur automatically. The Parked Regeneration process will take about 45 minutes.

13. If the DOC inlet pressure ((1) see above figure) is within the expected range, the routine will complete. If not, the service routine will abort.
14. After the DPF Parked Regeneration has completed, the engine will ramp down to 600 rpm to cool down.
15. The service routine is complete when actual engine speed is at 600 rpm (1).
