Service Update

49550 Brake Line Contacts Chassis Wiring Harness

Reference Number: N16204955

Release Date: October 2016
Revision: 00

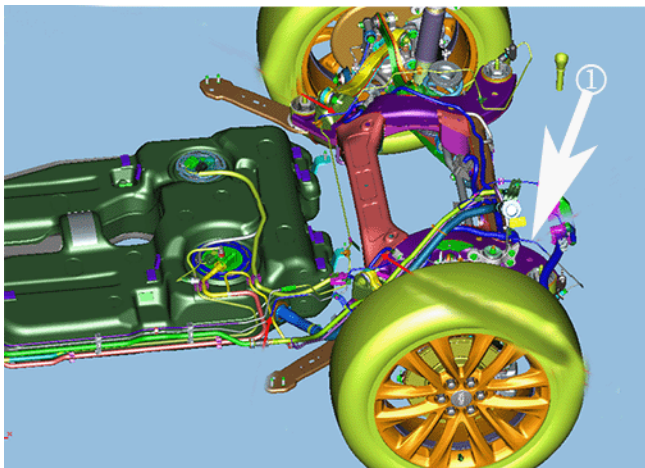
4603001

1. Raise the vehicle on a hoist. Refer to *Lifting and Jacking the Vehicle* in SI.

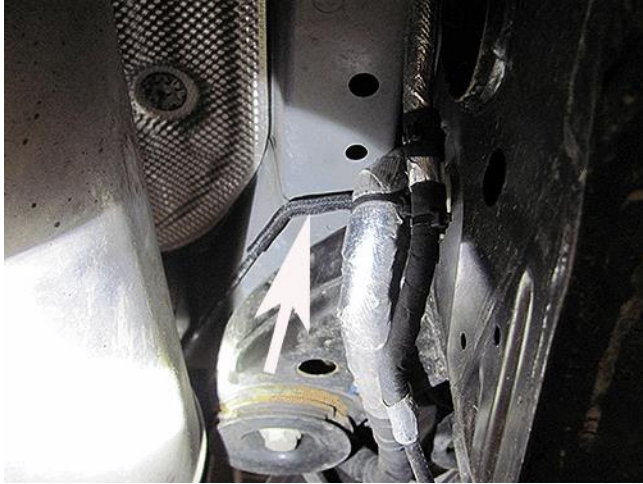
4603376

2. Locate the left rear brake pipe where it runs over the rear suspension cradle. Identify the area where the pipe may contact the chassis wiring harness (1).
3. Clean this section of the pipe with an isopropyl alcohol wipe.

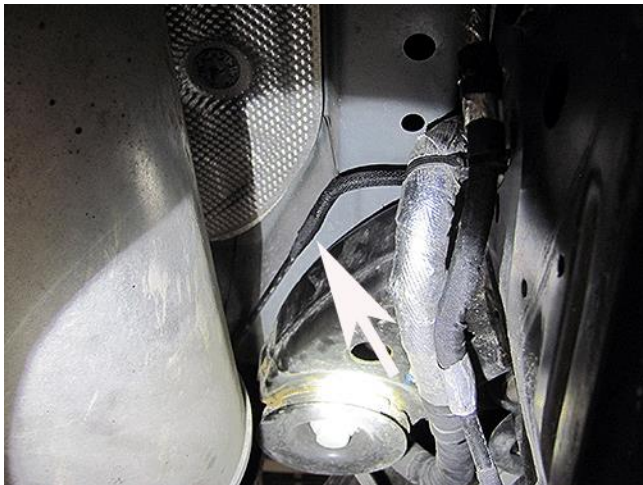
4603380

4. Install the protective sleeve as shown. Ensure it is positioned to provide maximum abrasion protection from the chassis wiring harness.

5. Wrap each end of the sleeve with at least one and one half turns of TS51036 abrasion resistant wire harness tape.
6. Lower the vehicle. Refer to *Lifting and Jacking the Vehicle* in SI.
