Document ID: IK1200909

Title: Complete Turbocharger Replacement Guidelines for MaxxFORCE® DT, 9, 10, 11, 13, 15, N9, N10 and N13 Engines

Applies To: 2010 MaxxFORCE DT, 9, 10, 11, 13, 15, N9, N10 and N13 Engines

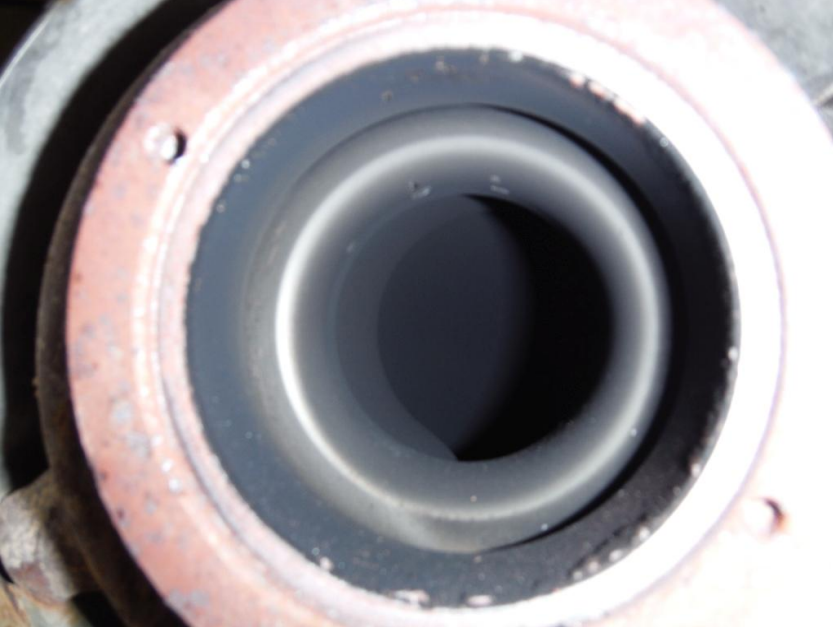
<p>Minor damage to the Turbine housing (Exhaust Side) of Turbocharger. Reference Special Requirement at the bottom of the page for proper cleaning and replacement procedure.</p>
	<p>Small nick's in the Turbine (Exhaust Side) Housing of the Turbocharger. Reference Special Requirement at the</p>

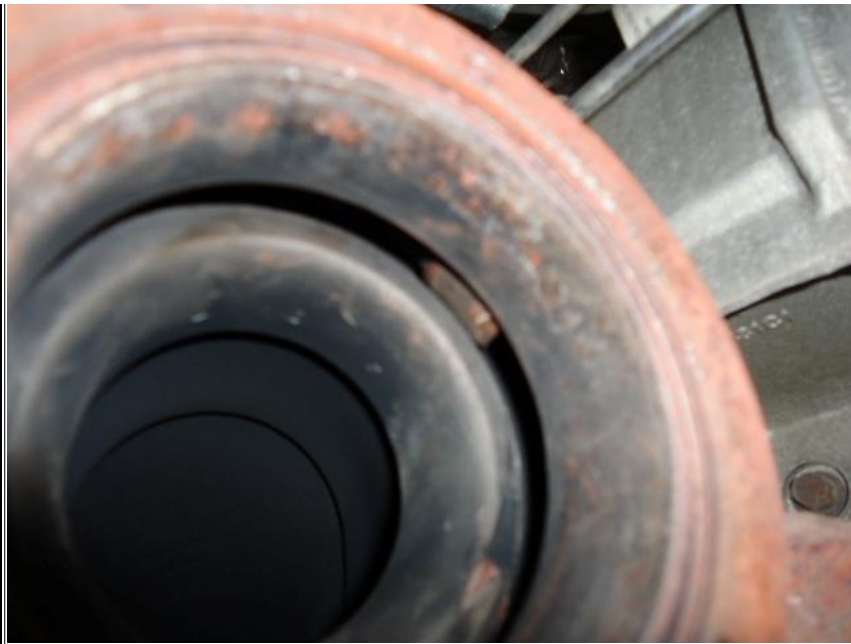
bottom of the page for proper cleaning and replacement procedure.

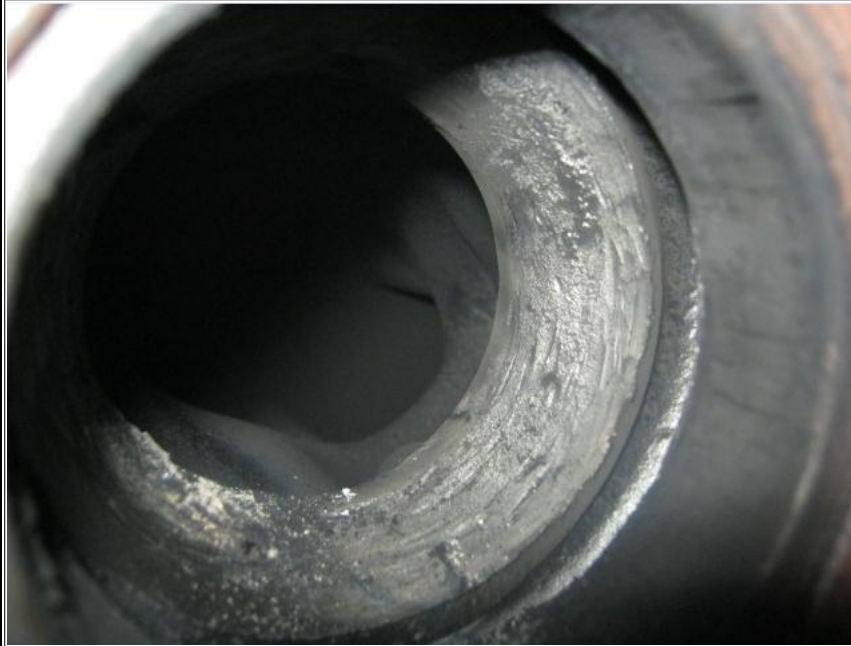
Major Damage to Turbine (Exhaust Side) Housing of the Turbocharger. Turbocharger is recommended to be replaced as an assembly.

Damage to Turbine (Exhaust Side) Housing of Turbocharger. Turbine housing will need to be cleaned.

Special Requirement at the bottom of the page for proper cleaning and replacement procedure.

Once clean of all soot reevaluate damage to Turbocharger. If major Damage to Turbine Housing of the Turbocharger is found after cleaning. Turbocharger is recommended to be replaced as an assembly.

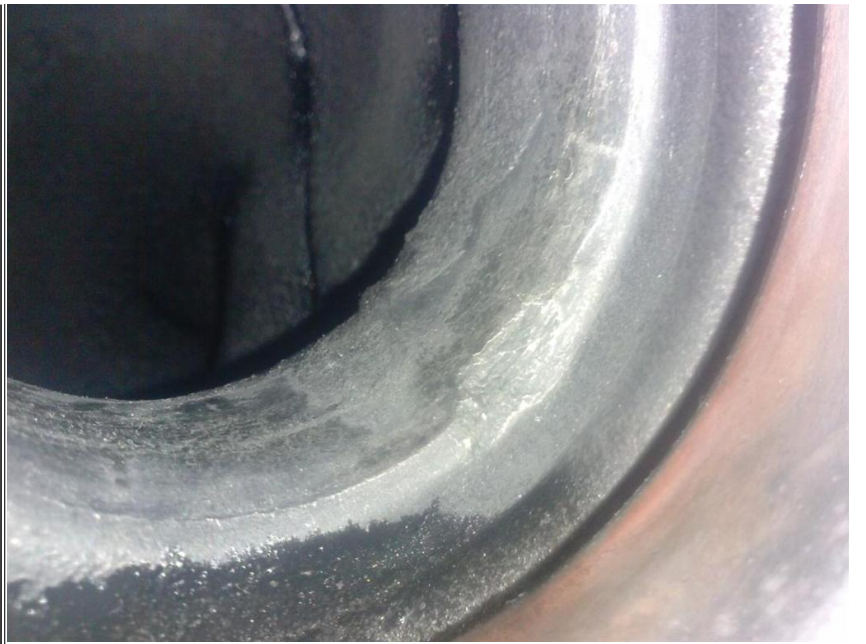
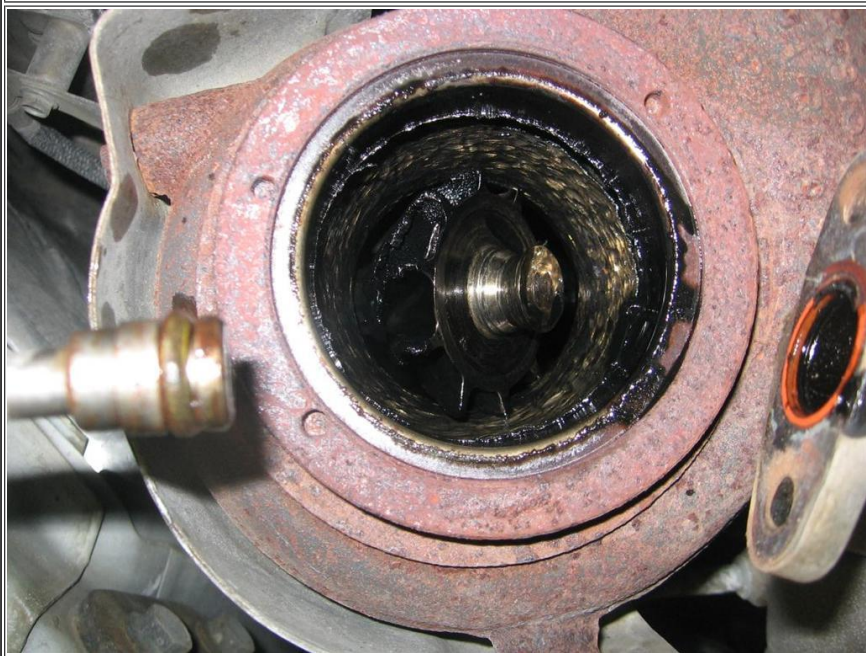
<p>Major Damage to Turbine (Exhaust Side) Housing of the Turbocharger. Turbocharger is recommended to be replaced as an assembly.</p>
<p>Removal of the wastegate has resulted in broken bolts on the turbine (Exhaust) housing. (MaxxForce 11, 13 and N13 Engines only)</p>	<p>Turbocharger is recommended to be replaced as an assembly. (MaxxForce 11, 13 and N13 Engines only)</p>
<p>A binding or sticking wastegate is found.</p>	<p>Turbocharger is recommended to be replaced as an assembly.</p>
